# APPENDIX C: HAZARD TREE ASSESSMENT

March 30, 2017

# Tree Risk Assessment Report – Beachcomber Regional Park

Walter Ernst, RPF (#4071), ISA Certified Arborist (PN-7288A),  
Certified Tree Risk Assessor (CTRA 1467)

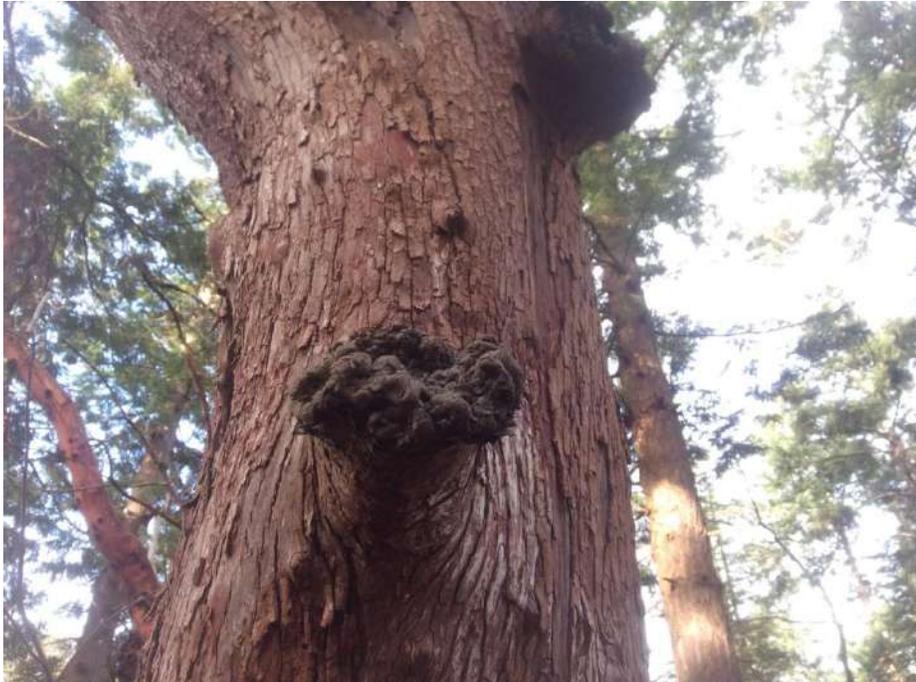
**Figure 1: Photo showing canker growth on Arbutus tree.**

**\*\* Ensure that debris from Arbutus are not in direct contact with other mature or immature Arbutus trees to minimize canker spread.**

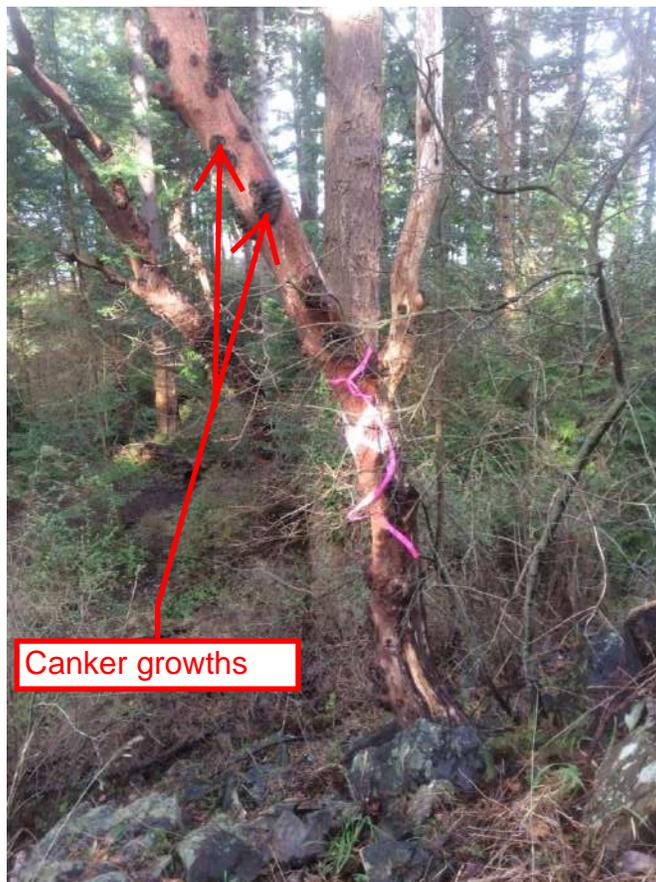
**Figure 2: Photo showing numerous canker growths on recently dead Arbutus tree.**

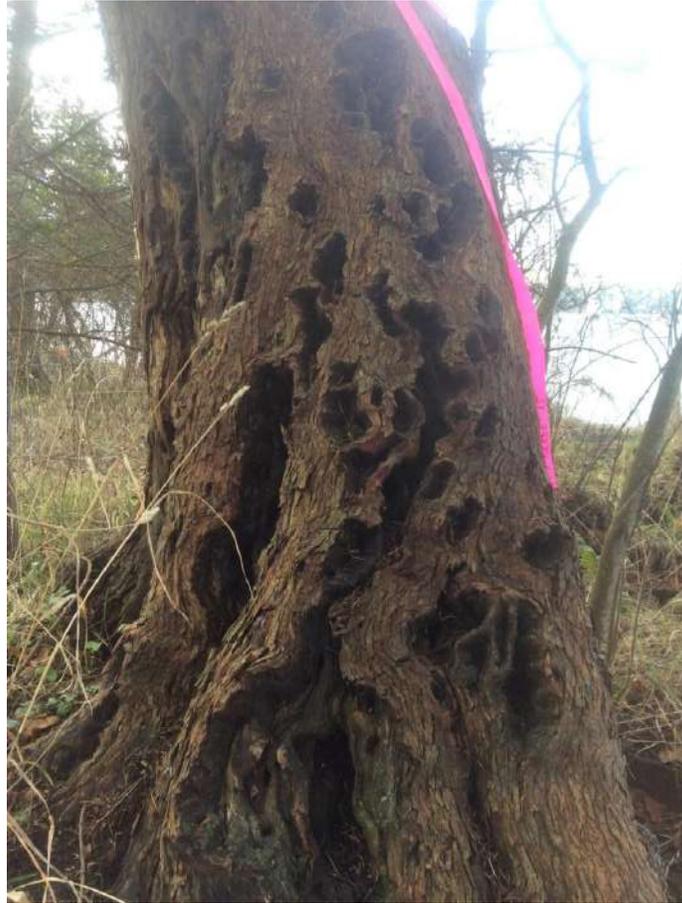
**Figure 3: Photo showing numerous canker growths at base of dead Arbutus tree.**

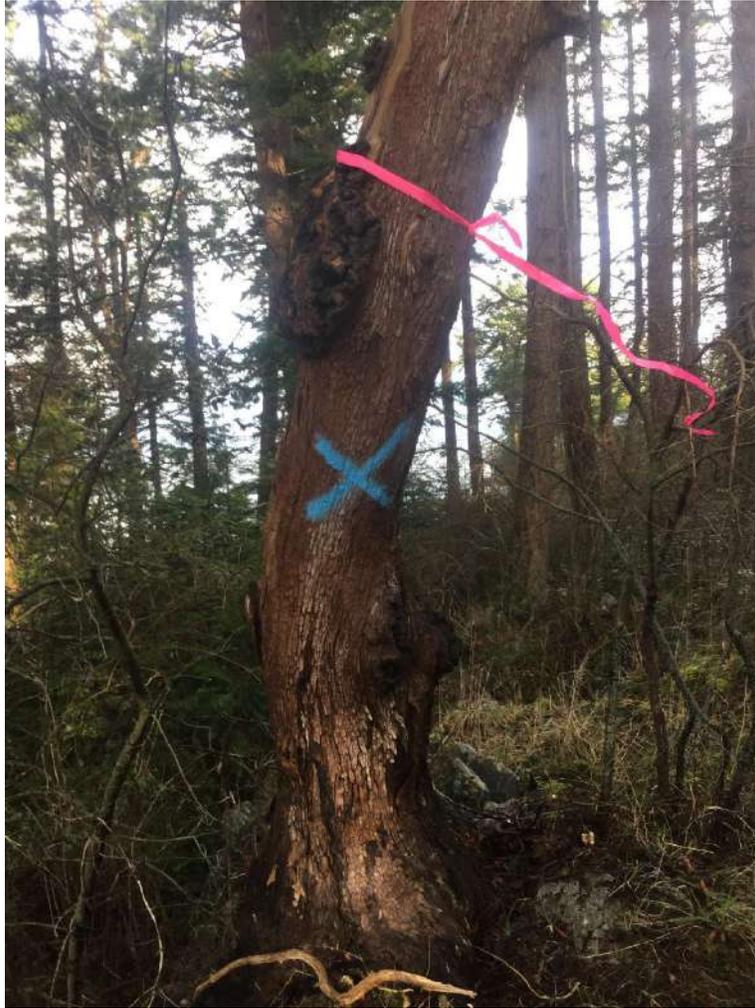
Figure 4: Photo showing marking standard used for Urgent Removal Trees

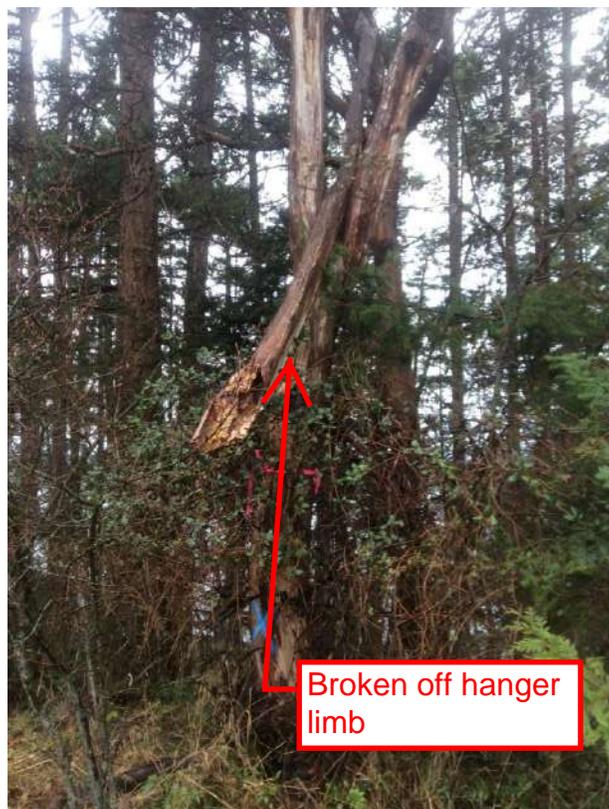
**Figure 6: Photo showing Urgent Removal –Tree #1 (Arbutus) at parking lot**

Tree #	Spp.	DBH (cm)	Ht (m)	Location	Risk	Tree Condition	Treatment Recommendations	Timeline for Tree Removal or Modification Treatment (Urgent, Future Treatment, Monitor)
1	Arbutus	35.0	6.5	Edge of park adjacent parking lot.	M-H	Imminent failure. Dead tree with broken limb hanging within fork. Significant rot. Potential for loose limb to slide out and fall. Madrone Canker suspected.	Directionally fall whole tree. Minimize damage to adjacent trees. Cut stem and large limbs into firewood lengths, fully limb the tree, and cut all non-firewood limbs and tops into 2m lengths and scatter to lay flat on the ground away from the trail pathway.	Urgent / Removal
2	Fdc	17.0	24.0	Within Park	H	Spindly tall dead Fdc tree. Flaking bark near top. Potential for top to break off. Tree 6-7m from Trail.	Directionally fall whole tree. Minimize damage to adjacent trees. Cut stem and large limbs into firewood lengths, fully limb the tree, and cut all non-firewood limbs and tops into 2m lengths and scatter to lay flat on the ground away from the trail pathway.	Urgent / Removal

Timeline / Tree Work Category	Applicable Tree #s	Recommended Work
<b>Urgent Tree Removal</b>	Trees 1 to 2, 4, and 6 to 7 (3 Arbutus & 2 Douglas-fir)	Directionally fall whole trees. Minimize damage to adjacent trees. Cut stems and large limbs into firewood lengths, fully limb the trees, and cut all non-firewood limbs and tops into 2m lengths and scatter to lay flat on the ground away from the trail pathways. For Tree #6 (Arbutus), rigging will be required in order to ensure two adjacent small Garry oak (3-4m height; located 5m to south of tree) are not damaged. Refer to Tree Risk Map for Garry oak locations.
<b>Urgent Wildlife Tree Creation</b>	Tree 12 (Arbutus)	Top tree at 4m height to remove weight off main stem. Care required in minimizing damage to adjacent Garry Oak. Refer to Tree Risk Map for Garry Oak location. Ensure rigging used to suspend limb, and worker may need to make a few cuts to avoid damage to Garry Oak. Adjacent Douglas-fir tree can be utilized to climb up and remove top. A long hand pruner or chainsaw is required. Cut debris to 2m lengths and scatter to lay flat to the ground away from the trail path.

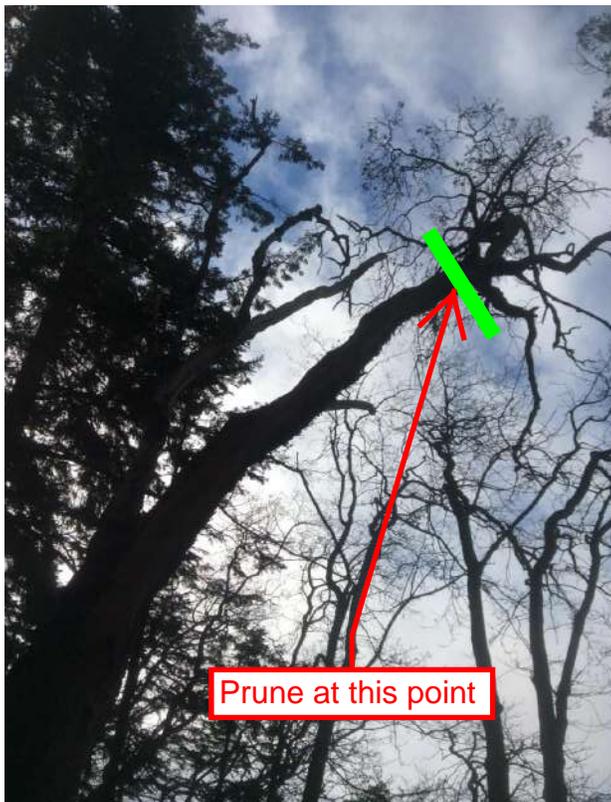
**Figure 7: Photo showing Urgent Wildlife Tree Creation –Tree #12 (Arbutus) at parking lot.**

12	Arbutus	55.0	7.0	Within park near benches, trail, and beach.	M-H	Dead tree with significant rot at base. Open wound at base with 2/3 rot. Madrone Canker.	Create wildlife tree. Top at 4m height to remove weight off main stem. Care required to minimize damage to adjacent Garry Oak. Refer to Tree Risk Map for Garry Oak location. Ensure rigging used to suspend limb, and may need to make a few cuts to avoid damage to Garry Oak. Can use adjacent Fdc tree to climb up and remove top. Long hand pruner or chainsaw required. Cut debris to 2m lengths and scatter to lay flat to the ground away from the trail path.	Urgent / Topping (wildlife tree)
13	Arbutus	95.0	17.0	Within Park, not marked.	L-M	Arbutus with dead limbs. Potential to break off at some point but not imminent. Arbutus still live and in low to moderate health. Upper 1/3 of tree still has foliage. Tree is declining rapidly. Open cavity at base with some rot but still structurally sound. Madrone Canker infected tree.	Reassess tree for further decline and risk. Prune dead limbs. Ensure pruning cuts are completed to ISA Arboriculture Standards. Cut pruned debris to 2m lengths and scatter debris to lay flat on the ground away from the trail pathway.	Future / Pruning

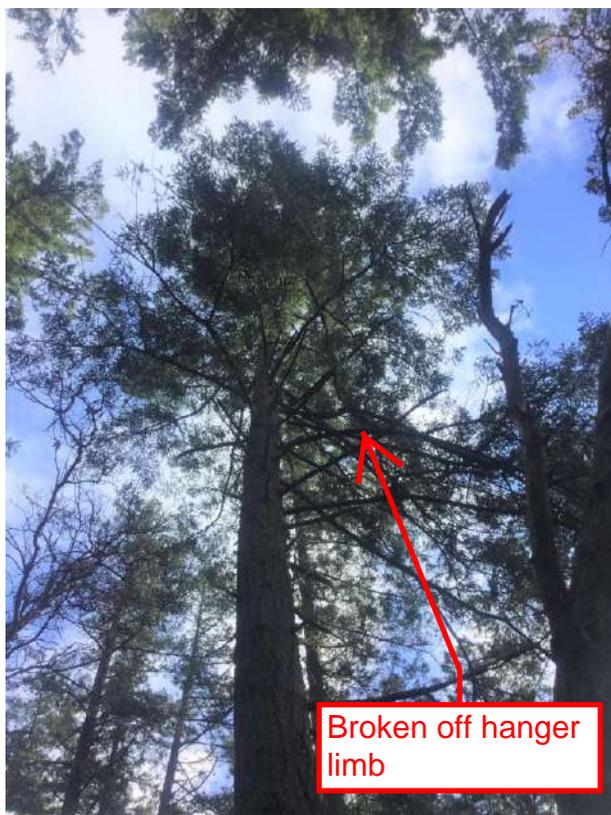
**Figure 8: Photo showing a Future Pruning Tree –Tree #8 (Douglas-fir).**

8	Fdc	110.0	40.0	Within Park, not marked.	L-M	Large healthy Fdc with large limb lodged in limbs 13-14m up the stem. Potential to fall. Additionally 8-12 larger dead limbs along first 1/3 of tree stem.	Reassess risk. Remove broken off limb and combine with limbing lower 8-12 dead limbs. Ensure pruning cuts are completed to ISA Arboriculture Standards. Cut pruned debris to 2m lengths and scatter debris to lay flat on the ground away from the trail pathway.	Future / Pruning
9	Arbutus	55.0	14.0	Within Park, not marked.	L	Arbutus with dead limb 5m up tree. Limb is 4-5m length. Potential to break off at some point but not imminent. Arbutus still live and moderately healthy. Likely infected with Madrone Canker.	Reassess tree for further decline and risk. Prune dead limb. Ensure pruning cuts are completed to ISA Arboriculture Standards. Cut pruned debris to 2m lengths and scatter debris to lay flat on the ground away from the trail pathway.	Future / Pruning

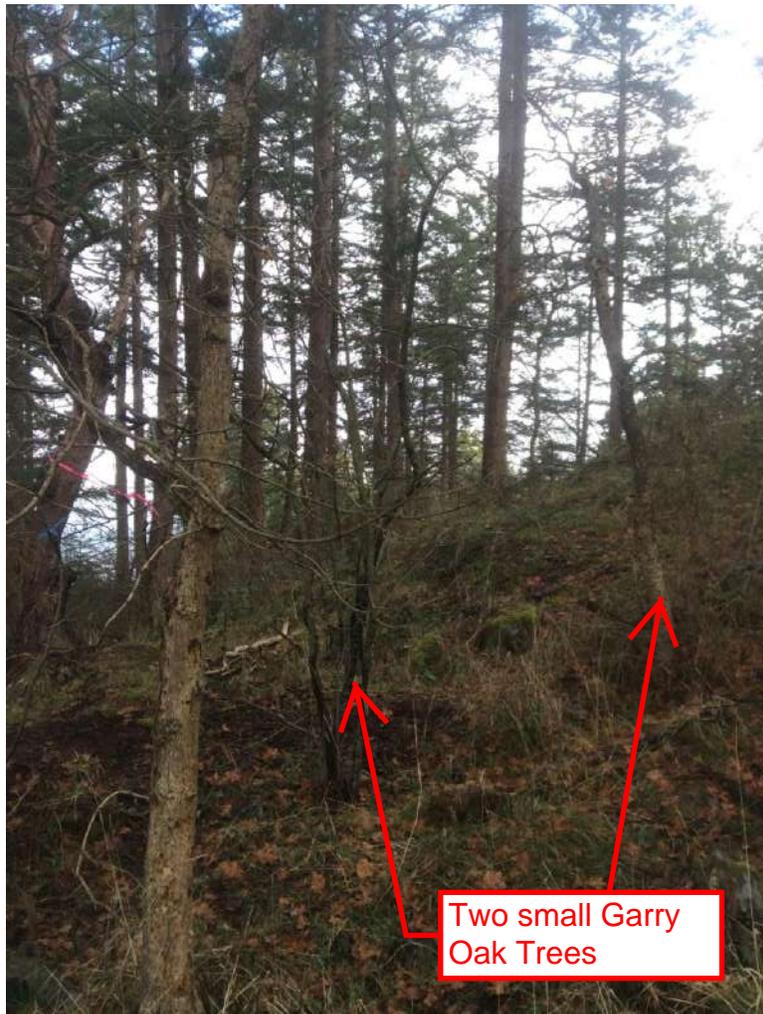
Garry oak trees were observed directly adjacent Trees 6 and 12 (both Arbutus). When conducting tree work on these trees, ensure that damage to the adjacent Garry oak is avoided as these trees are a protected species. Some rigging during tree work will be required to avoid the Garry oaks. The Garry oak trees are identified on the attached Tree Risk Assessment map. Refer to Figure 9 showing two Garry oaks located adjacent Tree #6.

**Figure 9: Photo showing two small Garry Oak adjacent to Tree #6.**
