northwest hydraulic consultants

Project No. 300063

January 3, 2013

**Subject: Miller Road Community Park  
Construction Completion Report**

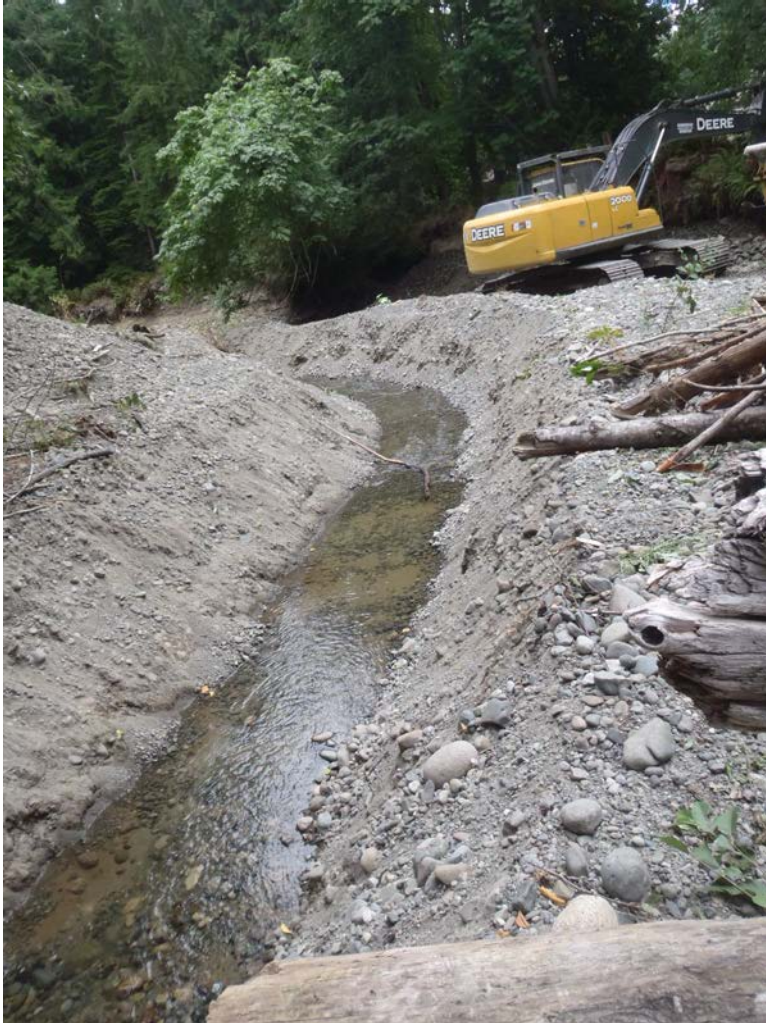
The site was accessed through private residential property off of Miller Road. The first step was to isolate the creek reach at the project site with stop nets, and then remove all fish in the work zone (Section 2.1). After the fish were removed, a John Deere 200DLC hydraulic excavator was used to construct a ramp from the top of the bank into the creek channel. The excavator was used to construct a diversion channel along the left bank, and the creek flow was diverted away from the toe of the right bank (Photo 1).

**Photo 1. A channel was constructed on the left bank to divert the creek away from the work area. Fish passage past the work site was maintained. Silty groundwater seepage in the work zone was pumped to the left bank floodplain, and was allowed to percolate into the ground.**

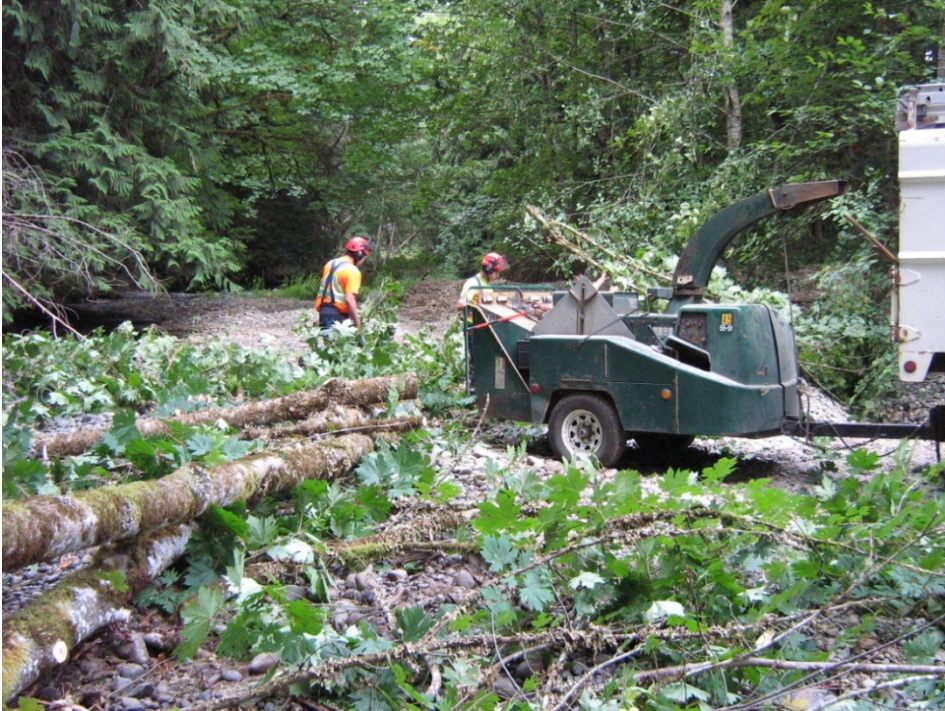
An arbourist contractor removed several trees that were overhanging the work site. The roots were left intact to preserve the creek bank integrity (Photo 2).

**Photo 2.** An arbourist removed several trees that were overhanging the creek. The tree roots were left intact on the bank.

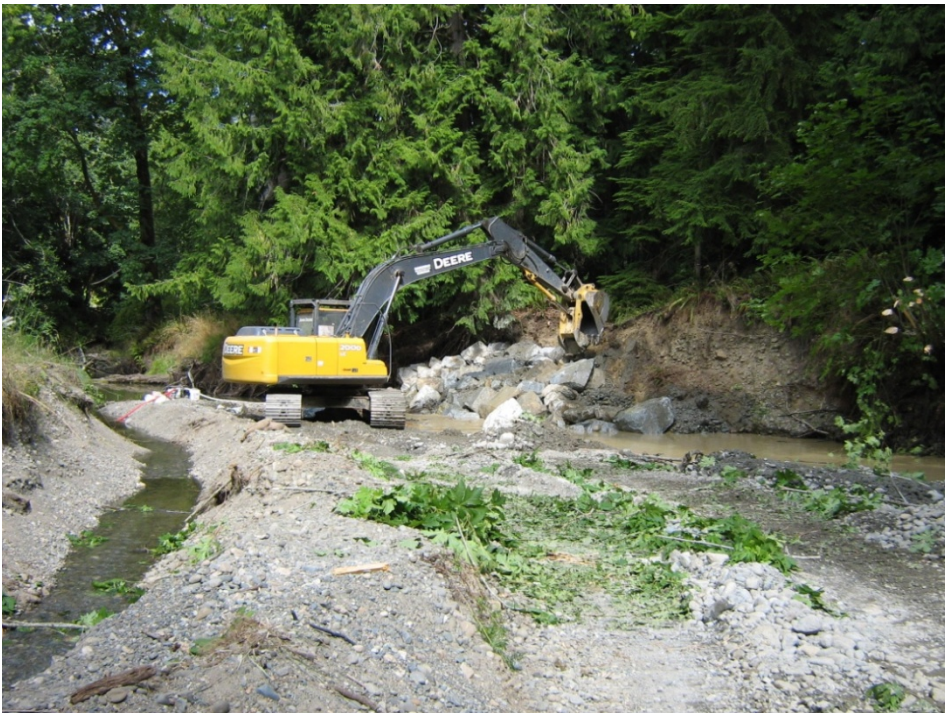
The eroding bank slope was prepared by grading the gravel subgrade at a 1.5:1 slope; then riprap was keyed 1.2m into the channel bed at the toe of the slope. The riprap was installed from downstream to upstream, and the embankment was armoured up to the design elevation (Photo 3). After the riprap placement was complete, approximately 250 m<sup>3</sup> of gravel was removed from the channel bar and stockpiled off-site. The volume of removed gravel was approximately the same as the volume of riprap brought to the site (Photo 4).

**Photo 3.** The eroding bank was prepared by grading the filter layer (gravel), and then riprap was keyed into the stream bed and extended up to the design elevation.

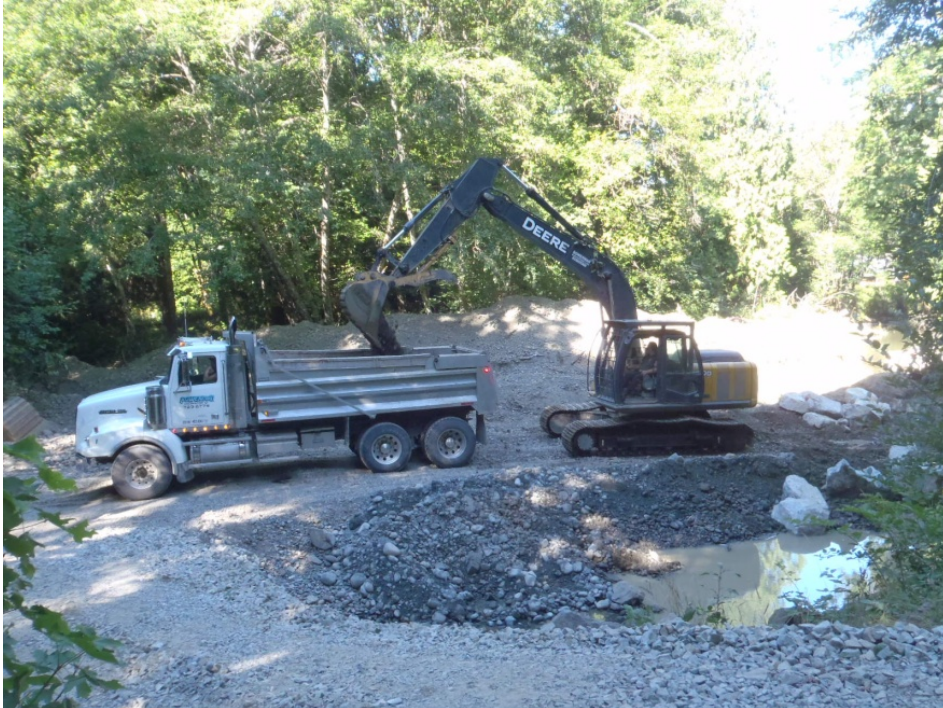
**Photo 4. Approximately 250 m<sup>3</sup> of gravel was removed from the gravel bar and hauled off-site.**

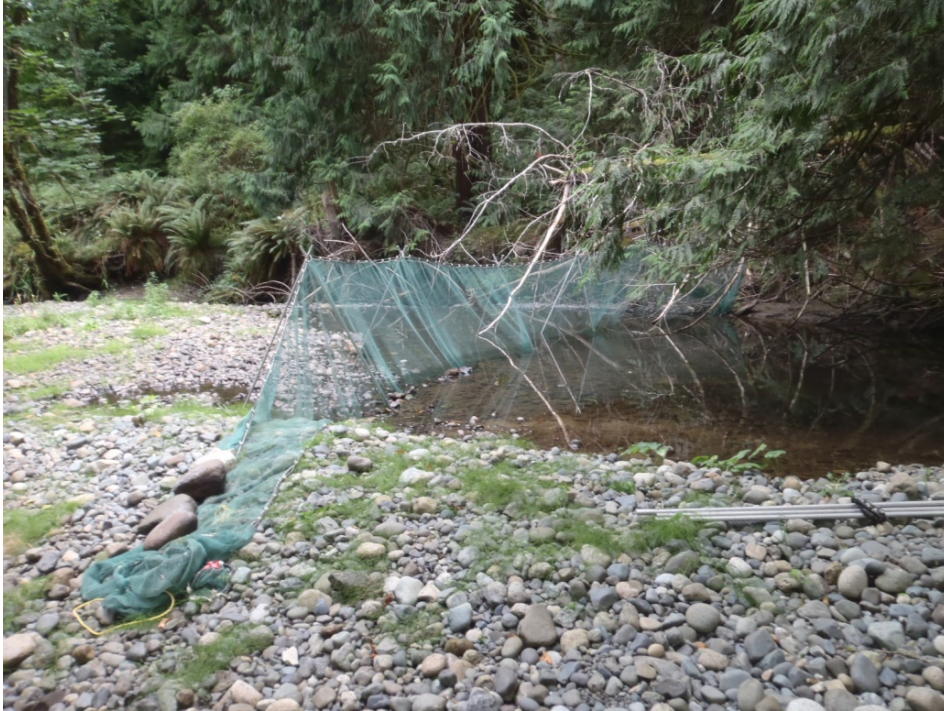
Fish Salvage commenced on August 20, 2012. The construction area was isolated with stop nets (2 m x 15 m, 12 mm stretch mesh) above and below the project area (Photo 5).

**Photo 5. Stop nets were used upstream and downstream of the project site to isolate the area. Fish were removed between the stop nets.**

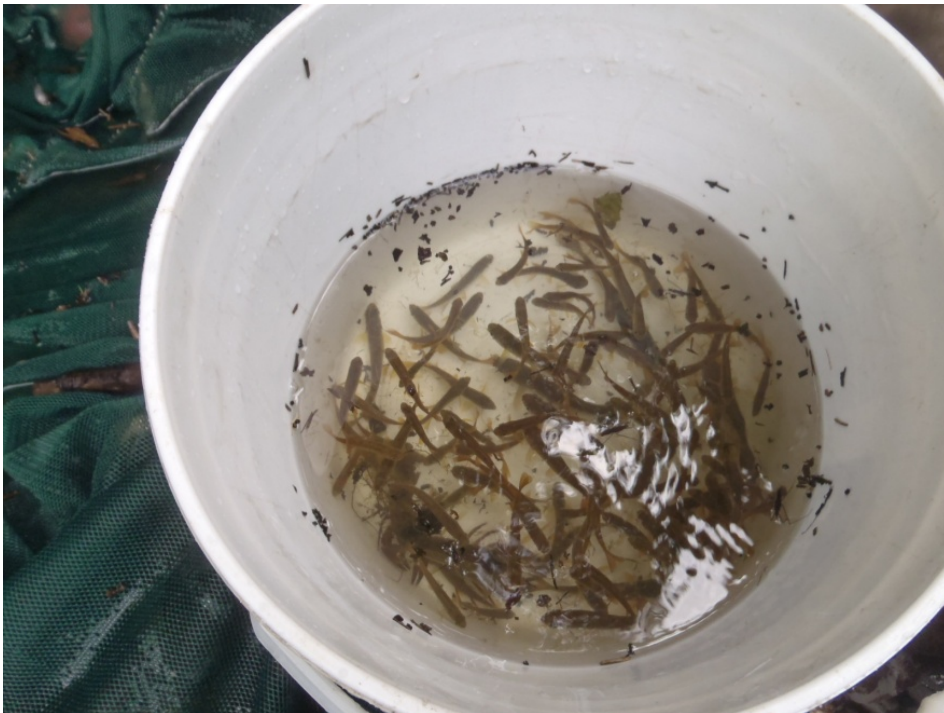
**Photo 6. The salvaged fish were identified and enumerated, then released above or below the project site.**

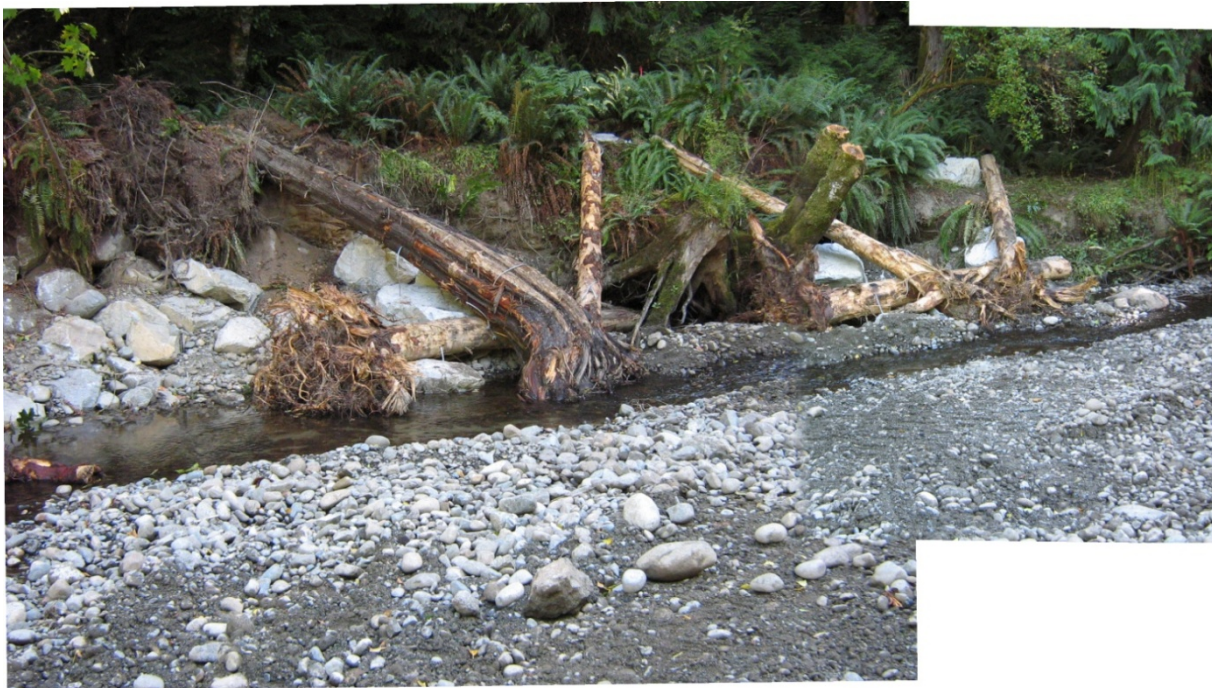
Tri-log type structures were built at the upstream end of the site to help direct the thalweg away from the toe of the bank, and a small rock apron was installed behind the log structures to reduce bank erosion. Scour pools are expected to develop near the tri-log structures. The scour pools should provide deep, slow water areas for rearing and holding salmonids (Photo 7).

**Photo 7. Tri-log structures were constructed at the upstream end of the site. Some riprap was installed behind the LWD to reduce bank erosion.**

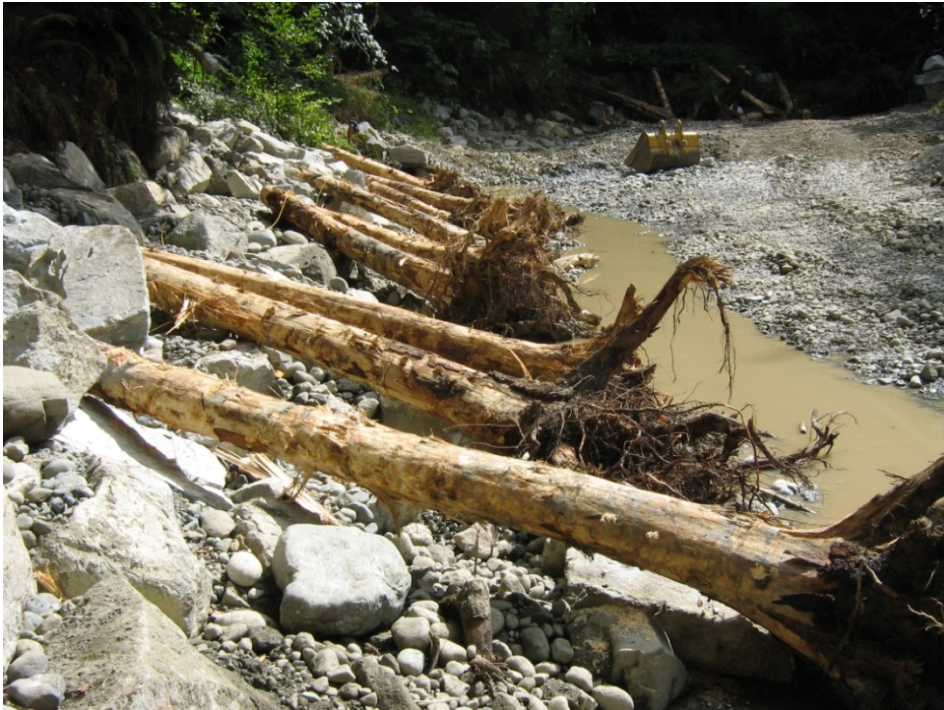
The linear riprap section downstream of the tri-log structures incorporated single stem logs with roots. The LWD is intended to add hydraulic variability, reduce near-bank water velocities, and create small scour pools and provide cover habitat (Photo 8). All LWD was anchored using boulder ballast secured with 12.5 mm diameter wire rope, clamps, and epoxy as per the design (Photo 9).

**Photo 8. LWD was added to the linear riprap section to improve fish habitat values.**

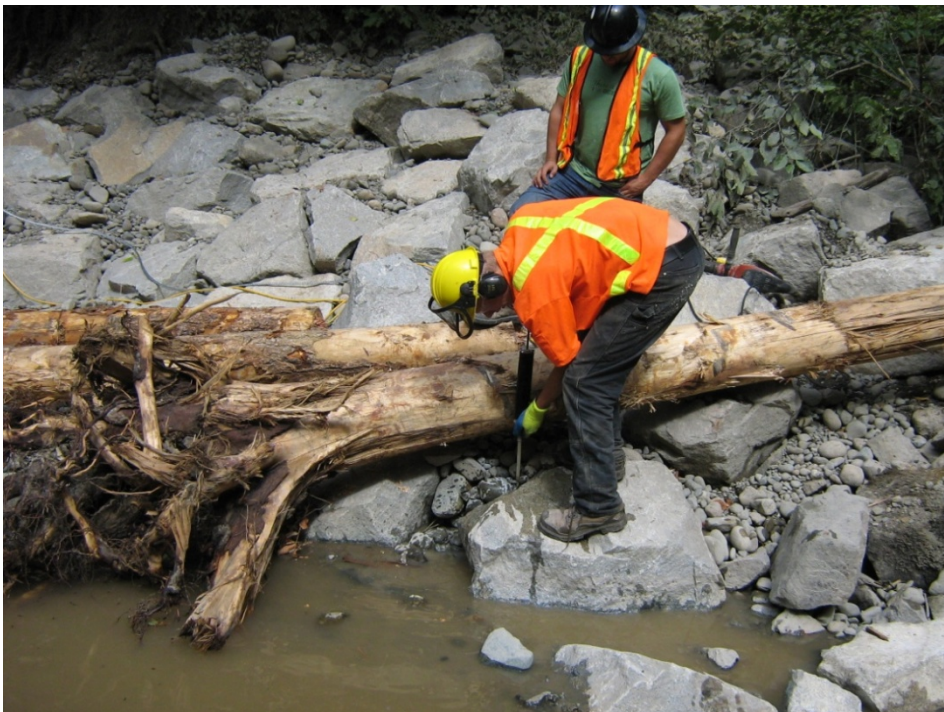
**Photo 9. The BCCF crew anchored the LWD to boulders using wire rope, clamps, and epoxy.**

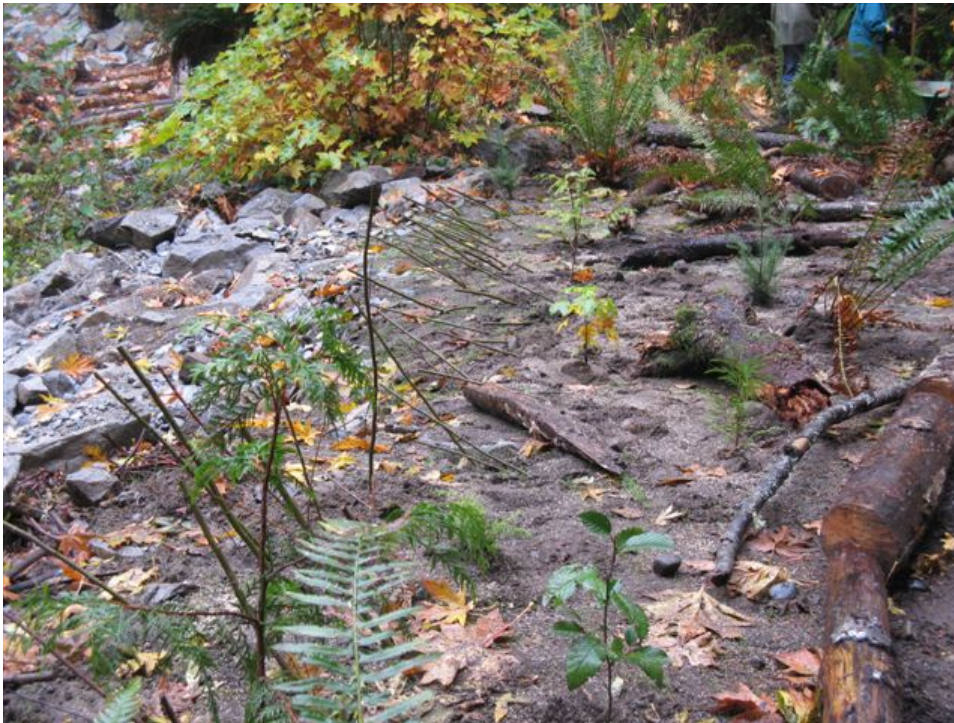
A riparian prescription was developed in early October, 2012. Planting was conducted with assistance from local fish and game/streamkeepers volunteer groups on October 26, 2012. Plants were obtained from the Nanaimo Area Land Trust (NALT) native plant nursery in Cedar, BC, as well as some sword fern salvaged from other areas of the park. Planting effort was concentrated at the access ramp area and the over-steepened banks at the downstream end of the site (Photo 10). Wood debris, primarily decomposing alder, was also added to the open disturbed areas to assist with plant survival; the dispersed wood debris adds nutrients, help retains moisture, and assists building soil. A list of the plants and cuttings planted is provided in Table 2. All the disturbed soil, including the left bank gravel bar, was seeded with a coastal revegetation seed mix (Table 3).

**Photo 10. The stream banks and disturbed areas were revegetated with native plants. Local volunteers assisted with the planting work.**
