**Haslam Creek  
Fish and Fish habitat Assessment**

**Prioritizing Restoration and Protection of the Fisheries Resource**

*Prepared*  
March 2001  
*by*  
Rob Hanelt, RPBio  
Aquaterra Environmental

*And*  
March 2010  
*by*  
Dave Clough, RPBio  
D.R. Clough Consulting (2010)

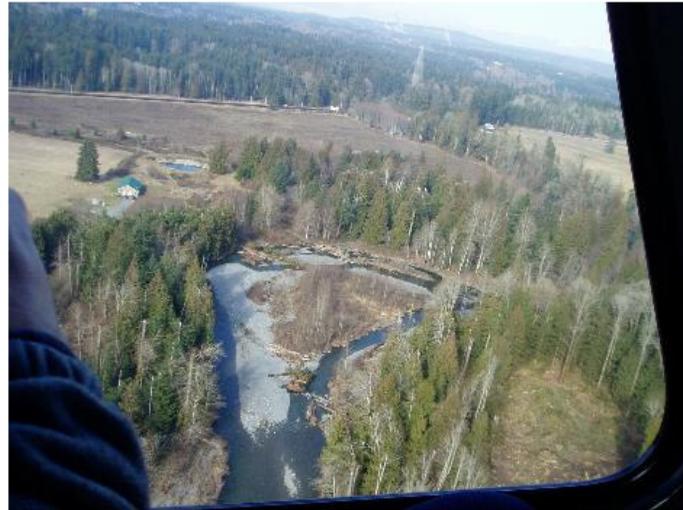
1.) Airphoto of channel braiding looking downstream at 1+700m.

**4. Bank Repair** – This reach would benefit from the placement of stump revetments along the eroded and failing banks (0+300m, 0+450m, 1+700m, 1+900m, 2+200m). Bioengineering techniques, as well as planting of native vegetation would assist in bank stabilization and protect the eroding banks. Reach 1 has eroding sites identified in Form 1 (Appendix 7). Also see photos.

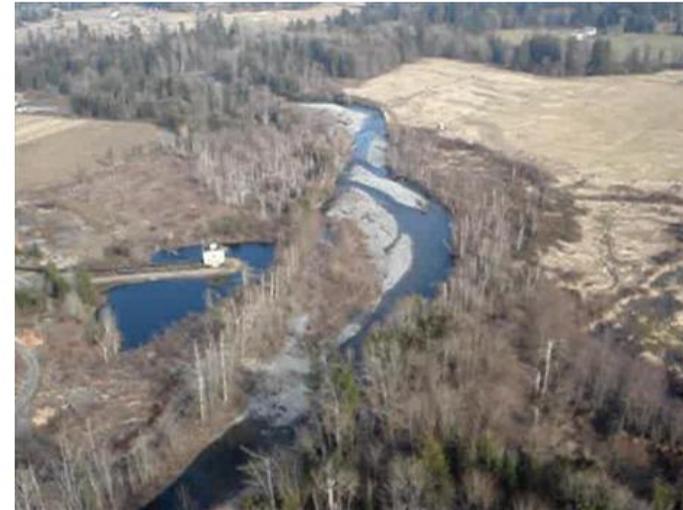
3.) Airphoto of Harmac Well looking downstream at 2+300m.

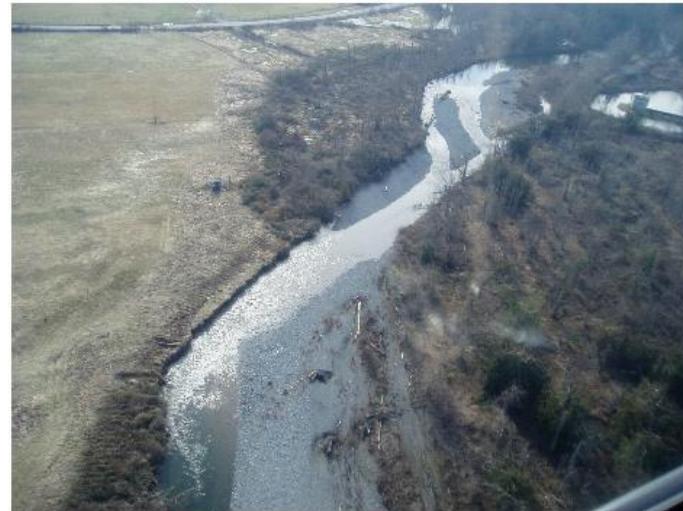
2.) Airphoto of sediment wedge looking upstream at 1+874m.

**8. Gravel Bar Scalping** – The excavation of the large gravel beds have occurred in 2007 and 2008 in Reach 1 (1+890m-1+960m and 2+350m - 2+390m). Gravel bars at the confluence (0+000m) with Nanaimo River and Napoleon Creek (0+300m) prevent upstream fish access during low flow conditions. Machine access during low flow summer conditions is achievable, which would allow trucking of material in and out of the site. In order to control the gravel movement within the channel, the gravel source needs to be addressed first. The eroding banks need to be stabilized, preventing

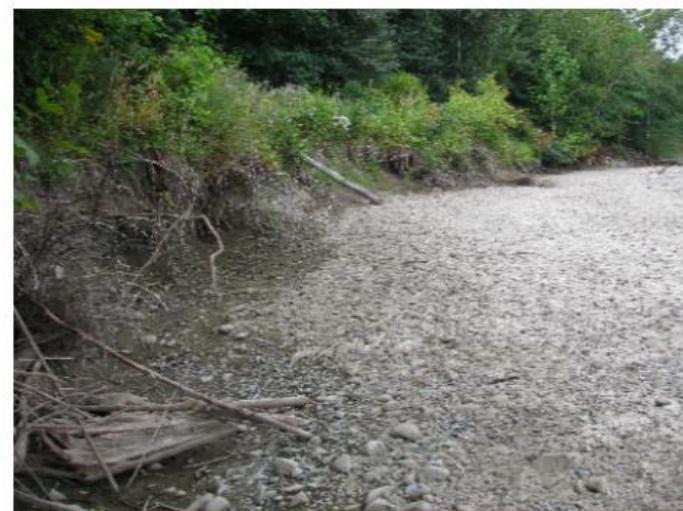
4.) Right bank erosion site looking upstream at 2+400m (2009).

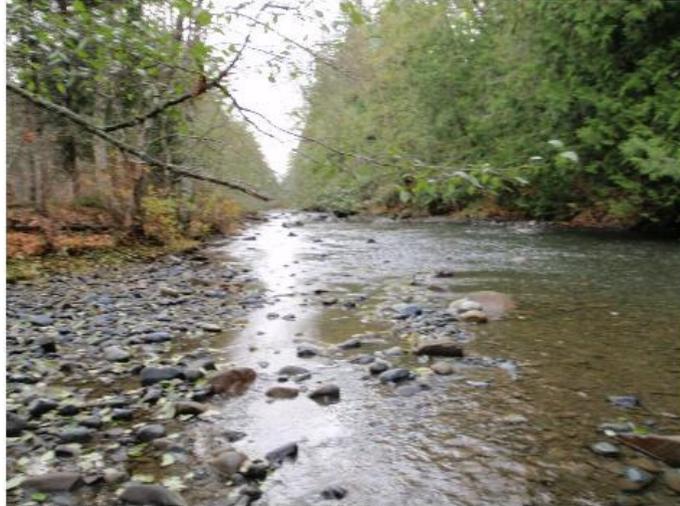
1.) Typical substrate and lack of LWD found in reach.

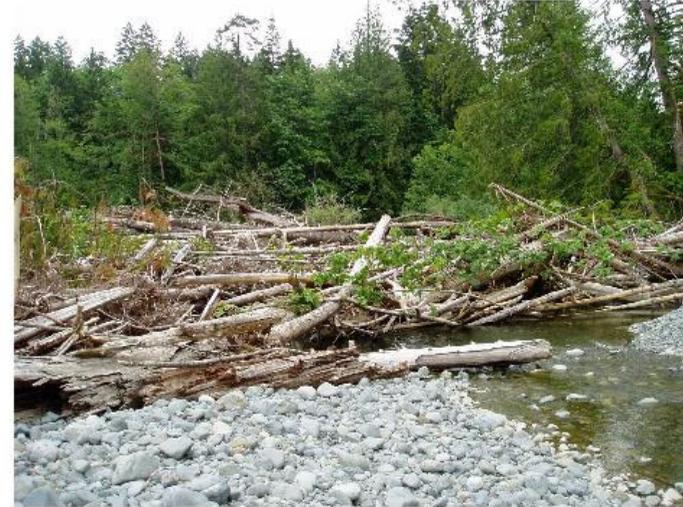
3.) Debris jam located downstream of creek braids at 4+300m.

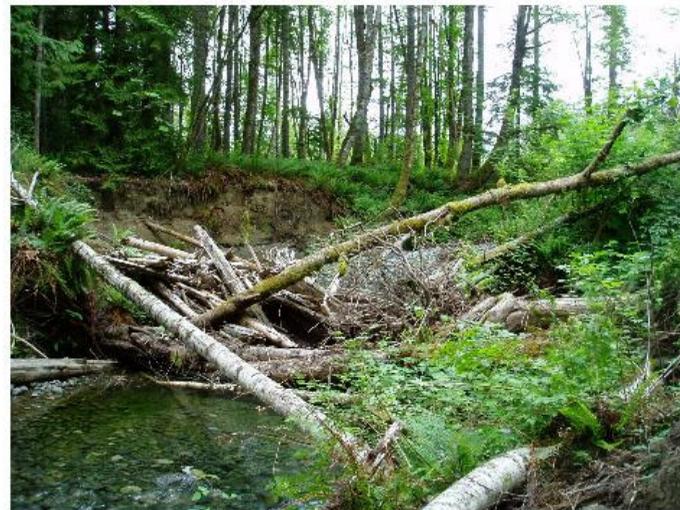
2.) Right bank braid showing riparian loss and erosion at 4+800m.

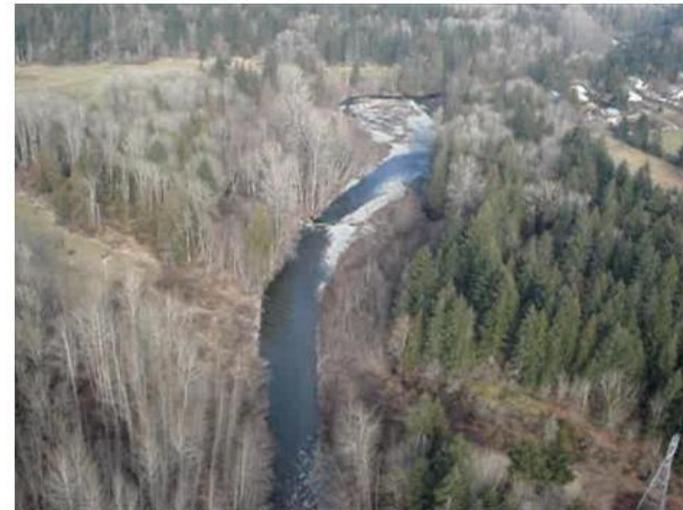
4.) Airphoto of 4+300m site looking downstream.

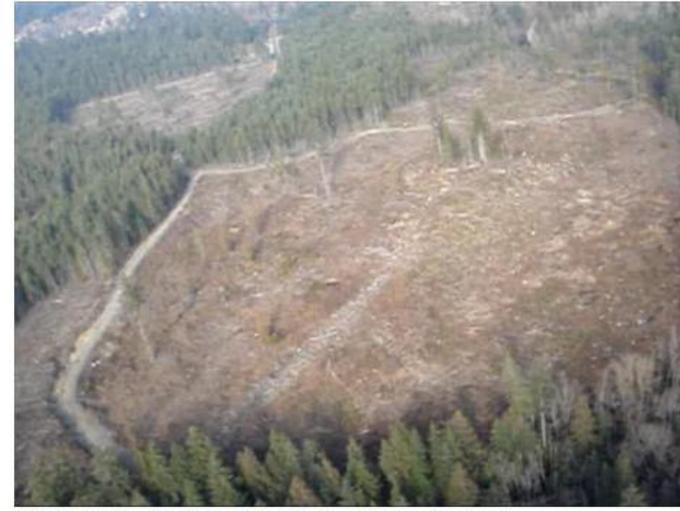
3.) Airphoto of left bank logging blocks at 7+850m.

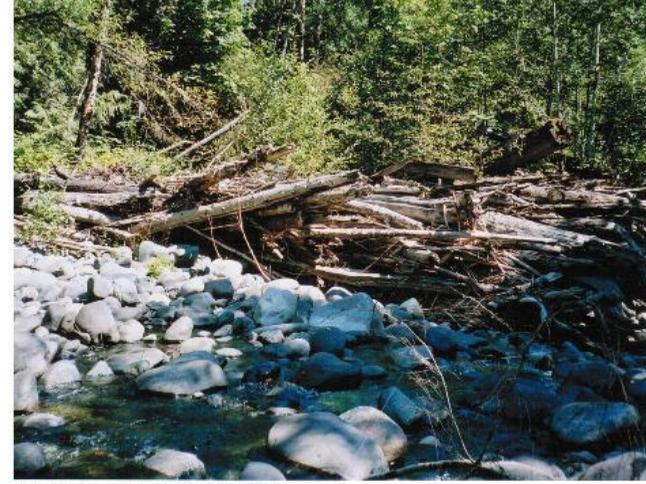
3.) River left debris jam at 8+317m.

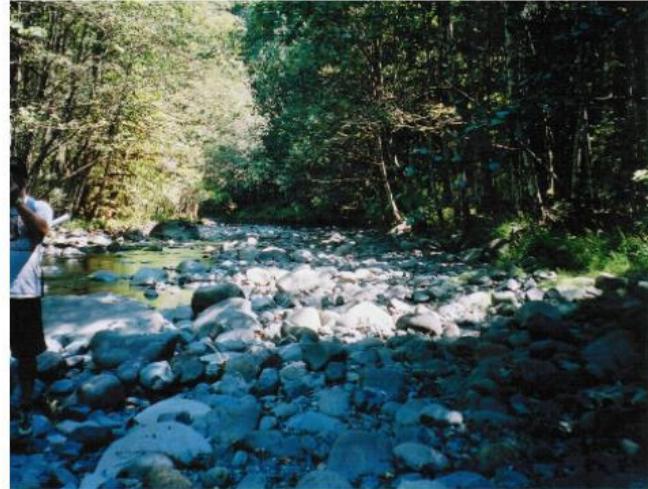
2.) Typical substrate and summer flow conditions.

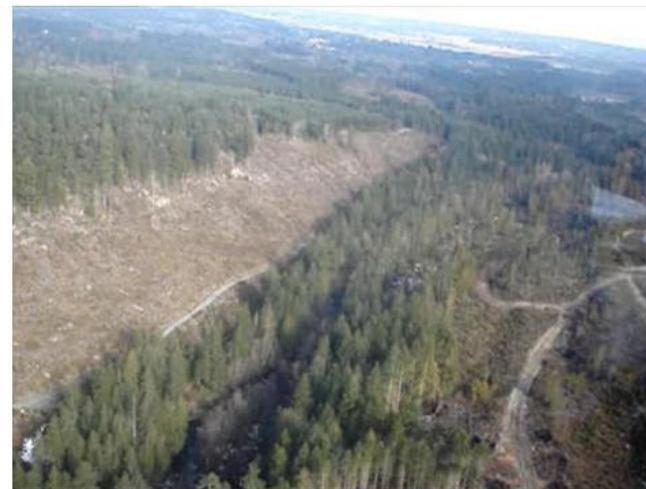
4.) Airphoto looking at left bank logging blocks at 9+101m.

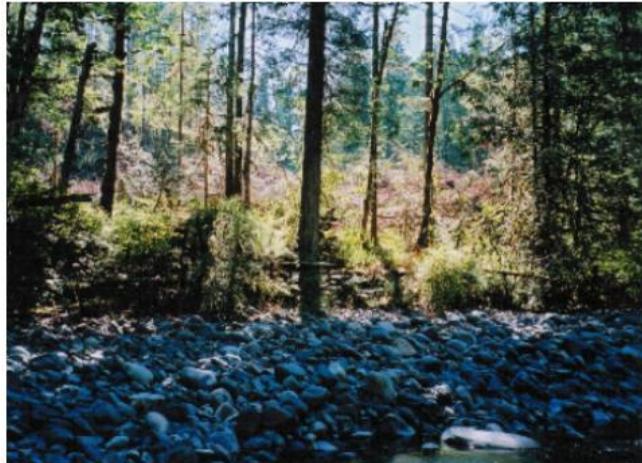
1.) Right bank logging block at 13+080m.

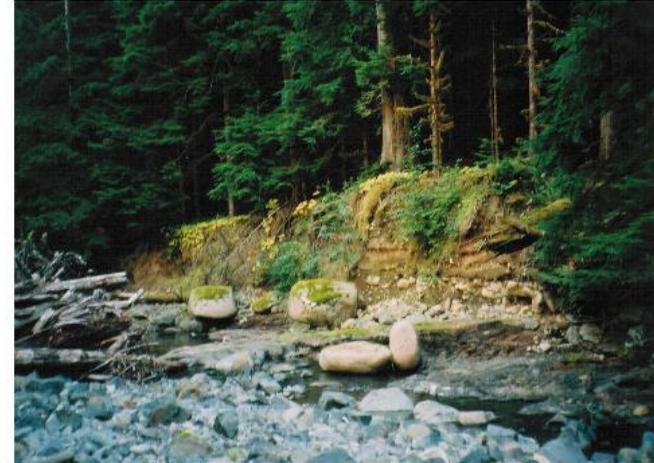
3.) Left bank erosion site at 15+835m.

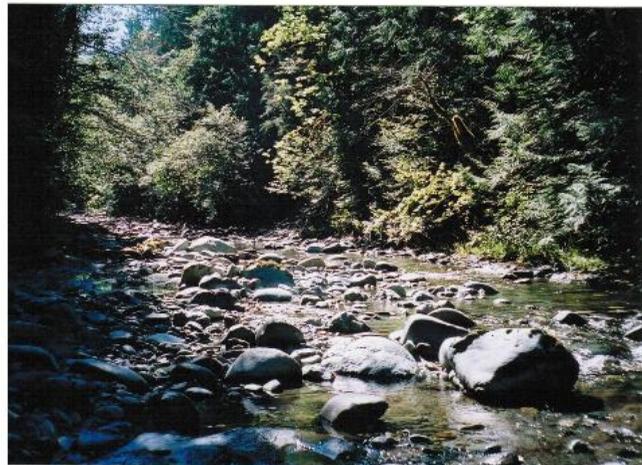
2.) Typical substrate and lack of LWD at 14+280m.

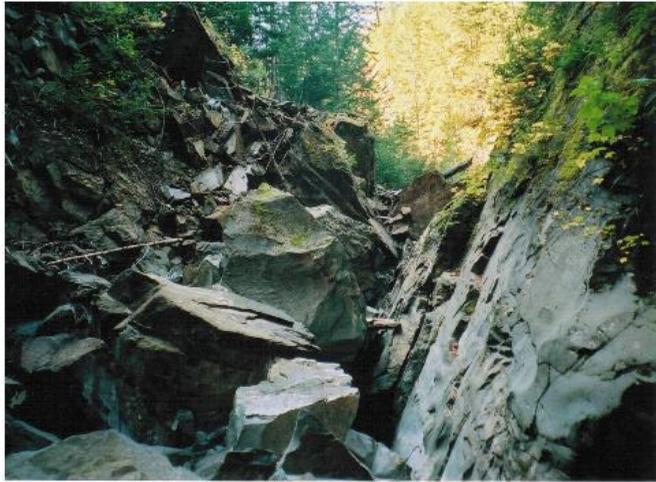
14+691m, 16+410m) are found throughout its length. A large debris slide plugs the entire channel at 16+976m to 16+994m.

5.) Large debris slide plugging creek looking upstream at 16+976m.

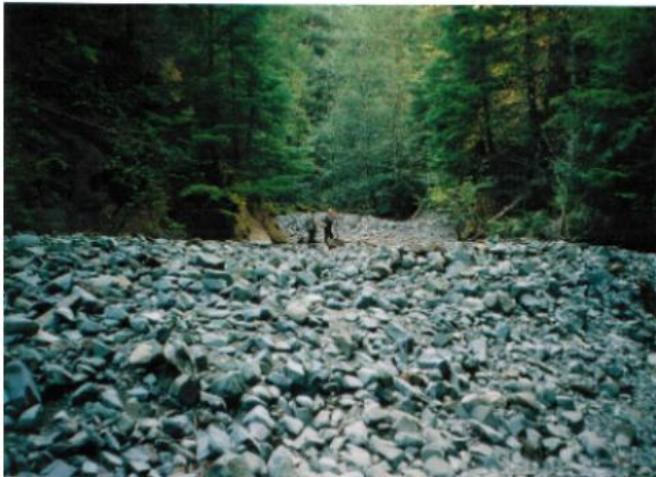
6.) Large sediment looking upstream at 17+000m.

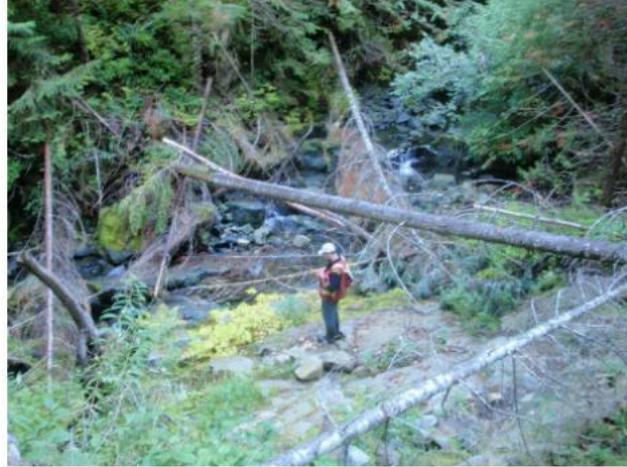
Altered sites, logging activity and erosion sites are found along this reach. The USHP survey of this reach ended at a bridge crossing (22+119m). A 13m wide left bank slide on a 75% slope was located at the downstream end of the reach (21+769m to 21+782m). A 25m left bank braid is located just downstream of the logging block, providing potential off channel habitat. A logging road gate is found (22+029m to 22+054m). Logging activity (22+043 to 22+096m) was evident approximately 30m from the stream banks.

1.) Right bank slide at 21+782m.

**1. Slide Stabilization** – This reach has one known slide (21+769m to 21+782m) along the left bank (Appendix 7 – Form 7). The private land forestry owner and road contractor should be responsible for the repair to the road and for the slide stabilization.

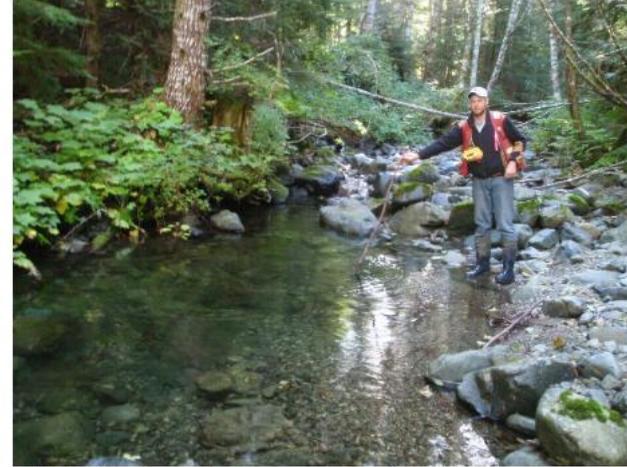
3.) Right bank pool looking upstream at 22+075m.

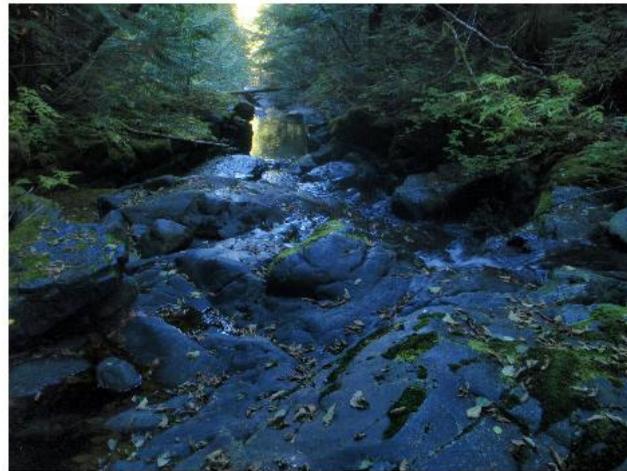
2.) Bedrock substrate looking downstream at 21+880m.
