REQUEST FOR TENDER No. 20-038

Gabriola Island Village Way Path Construction Project

Addendum 1 (21 Pages)

Tree Risk Assessment Village Way Path, Gabriola Island

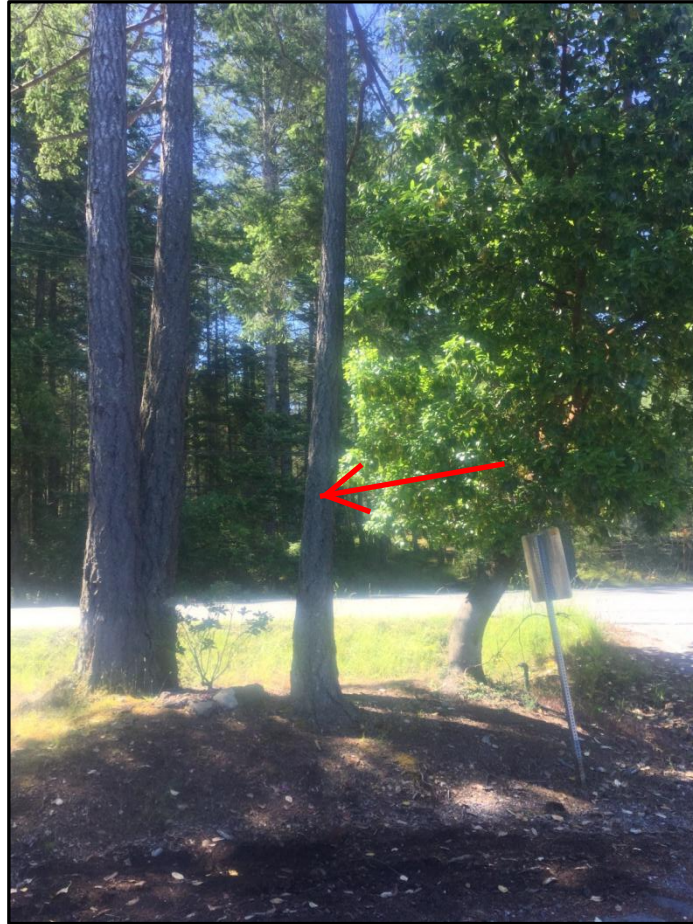
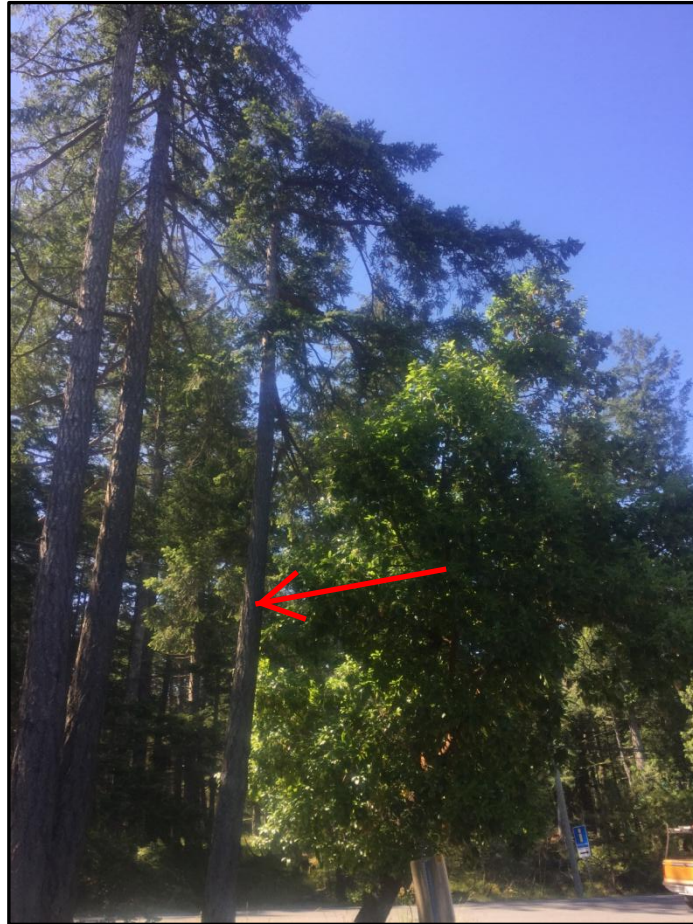
This tree consists of a smaller intermediate Douglas-fir (*Pseudotsuga menziesii*) of moderate health. The DBH and height of this tree are 33.7cm and 12.3m. Refer to Figures 2 and 3.

Figure 2: Tree #1 Douglas-fir

Figure 3: Tree #1 Douglas-fir

The tree has approximately 45% live crown ratio. Even though the tree looks in poorer form, it still has healthy (green) looking foliage. The base of the stem was sound as determined with a mallet. The root system was not visible and; therefore, difficult to assess. However, given the current condition and location of the tree dripline (critical root zone area) in relation to the existing pavement (parking lot and North Road), there is a low to moderate probability that roots were previously impacted through site changes (drainage, grade, compaction) or through physical damage.

- a **low risk** associated with root failure and/or whole tree failure (significant damage to vehicles and/or injury / death to the public if the tree was to fail)

Retain and monitor this tree for changes to health, structural stability, and associated risks (every 2-3 years).

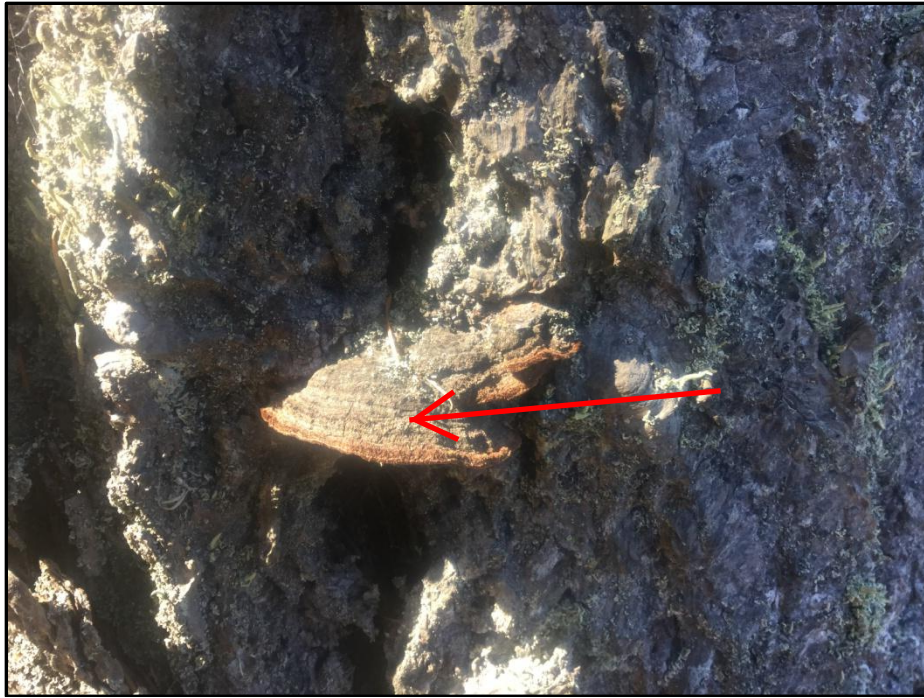
Figure 4: Tree #2 Douglas-fir. *Porodaedalea pini* conk on main stem.

A significant number of *Porodaedalea pini* conks were observed on the main stem of the tree (minor amount on the secondary fork) which indicates the presence of a column of heartwood and sapwood rot well up the stem. Through sounding it was determined that there are hollow sections in the stem. Additionally, the two forks have a tight union where joined with the potential for included bark resulting in a weaker attachment. Based on the above observations, there is potential for the stem to break off as a result of the high rot component (weak outer supporting shell) or the weaker fork attachment.

It is recommended that this tree is either fully removed or wildlife treed at 3-4m (which would reduce the overall risk to low).

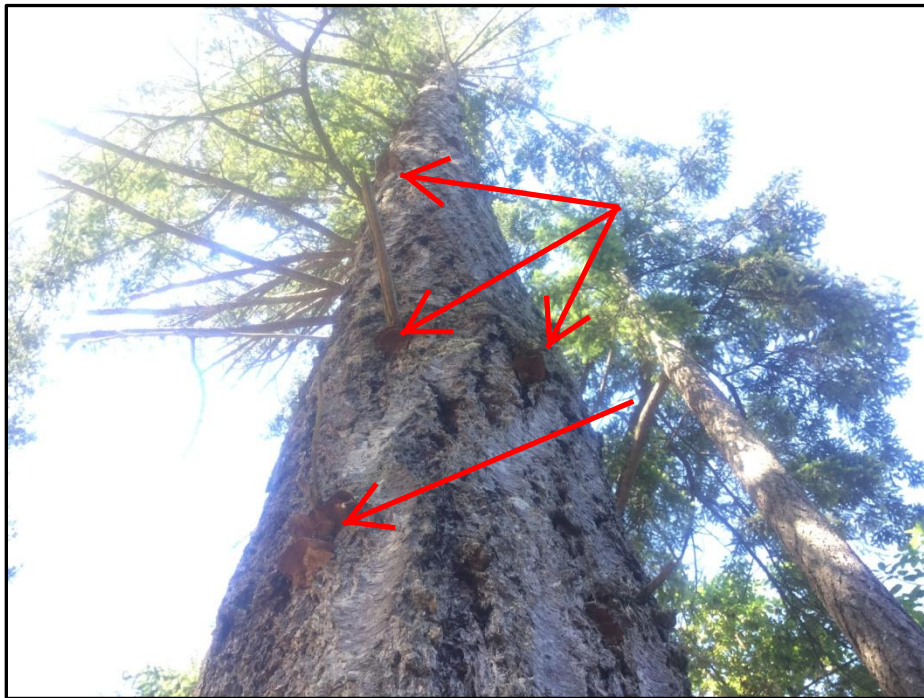
Figure 5: Tree #2 Douglas-fir. *Porodaedalea pini* conks on main stem.

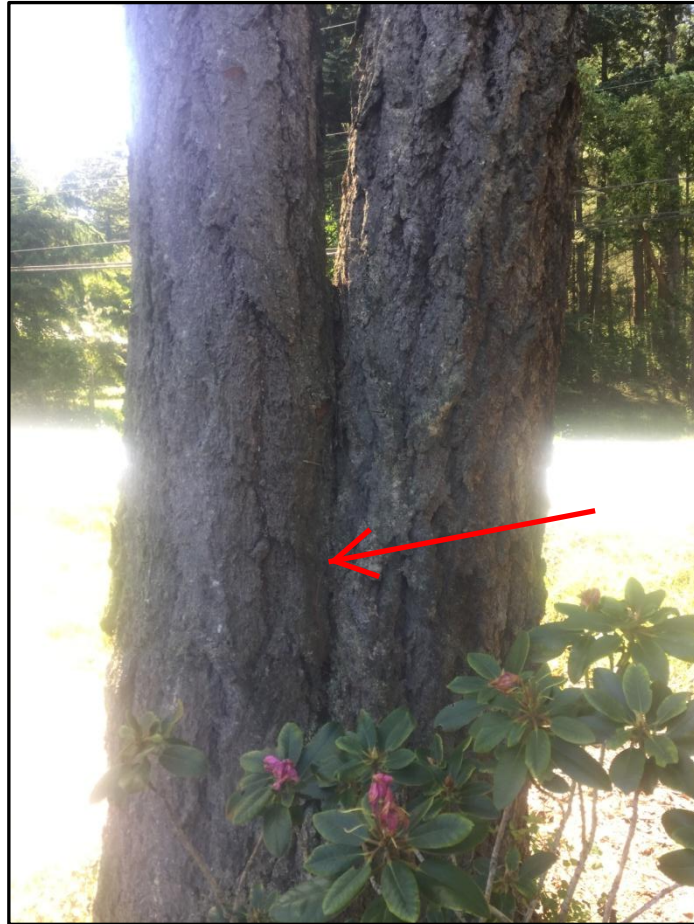
Figure 6: Tree #2 Douglas-fir. Tight fork union (weak attachment).

- a **low to moderate risk** associated with root failure and/or whole tree failure (significant damage to business infrastructure, vehicles and/or injury / death to the public if the tree was to fail).
- a **moderate to high risk** associated with partial or whole tree failure (significant damage to business infrastructure, vehicles and/or injury / death to the public if the tree was to fail).

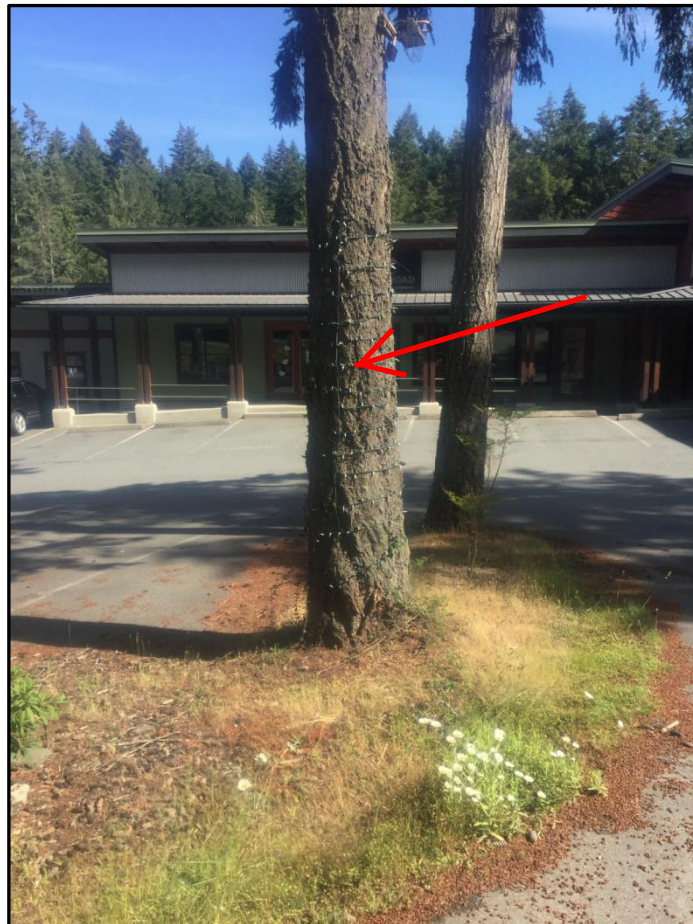
Figure 7: Tree #3 Douglas-fir.

This tree consists of a larger Douglas-fir (*Pseudotsuga menziesii*) of poorer health. The DBH and height of this tree are 63.8cm and 27.2m. Refer to Figures 7 and 8.

Retain and monitor this tree for changes to health, structural stability, and associated risks (every 2-3 years).

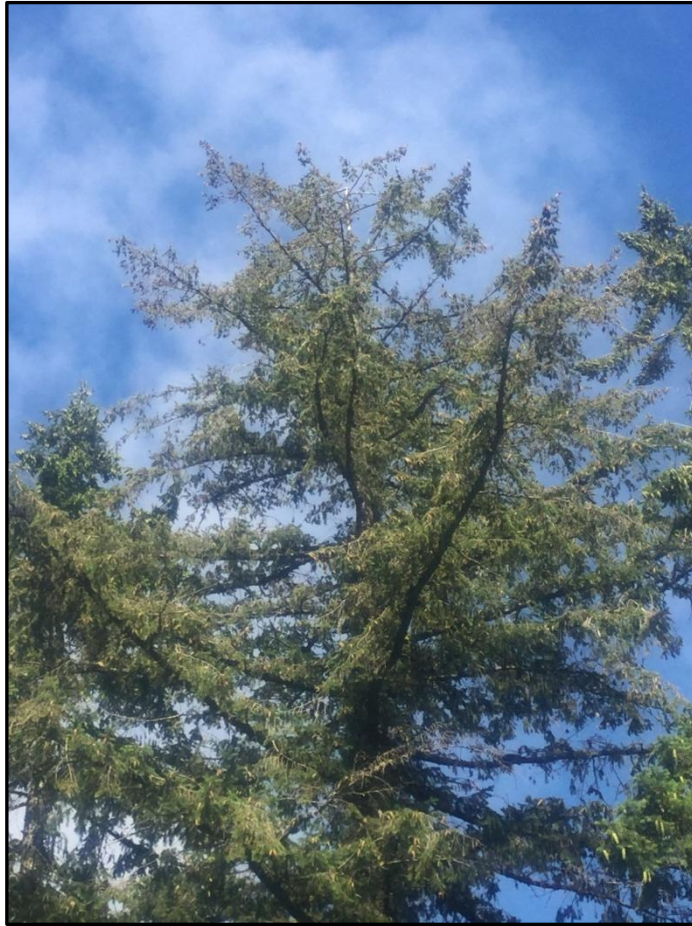
Figure 7: Tree #3 Douglas-fir. Thinning and chlorosis in upper crown.

The tree has approximately 78% live crown ratio. It was estimated that 25% of the foliage is healthy, 60% is chlorotic (yellowing), and 15% is necrotic (foliage death along twig segments). Heavy thinning and a stress cone crop were observed within the crown which indicates the tree is in a gradual state of decline.
