Morison Creek Habitat Survey – 2018

On behalf of
Mid Vancouver Island Enhancement Society
(MVIHES)

January 2019

Written By D.R. Clough Consulting

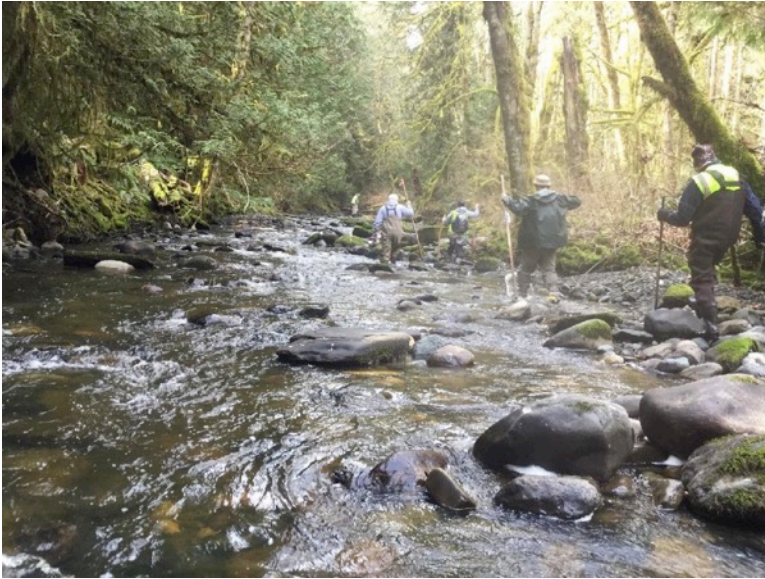
1.) Riffle 1 in lower Morison

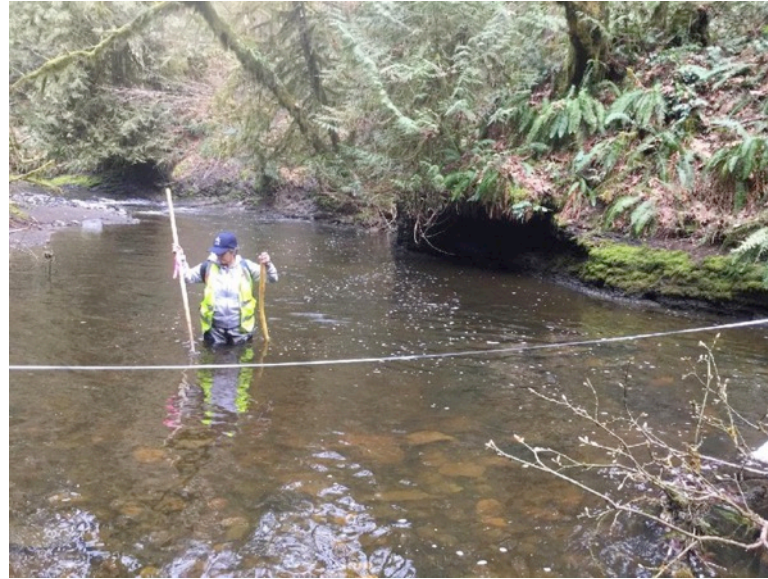
2.) Pool 5 in lower Morison

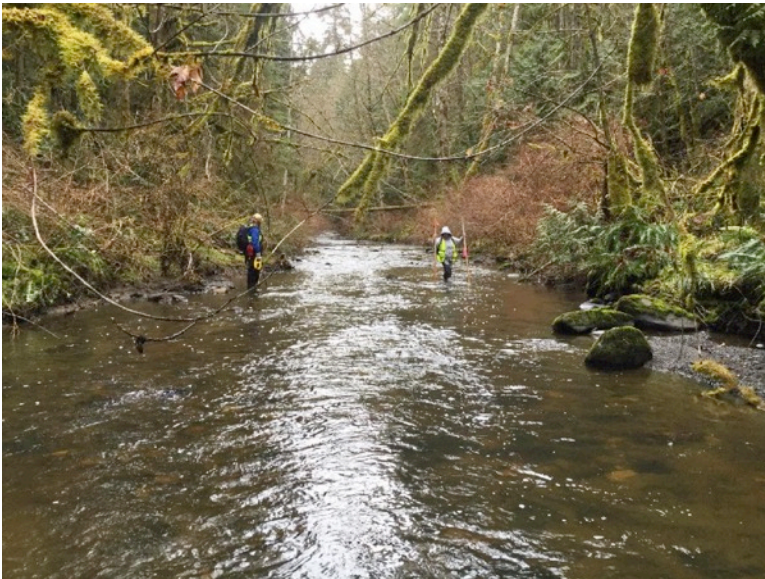
3.) Riffle 20 below Triple Falls

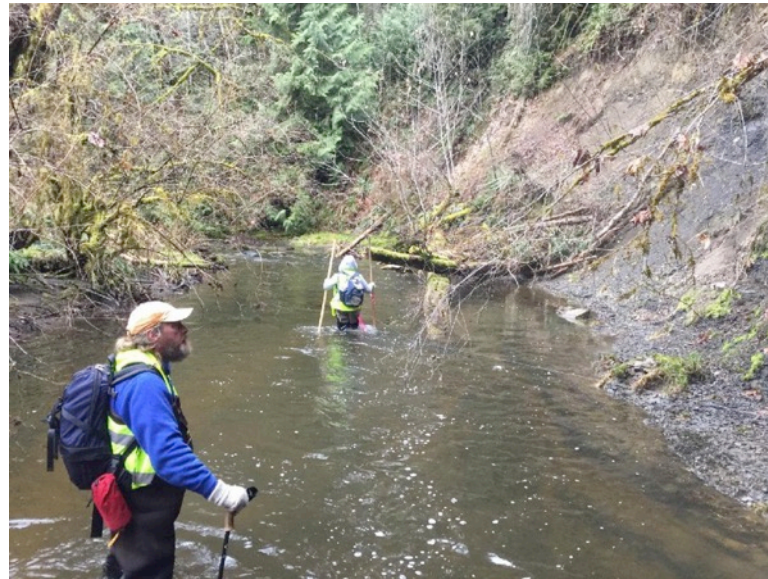
4.) Pool 16 at old erosion site

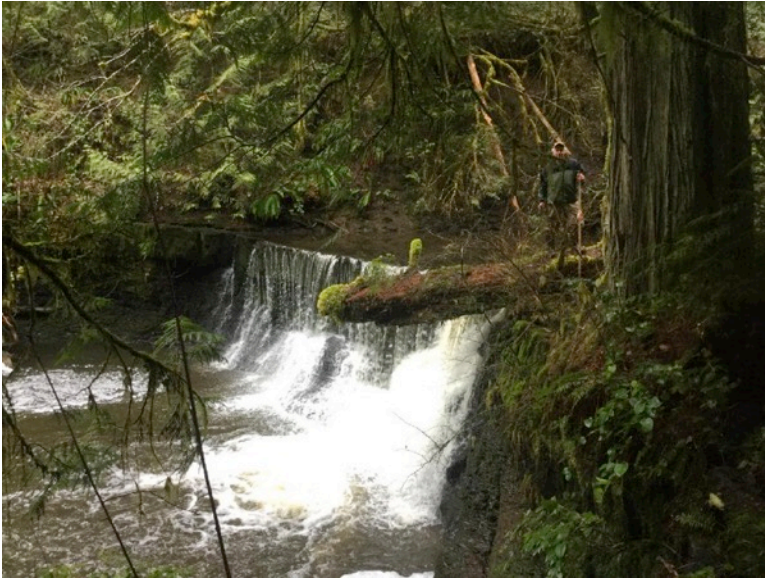
1.) Baxter Falls

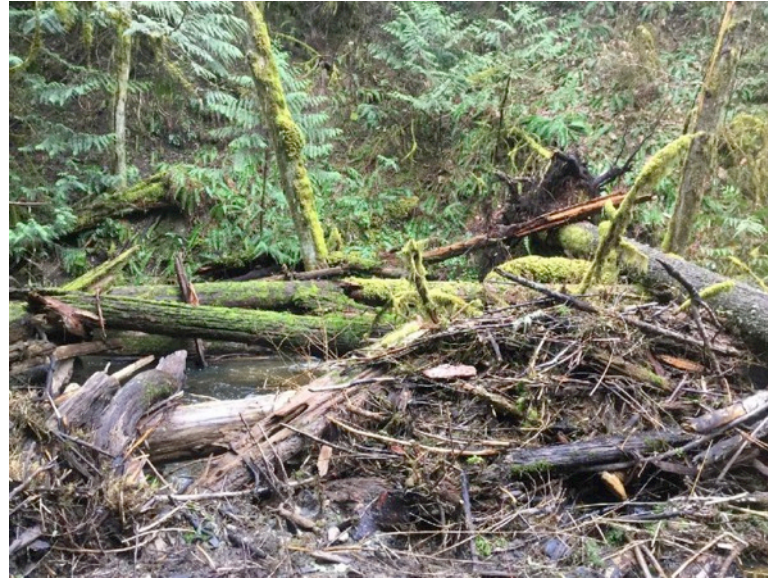
This reach had one significant bank erosion area just above Baxter Falls where approximately 30m of treed bank had slid down over the underlying bedrock into the channel creating a jam. The cause of the slide does not appear to have been aggravated by any recent human developments; an area of thin soils and poorly established roots. The consequence has been some opposite bank erosion and overflowing into a treed area which may cause more failure. The benefit of the slide was the introduction of considerable LWD creating the best fish cover we had observed in the lower river. A beaver had taken up residence and was using the wood material as foundation for a dam that will invariably blow out in winter.

2.) Pool 2 at jam created by right bank slide

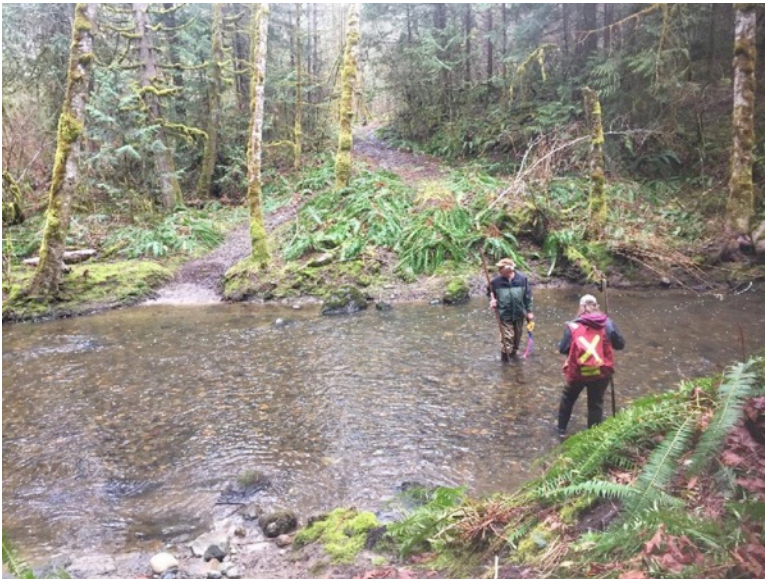
3.) Stagdowne Trail Crossing at Riffle 5

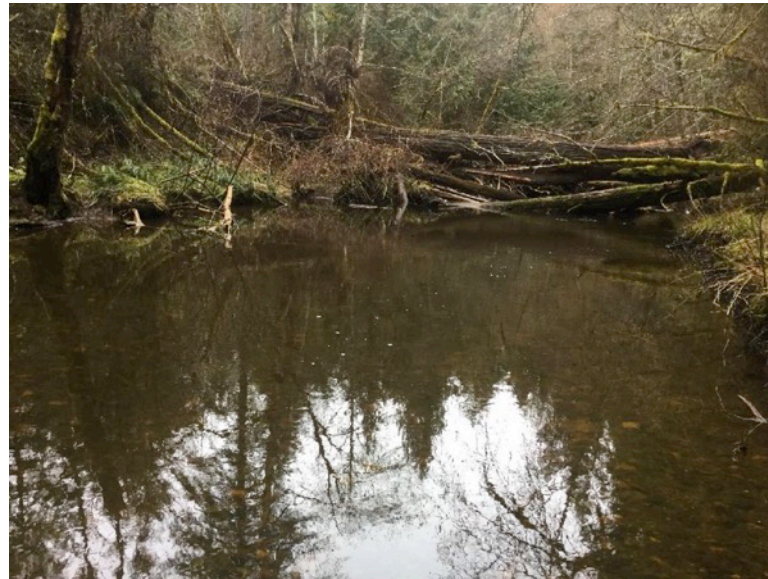
4.) Beaver dam pool 4

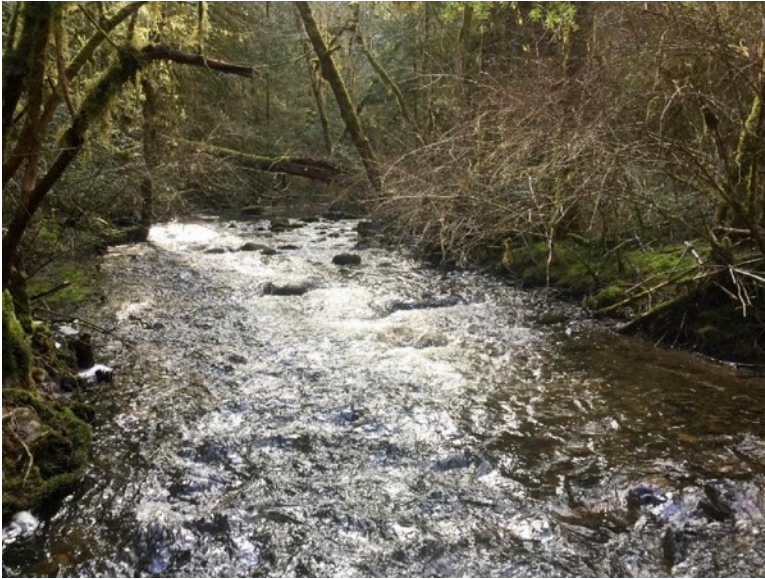
1.) Reach 3 at confluence with Swayne

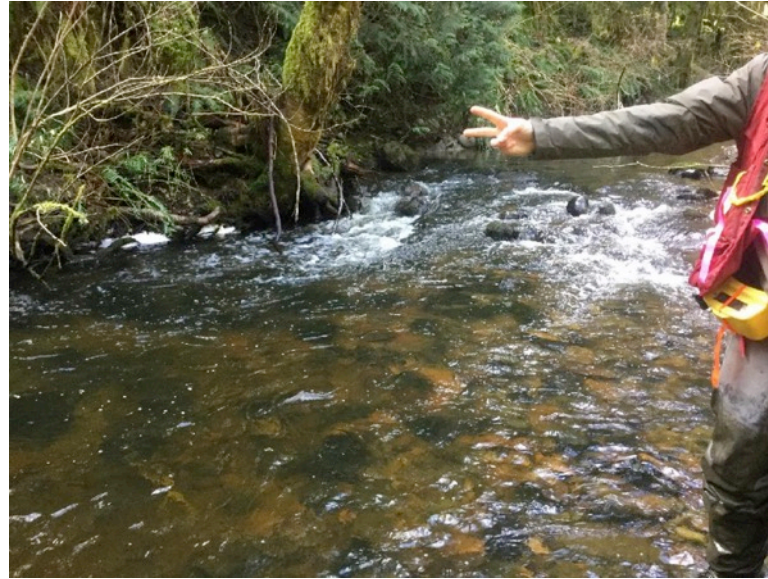
2.) Pool 2 in Reach 3 with Alder root wad

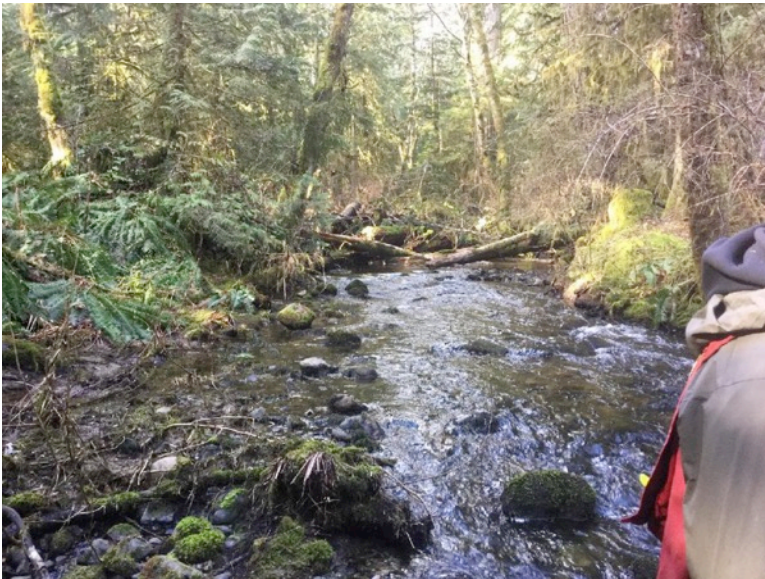
3.) Typical riffle with Alder canopy and debris

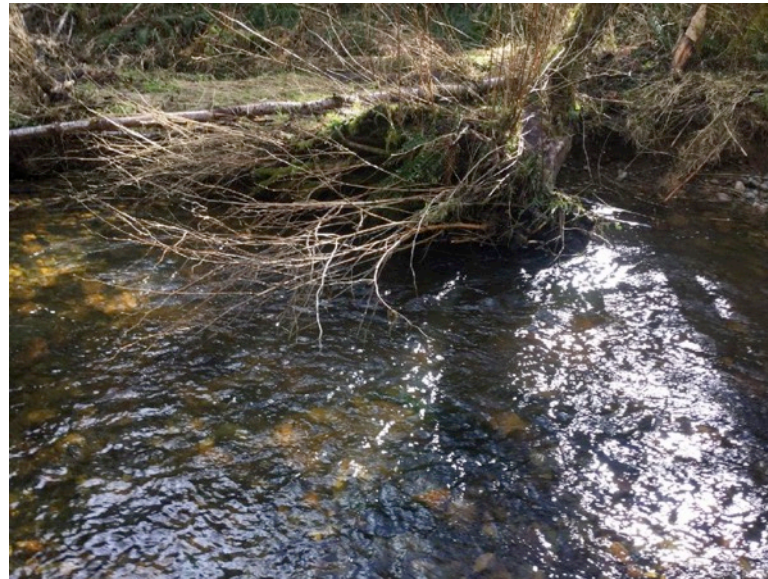
4.) Brush and Alder roots provide pool cover

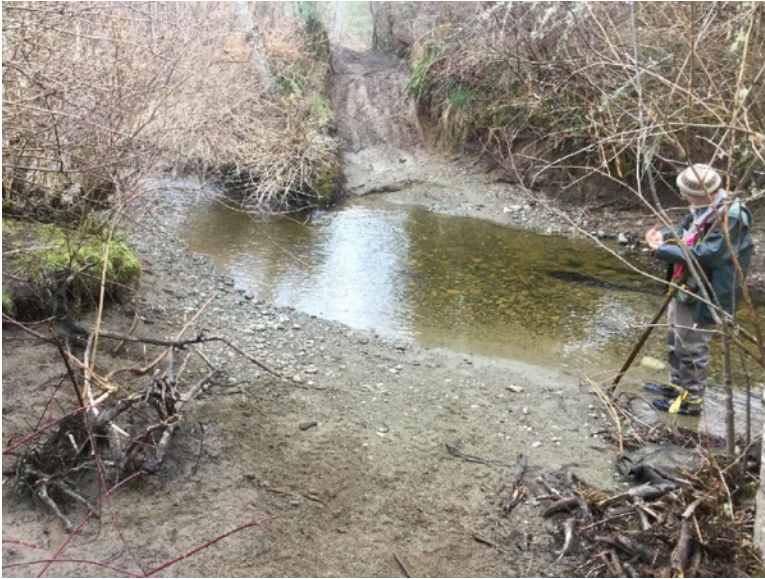
1.) Reach 4a at quad trail crossing

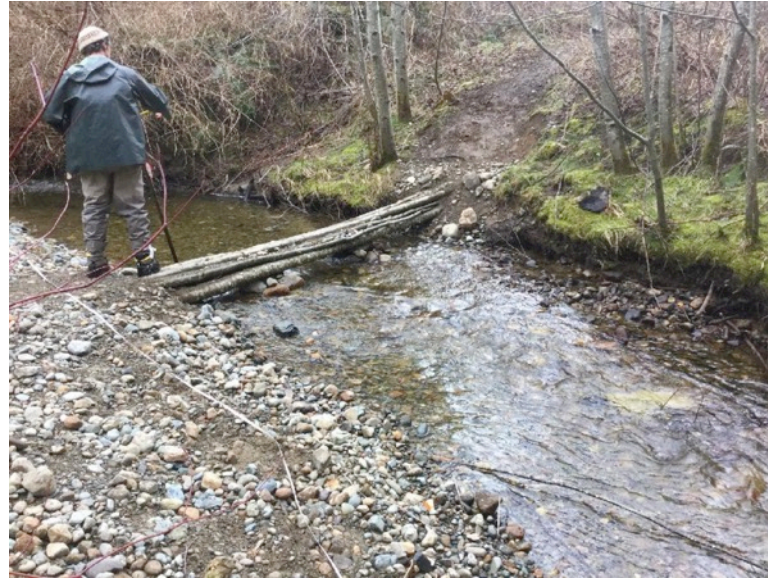
2.) Reach 4a at mountain bike crossing

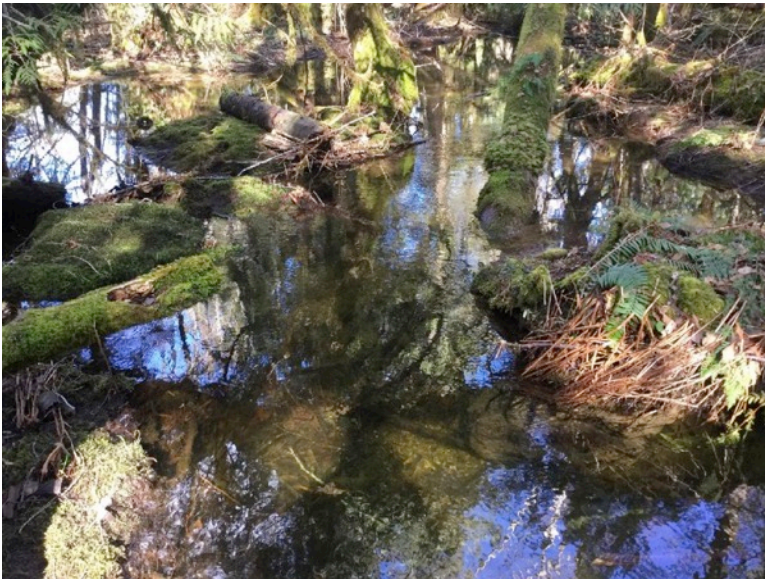
The channel is low gradient and on fine clays and loam that are vulnerable and were damaged by historic logging. The low gradient waterway has little erosive power and appears to be following the ruts and disturbances of the old logging. The low banks are composed of Red Alder root masses that are covered in moss. There are numerous isolated pools in the forest from groundwater or flooding. The Alder trees have been dying and falling into the channel creating some cover. The substrates are very sandy and clean gravel areas are limited. From the survey results above, the pool area ratio is high with clear sandy bottoms. These shallow pools may not dry in summer benefiting from 70% or greater canopy closure from the Alders above. This area may offer small perennial pools for resident fish as well as being amphibian habitat with the many isolated forest pools and blow down debris.

3.) Reach 4b2 typical disturbed channel

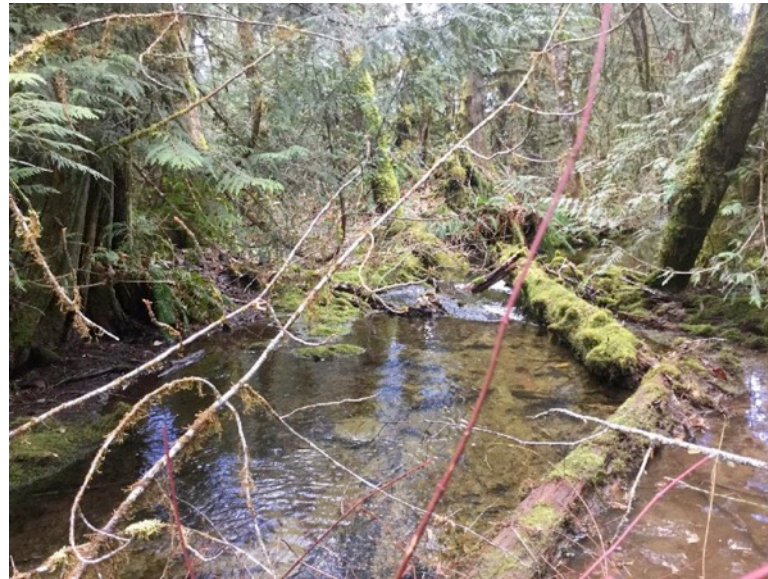
4.) Reach 4b2 with aging Alder and young Cedars

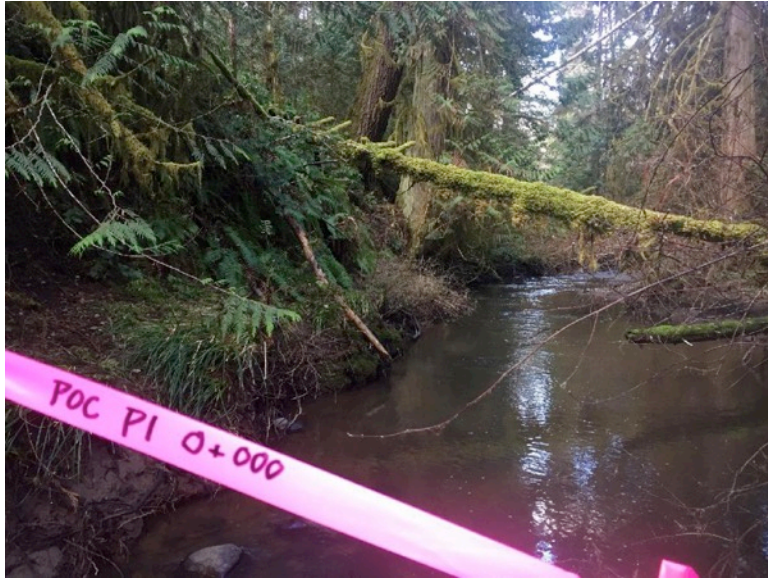
1.) Swayne R1 is confined and treed

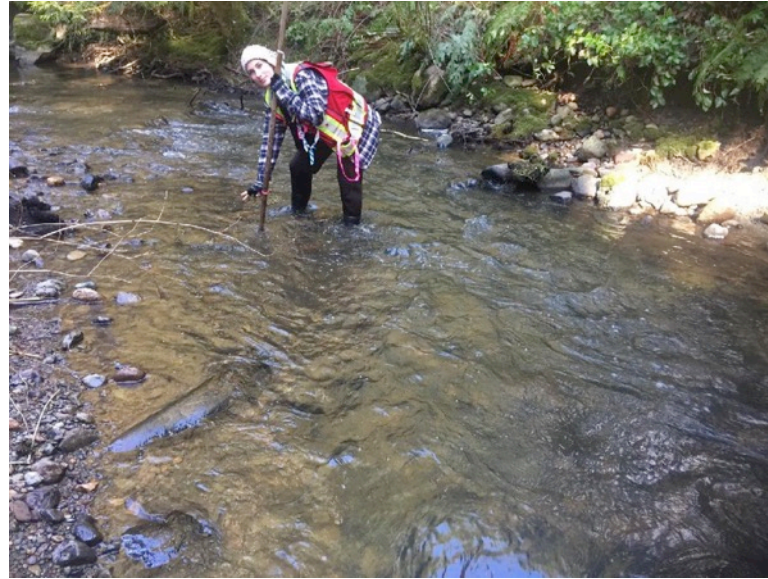
2.) Typical riffle with good mix of substrates

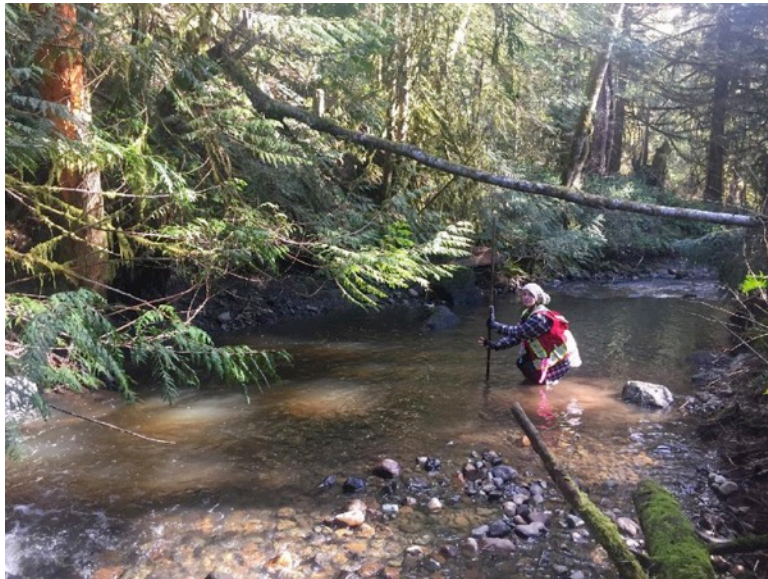
3.) Overhead canopy is a recovering conifer forest

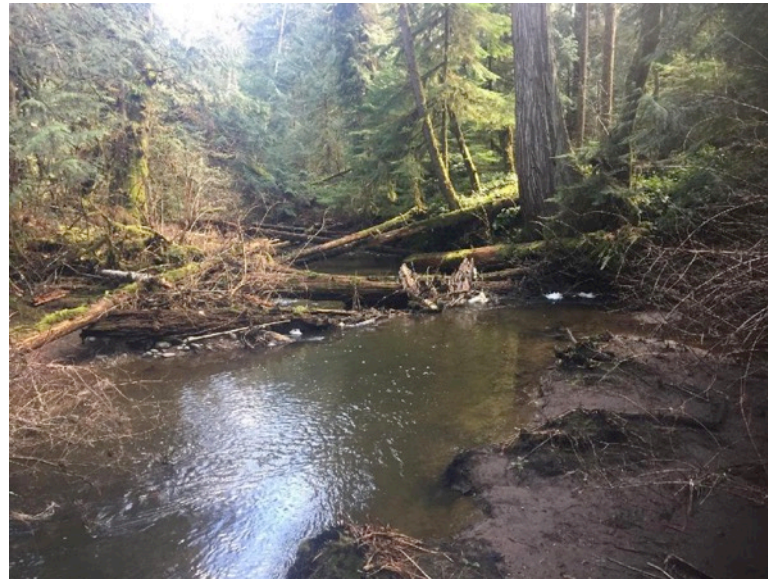
4.) There are some good cover locations (LWD)
