Nanaimo River Chinook Salmon Recovery Plan Habitat Assessment Report.

Fisheries and Oceans Canada
Nanaimo B.C.

December 2021

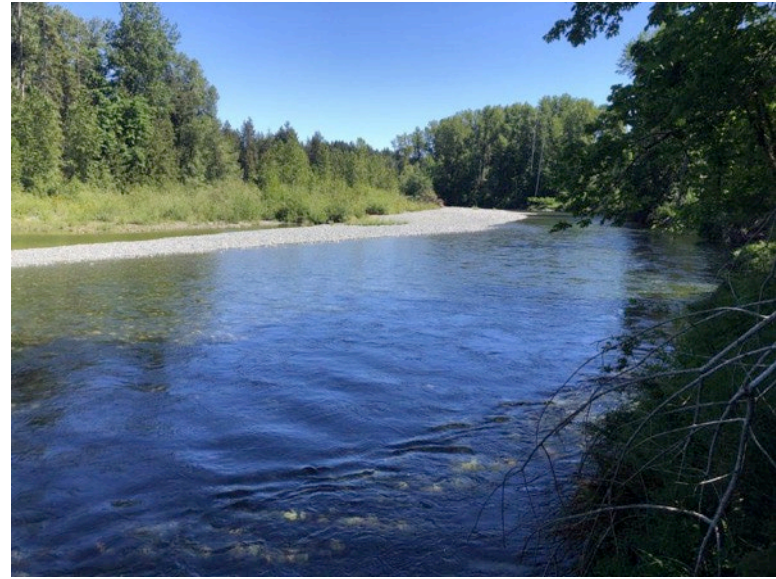
1.) Riffle 1 Placemark 7, Morden Trail head, clean gravel

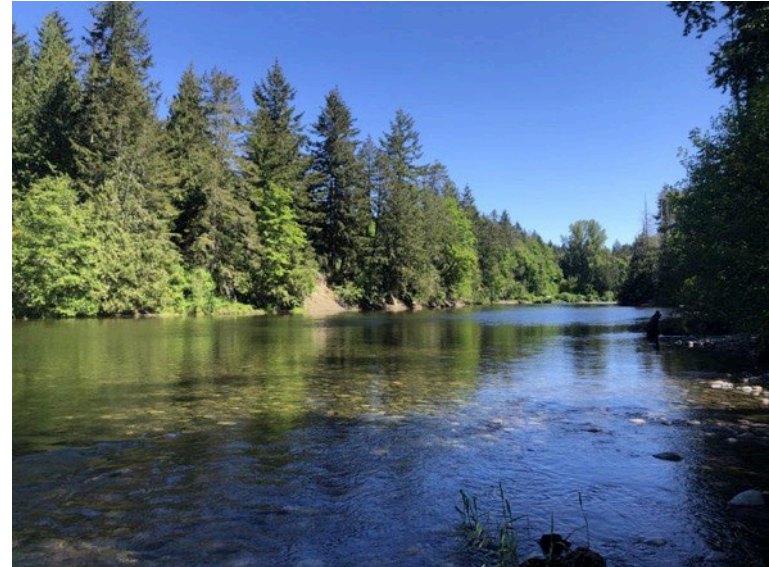
3.) Riffle 2, right bank island with dry flood channel and LWD.

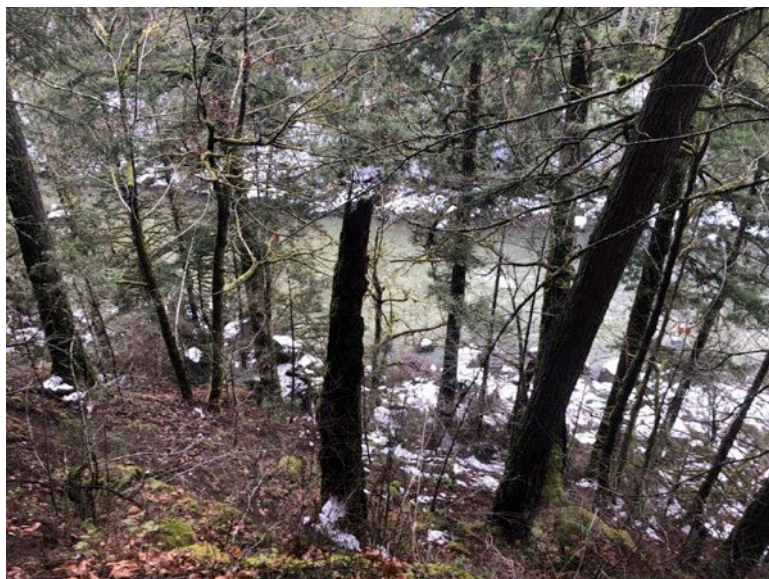
5.) R4-Glide 1 along steep but stable riparian zone left bank

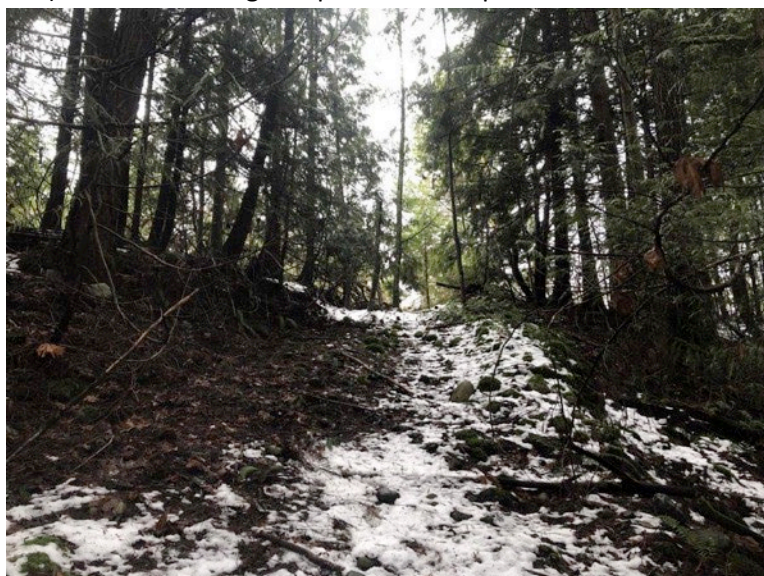
7.) R4-One of two old logging roads on left bank along the trail.

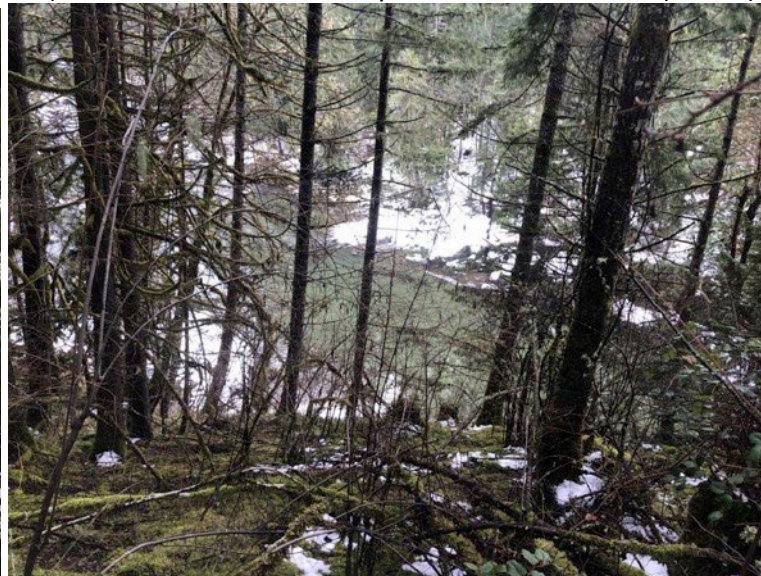
8.) Reach 4 – Pool 1 at top end has steep banks.

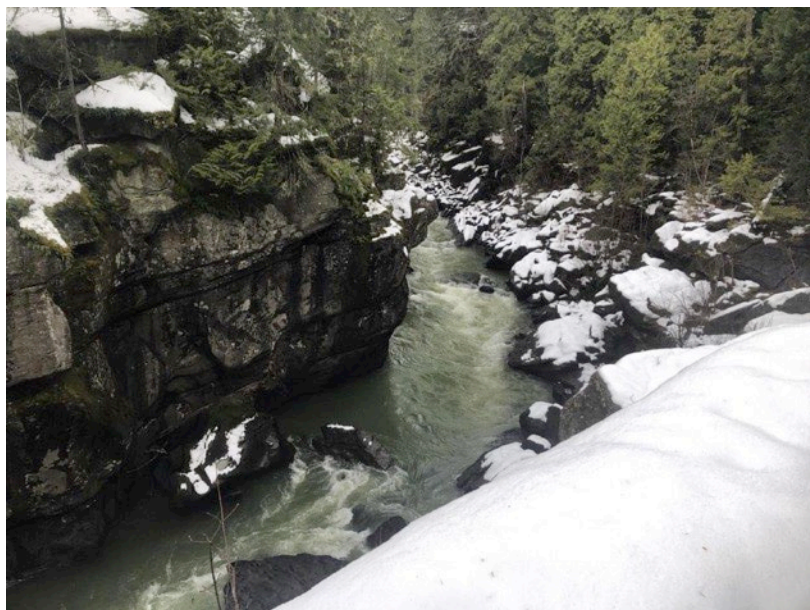
5) R5 – Pool 3, note 15 m high scour line on bedrock walls

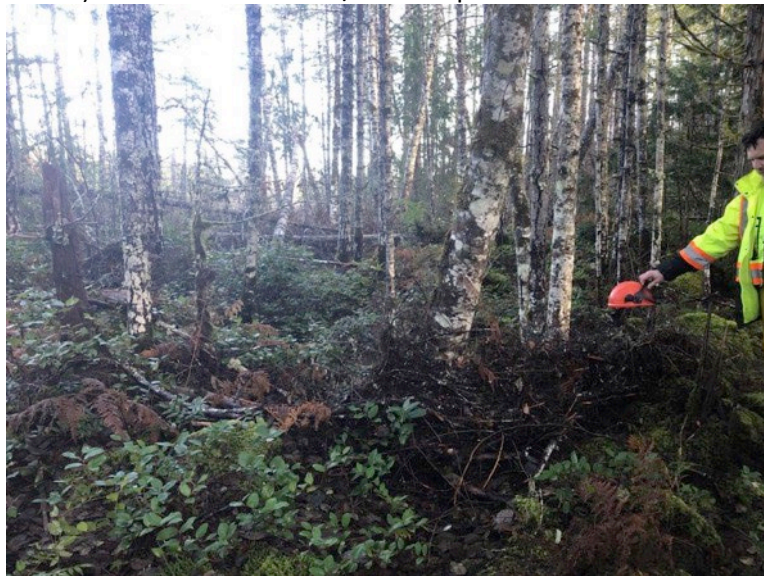
3.) R12- Glide 2 -LB riparian is flooded to 1.0m, uprooting trees.

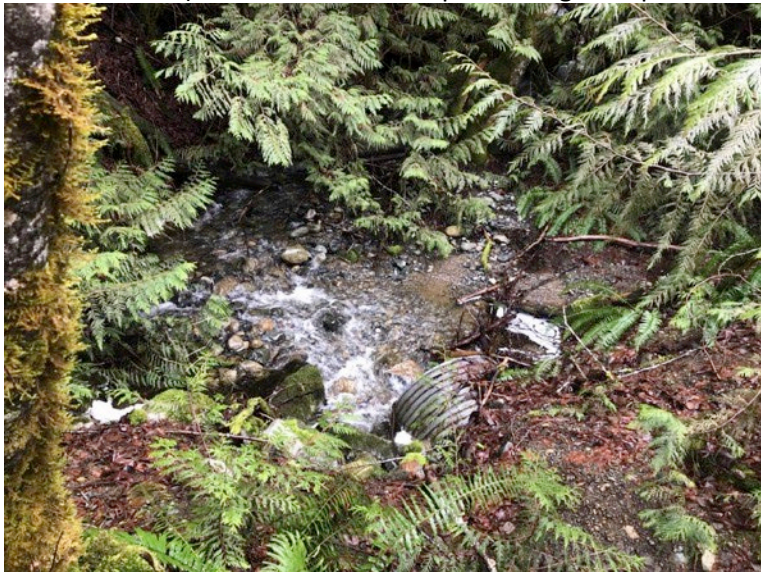
3.) R13 Placemark 9 culvert under rail grade

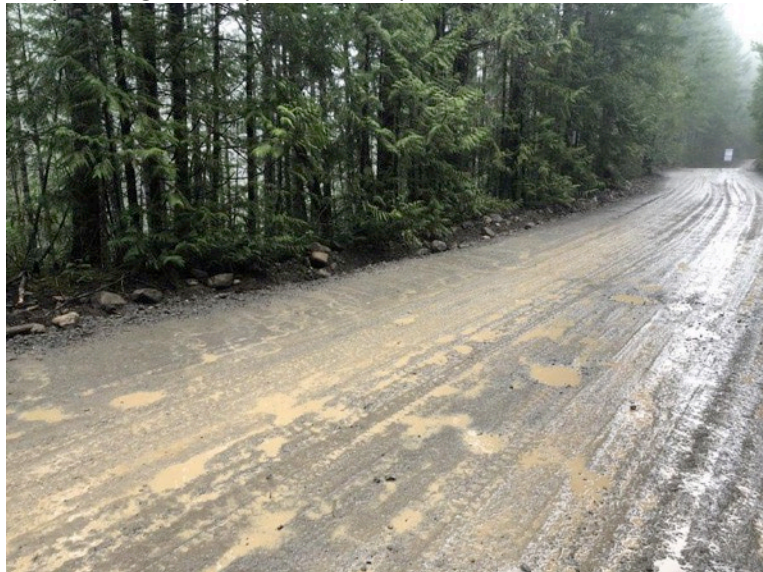
3.) Road is 10m from river, note grader berm on river side

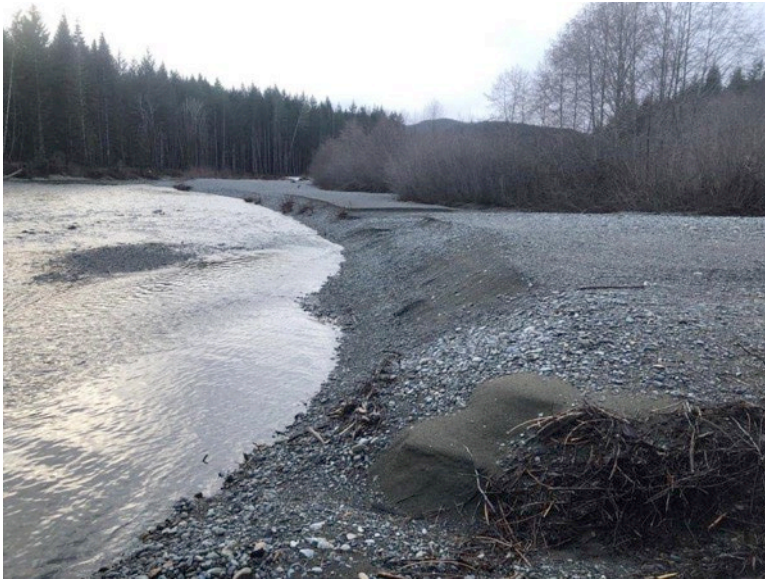
1.) R22 - Riffle 3- gravel bar needs planting

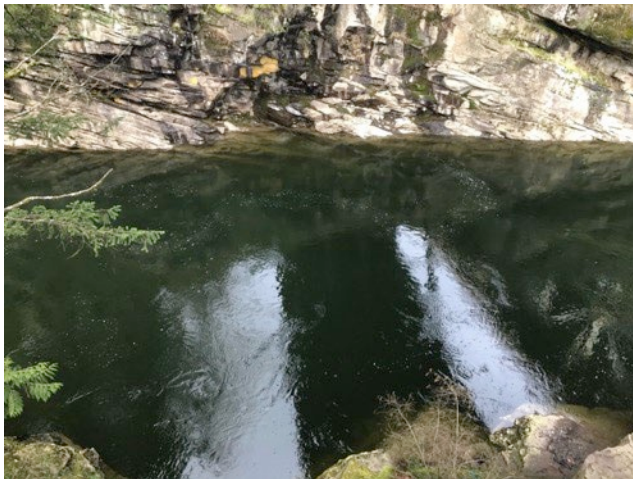
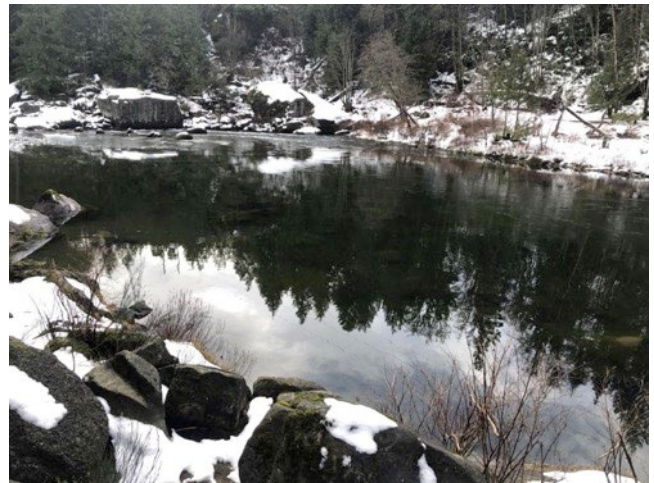
Deep Bedrock controlled Pools in Reach 4 and 5

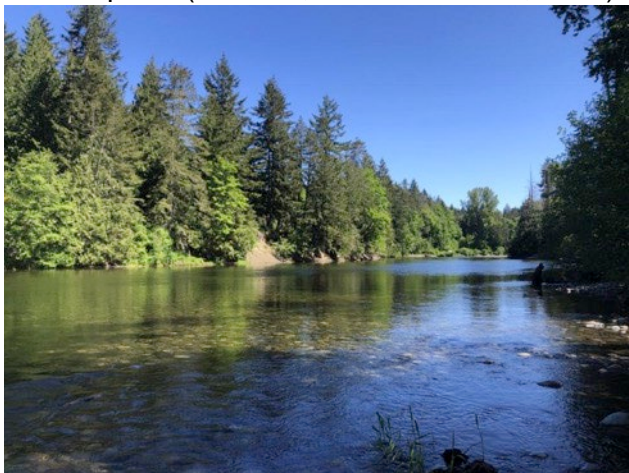
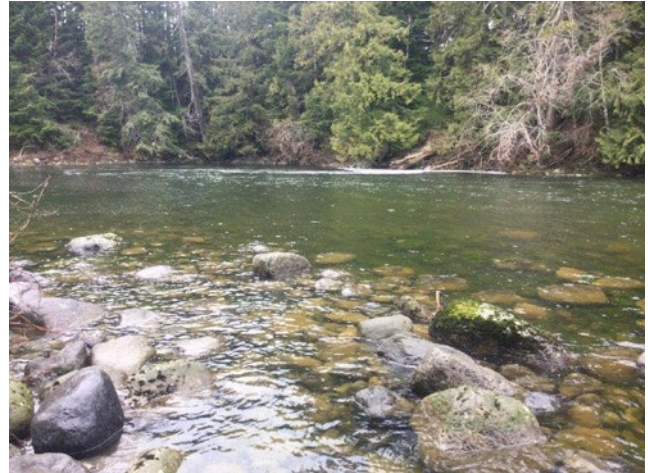
Reach 2 shallow gravel scour pool above Morden Trail Reach 13 corner Pool 1 at 180 °bend in river.

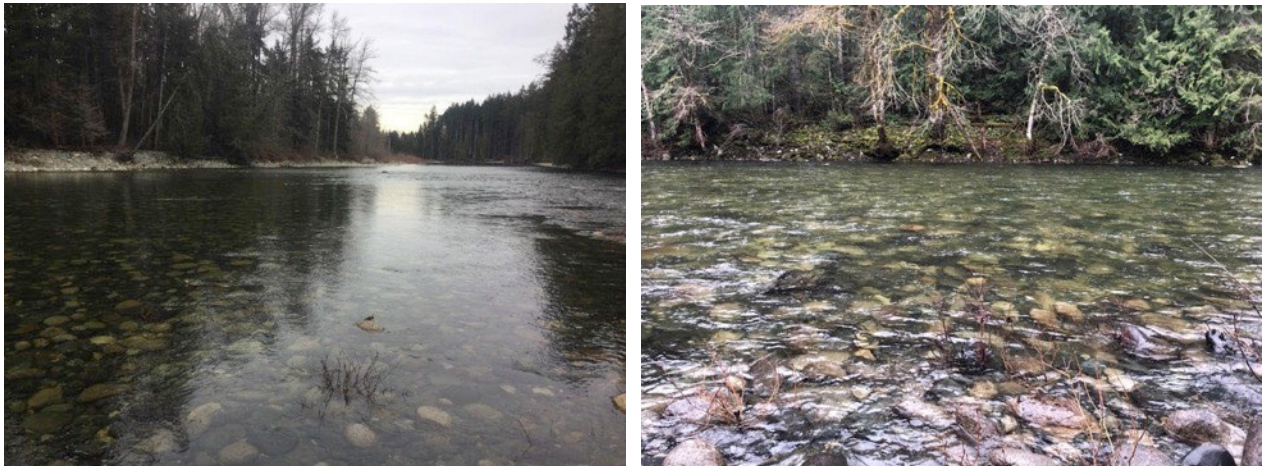
Pool area has been lost to sedimentation. In Reach 2,3 and 22, many pools were filled in by sediment deposition. There are locations in these reaches where the channel sediment deposits are now the same height as the banks forcing flood waters to migrate into the floodplain resulting in more erosion.

Reach 3, Glide too shallow to be a pool. Reach 12 Glide once a riffle before the gravels washed away.

Restoration of pools would require devices to scour or trap and hold substrates. Pools are created by installation of logs, rock groynes or rock crests in the channel. The instream devices have to be able to sustain against such forces as buoyancy, water velocity and debris impacts. The reaches of the Nanaimo River certainly require more and deeper pools but creation/improvements to pools would first require a hydrological assessment by river engineers. Standard biological prescriptions used for smaller/healthier streams are not applicable to the Nanaimo River due to its size and condition. The Nanaimo River appears to be in a state of flux on pool and riffle habitat. The upstream areas are degraded and lack structure to rebuild, while the lower reaches are aggraded with excess gravel. These impacts are in similar locations on the east coast of Vancouver Island in rivers such as the Cowichan, Koksilah and Chemainus. Restoration along these rivers included the removal of sediments and stabilization of banks. These prescriptions first require the river engineering studies of the river.

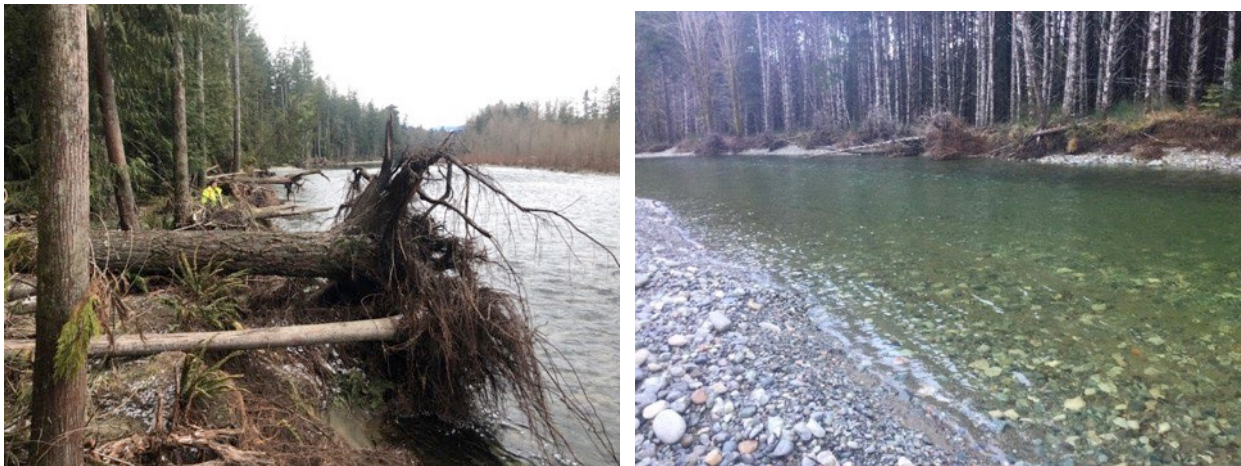
The reaches (R3 & R22) that had the higher counts of LWD, were found in unconfined areas where the eroding banks had dense stands of second growth fir. Unfortunately the LWD recruited from the forest is poorly anchored and passing through with flood events. The mid and upper reaches were less populated with LWD. Reaches with more confined banks of bedrock, boulder and cobble with less meander lack the conditions to trap or hold LWD. High water level/velocity easily cleans the banks of any LWD. Old growth LWD is heavier and longer and would have offered more functional cover but it was not observed anywhere in the river.

LWD is rare, small and poorly anchored throughout the river; observed in Reach 3 & Reach 22

Restoration of LWD was identified as an opportunity in Reach 3 and 22 where there are low eroding treed banks. Stabilizing the second growth felled trees along these wide reaches was ranked medium. The prescriptions for LWD anchoring would involve burying and/or rock ballasting the trees along the banks.

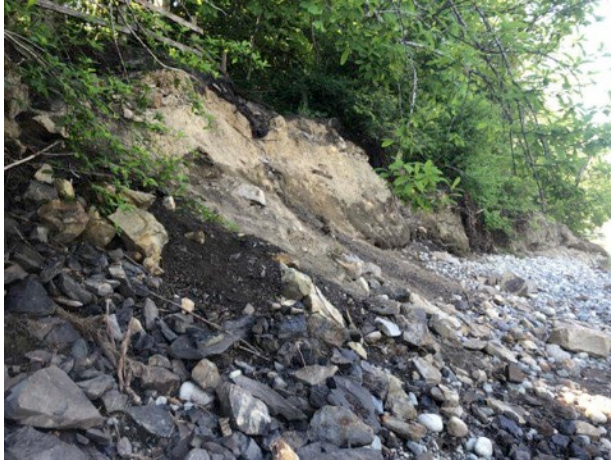
Reach 2 erosion at RDN trail head

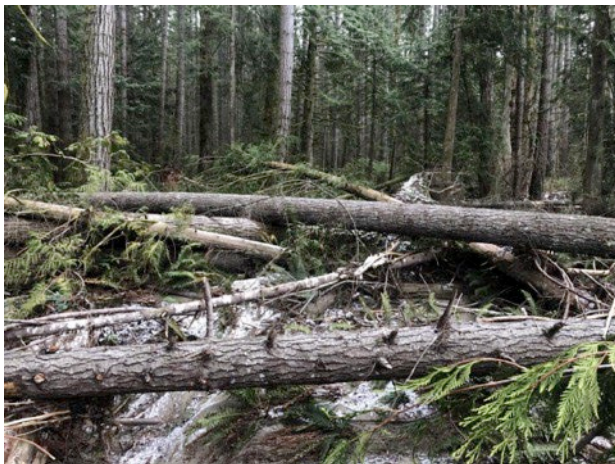
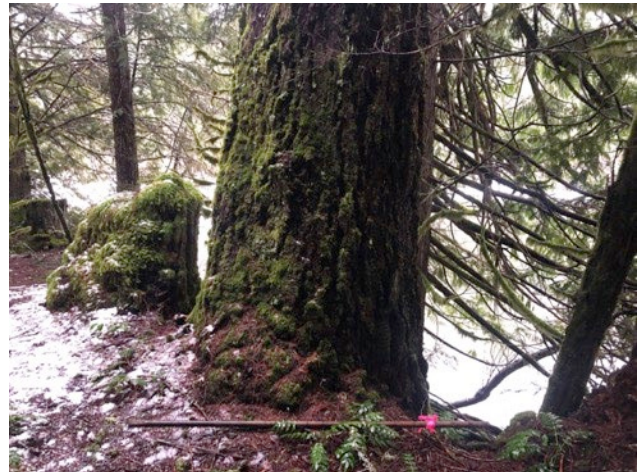
Reach 2- Young trees pushed over by floods Reach 14 - Old Growth (1.8m Douglas Fir) holding on

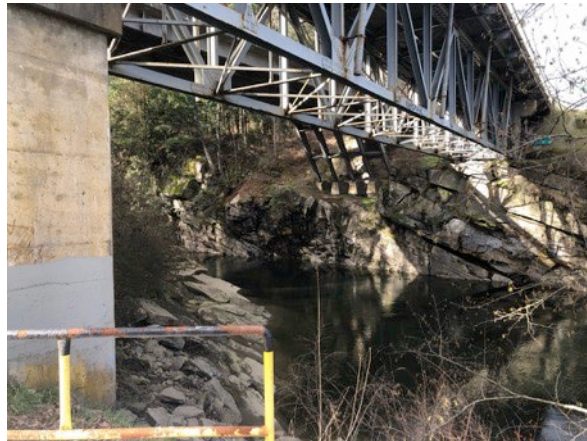
Water Quality – The highway and bridge are potential sources for pollution from runoff and spills. The bridge area catch basins drain straight into the Nanaimo above the pumphouse and hatchery intake. Installation of curtain drains to settling areas is recommended. particularly a concern.

Hwy 1 Bridge drain pipes go direct to pool.
