# Holden Creek Stream Survey - 2016

On behalf of  
The Regional District of Nanaimo  
Drinking Water & Watershed Protection

October 2016

Written by D.R. Clough Consulting

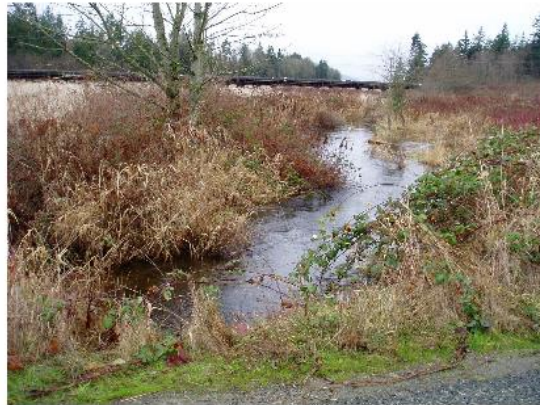
**R1 - flooding below White Rd to Trestle**

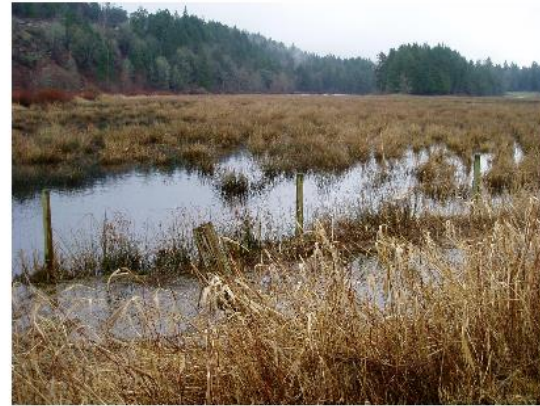
**R1 - Flooded pastures above White Road**

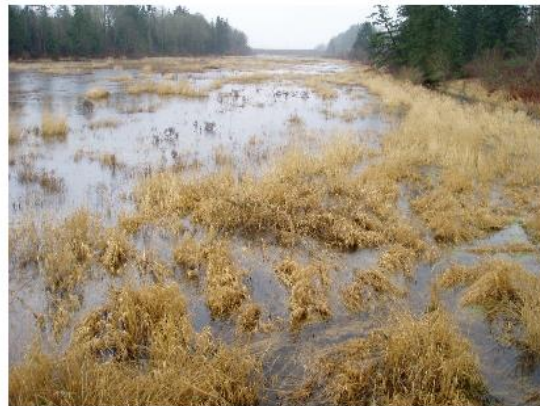
**R1- flooding towards Duke Point/ocean**

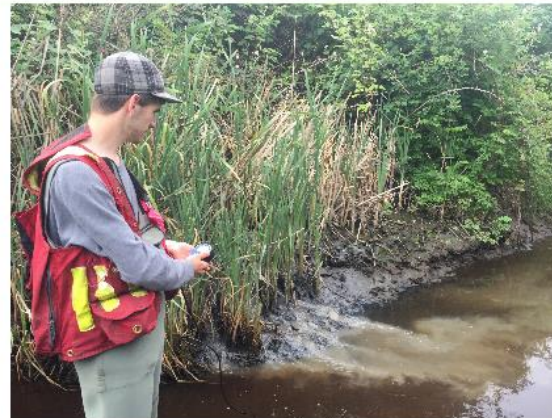
**R1 - water quality site near ocean**

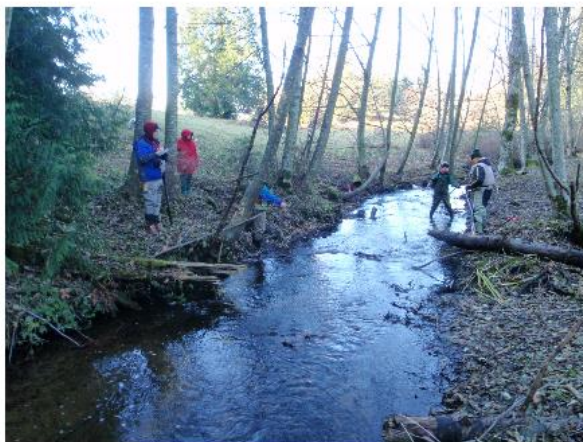
**R2 - lack of LWD for cover habitat**

4	Improve fish habitat.	Add large woody debris for cover.	Property owners permission required.
Holden Lake	Monitor water quality.	Establish a temperature data logger and conduct routine water chemistry.	Work with local schools and property owners.
Quennell Lake	Monitor water quality.	Establish a temperature data logger and conduct routine water chemistry.	Work with local schools and property owners.

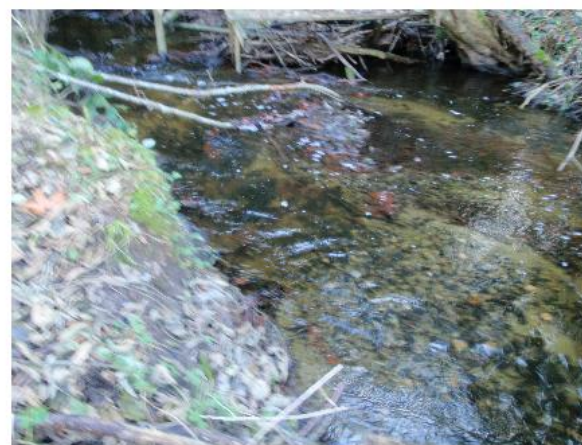
**R2- sedimented spawning gravel sites**

2	Poor water temperatures and oxygen.	Plant trees for shade along riparian area.	Seasonal flooded areas will require shrubbery prescriptions and dry areas with conifers.
2	Limited and sedimented spawning gravels.	Replace gravel and eliminate sediment sources in pool tailout locations noted in the USHP survey	Property owners permission required.
2	Poor instream habitat	Install woody debris and boulder structures to improve cover, bank protection and water quality.	Property owners permission required.
3	Improve shade to reduce water temperatures and improve oxygen.	Under planted conifers in the alder and maple dominated areas.	Property owners permission required as well as a review by a RPF / RPBio.
3	Improve fish passage	Assess the culverts (Holden Corso and Rugg Road) and dams for improvement.	Engage highways (MOTI) and property owners as partners.
4	Improve spawning gravel.	Replace spawning gravel and eliminate sediment sources.	Place gravel below lake outlet.

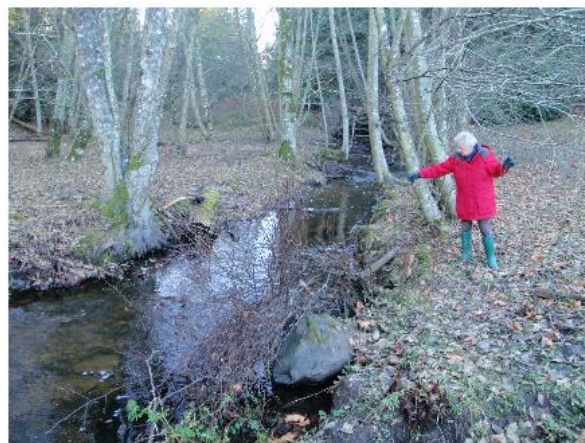
**R2 - Shallow pools**

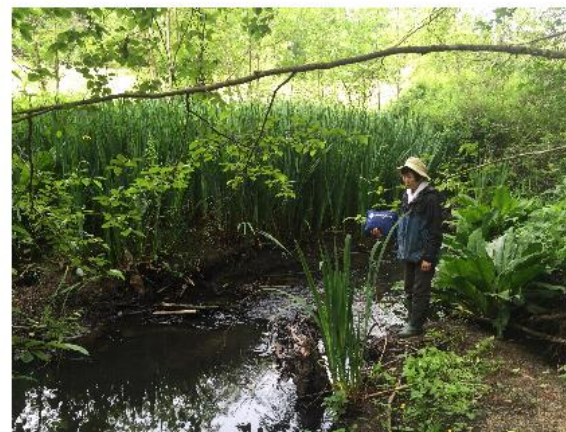
**R2- June WQ at Pony Farm - oxygen 7.8ppm/Temp. 16.9C**

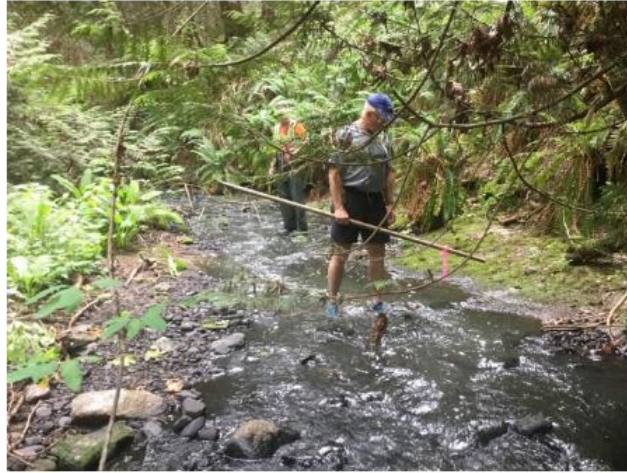
**R3-Lower riffle in higher gradient**

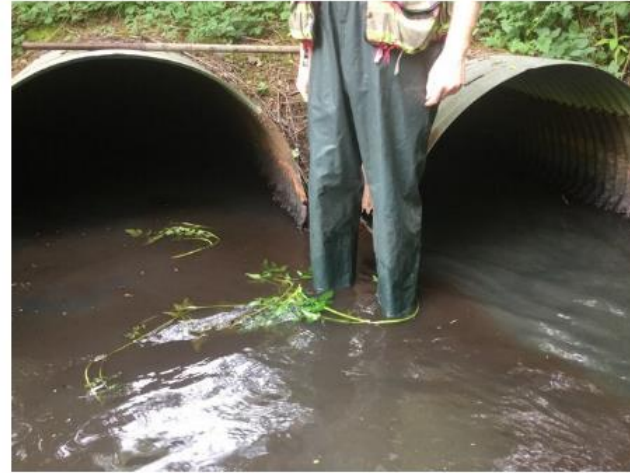
**R3 - Rugg Rd Culvert 1**

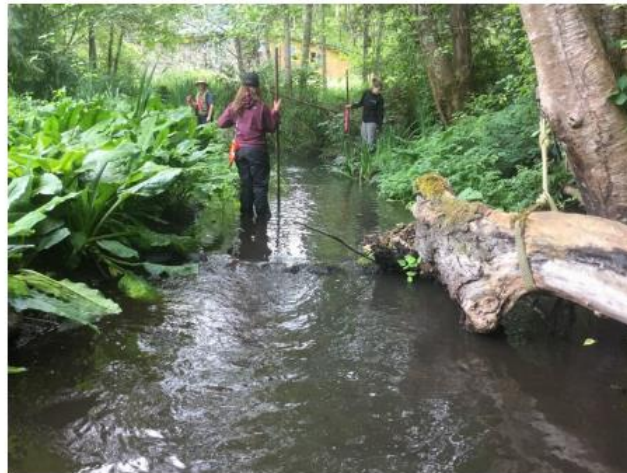
**R3- Pool below Holden Corso Rd**

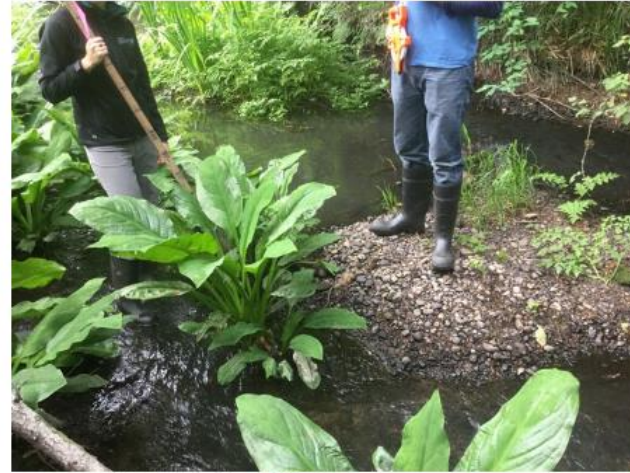
**R3 - below Rugg Rd Culvert**

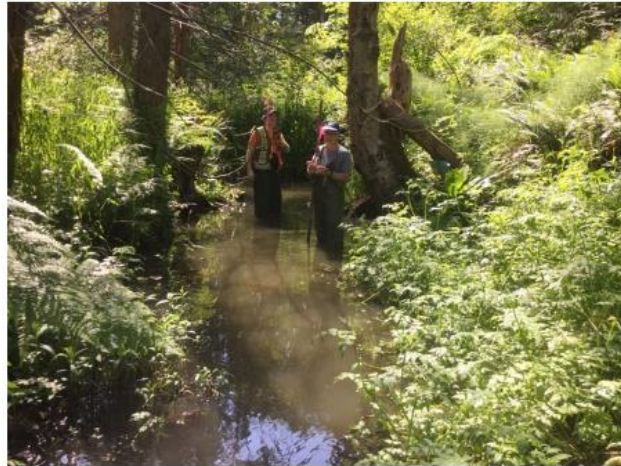
**R4 - best riparian canopy in this reach**

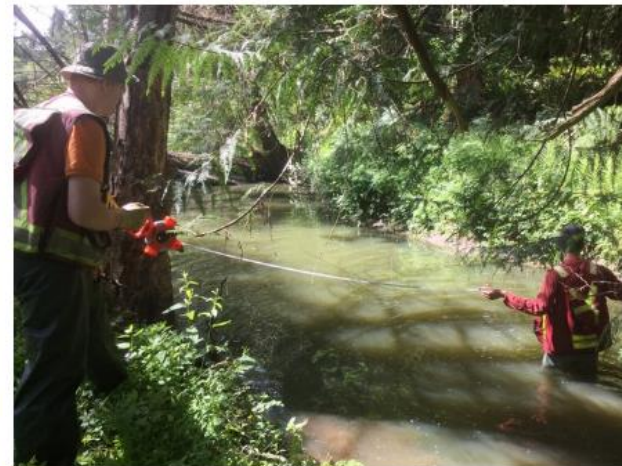
**R4- deep pools in this reach**

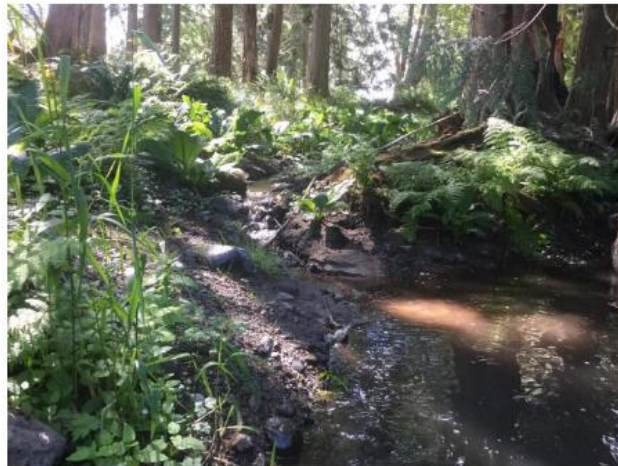
**R4- short riffles in low gradient reach**

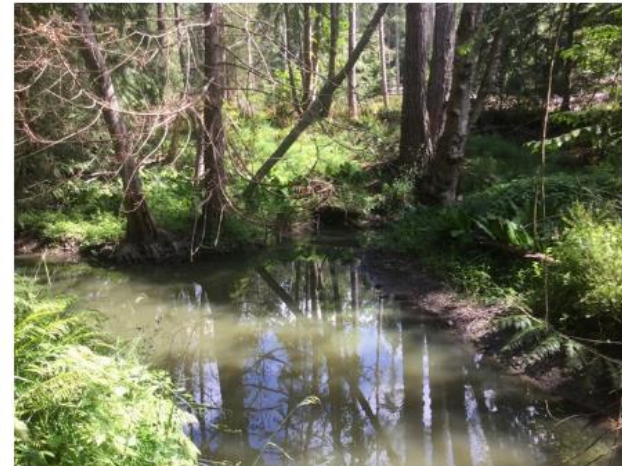
**R4- good winter habitat, marginal oxygen (5.7 ppm)  
high temperatures (16.8C) in summer.**
