Cat Stream Habitat Overview Survey

Regional District of Nanaimo

D.R Clough Consulting

June 2017

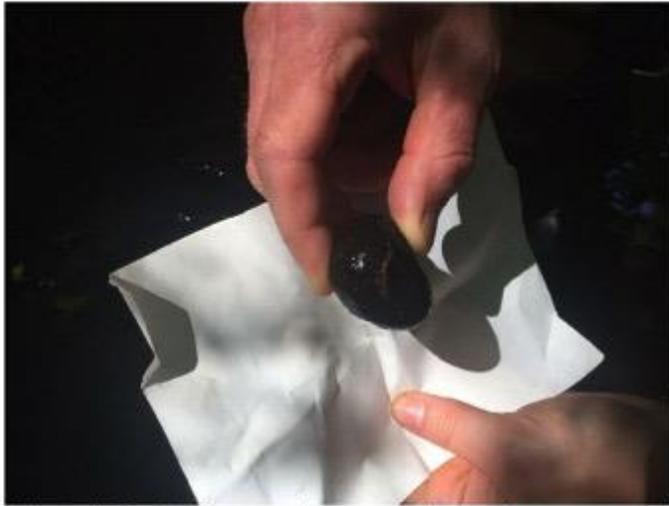
Photo 1) Black slime coating streambed substrate

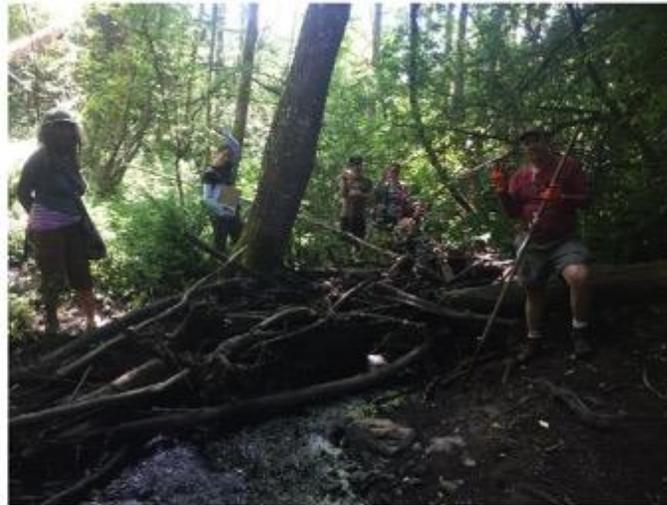
Debris jams that completely plug the channel in three locations are another concern related to wood instream. These jams are established on large wood cover logs that became plugged with smaller branches, lumber, garbage and sediment (including garden debris and yard waste). Fortunately these debris jams are easily accessible from Park Avenue, are small and could be hand removed (Table 9 -1.3). The material is loose branches, lumber, garbage and silt. The native materials can be removed to above high water and used to create or protect tree seedlings and add to forest coarse woody debris for amphibians.

Photo 2) R1, Pool 3 woody debris jam #1

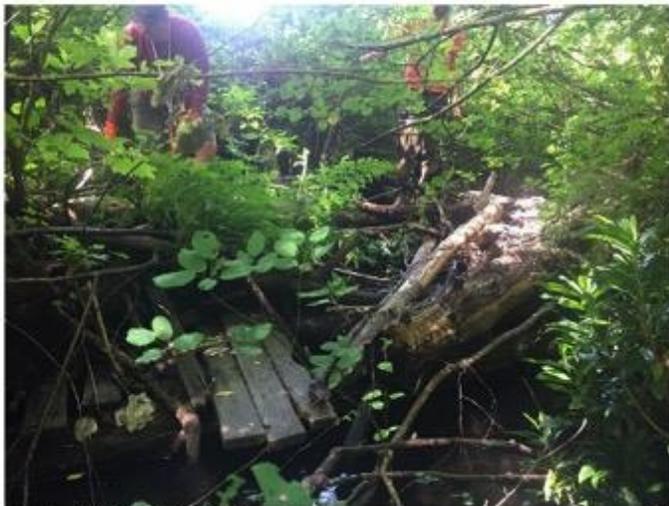
Photo 3) R1, Debris jam #3

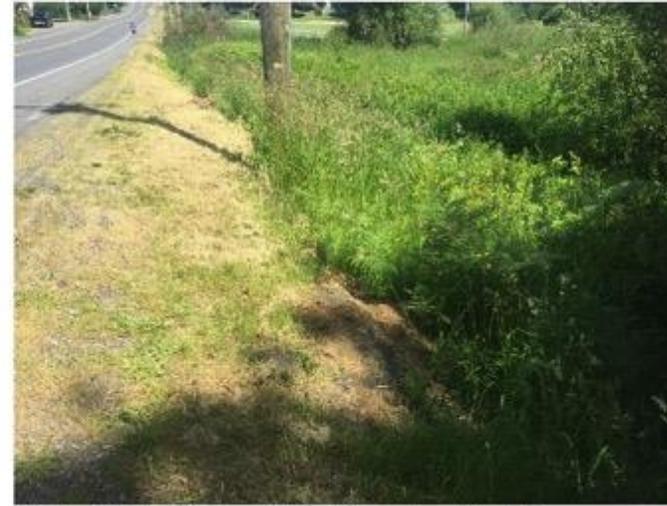
Photo 4) R1, Compost dumping along Park Avenue

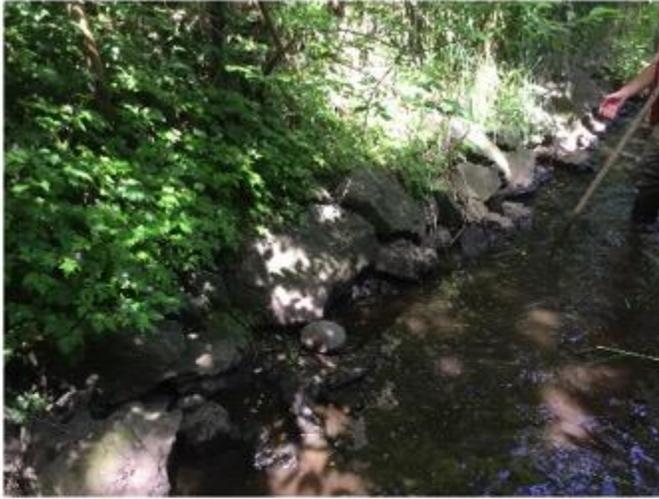
Photo 1) R2, Historically armored left bank

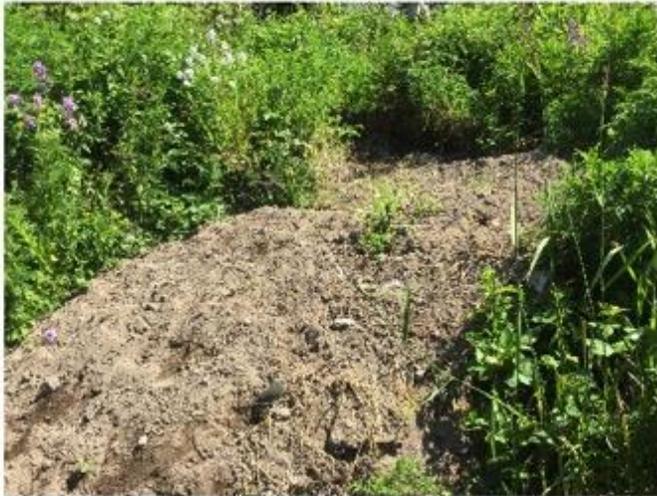
Photo 1) R2, Exposed slide materials eroding into creek

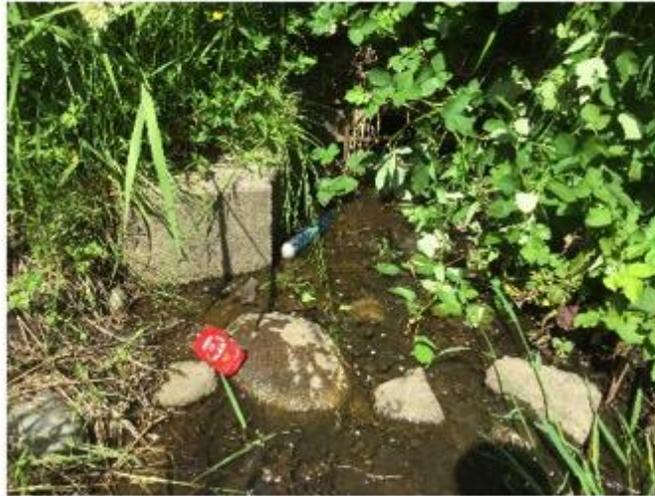
during the summer and is a wide floodplain during the winter. The low gradient pooled water here provides rearing habitat for juvenile fishes, however the instream cover is entirely wetland grasses that load the stream with organic material impairing oxygen levels in summer and having low bank stability characteristics. This reach was influenced by road and lawn runoff; as seen in the sediment accumulation on the creek bed. Several manholes on dead end streets lead right to the creek (i.e Pine, Rosamond). Storm water filtration is recommended (Table 9-item 2.4)

Photo 2) Pine street culvert effluent contributing poor quality water and sediments

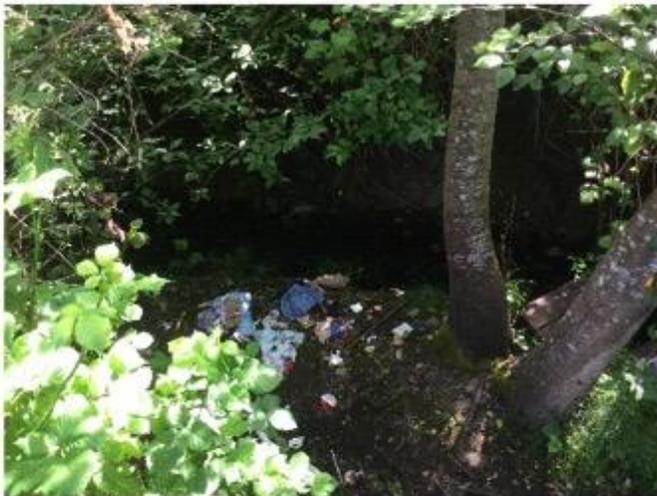
Photo 3) R2, 5th Street culvert garbage and drug debris

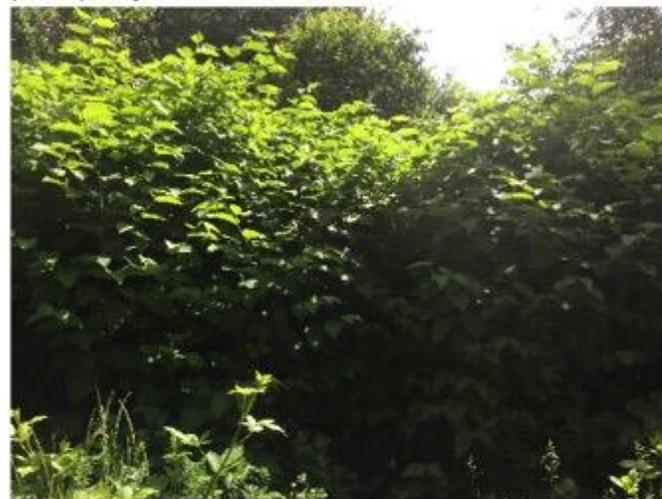
Photo 4) Invasive japanese knotweed at the end of unnamed alley way

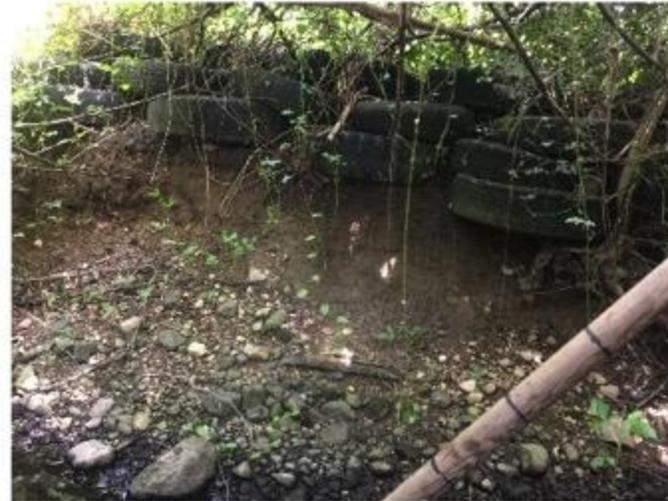
This reach had eroded, steep banks that had been historically armoured with old tires and rock. Most of the riparian of this reach was vegetated residential yards. Many of these yards were unfenced resulting in lawn materials, yard sediments migrating into the channel during rain events. We also observed dogs playing in the creek from surrounding properties.

Photo 2) R3, Right bank reinforced with old tires

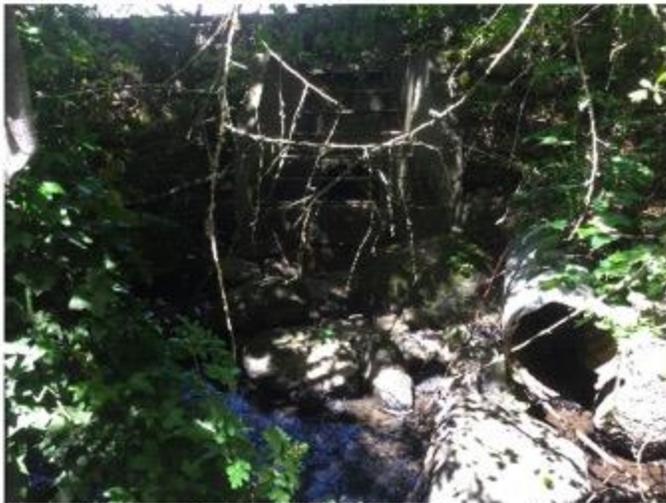
Photo 3) Two culverts draining from Beaconsfield Road

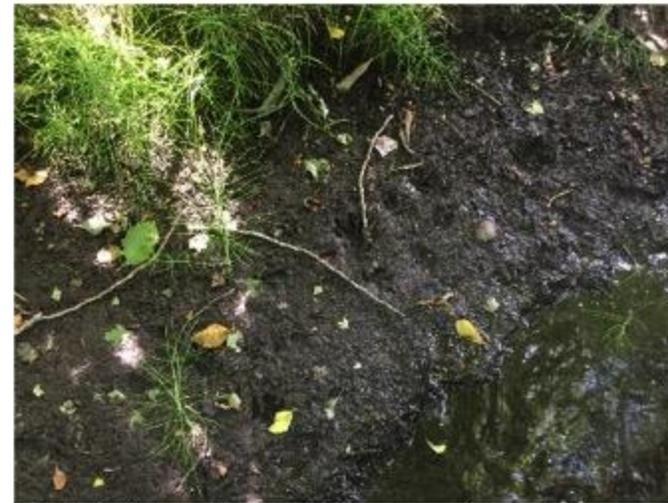
Photo 4) Accumulated sediments, erosion and raccoon tracks

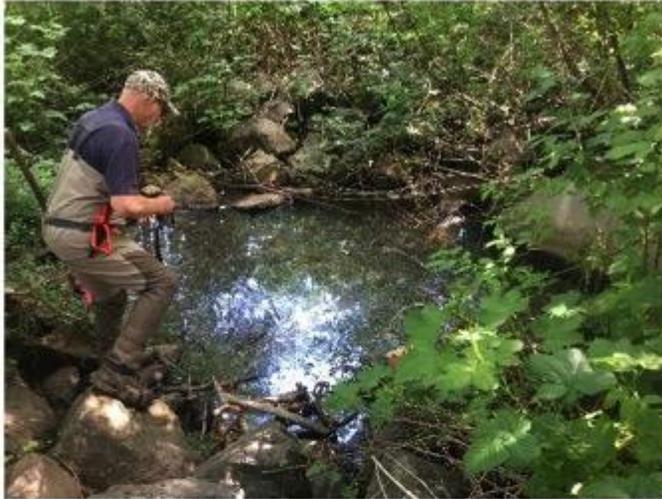
Photo 1) Wetland drainage under ball field access trail. Stagnant pool at culvert outlet.

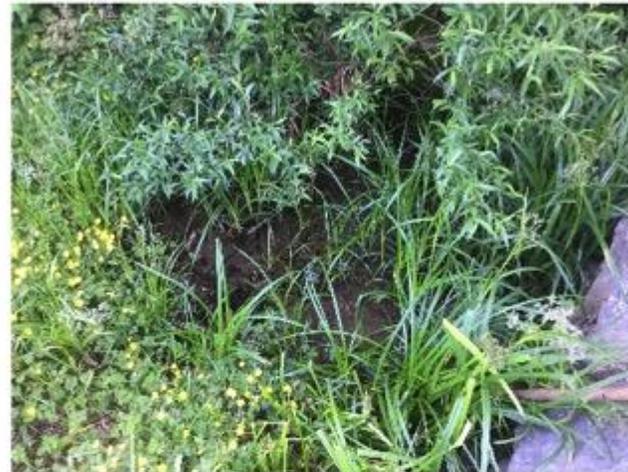
Photo 2) Serauxmen park drainage channel with accumulated fine sediments

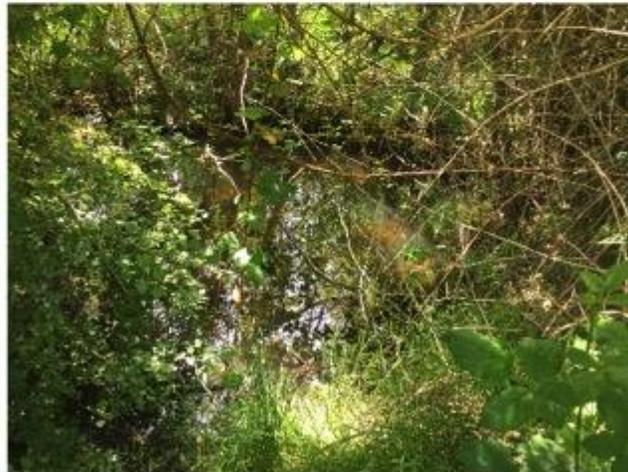
Segment 4-3: Another VIU slope drainage that has a series of small pools and ditches connecting to segment 4-2 at Site 10 on Figure 4. It is approximately 210m long. This segment joins above the foot trail and is not fish accessible nor habitable. At the 'DRC Site 10' station there is a 300mm pipe crossing under the walkway. On the high side of the walkway there are

several pools of standing water. The water here drains through a series of culverts to the ditch line along Third Street. As summarized in Table 8, the water quality in these pools was very poor and the water smelled stagnant. This area was also very muddy and likely contributes sediments downstream.

Photo 3) DRC Site 10, stagnant pools with poor water quality and impaired drainage

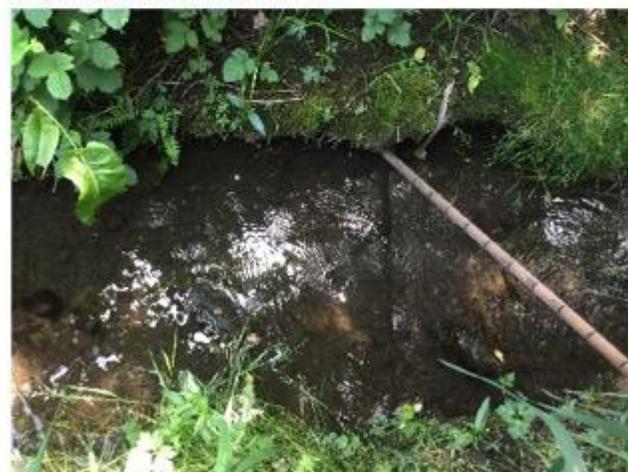
At Segment 4 are DRC sites 11 and 12 (Figure 4) situated below the University Crescent Residence and adjacent to the stadium and running track. Site 12 is suspected to be the VIU Aquaculture runoff and is one of the most significant contributors to downstream flow. At the time of the survey the 1000 corrugated metal pipe (CMP) outlet was flowing at approximately 175 lpm. The water being discharged here was good with respect to oxygen and pH parameters and is previously treated by UV radiation to kill any biotic contaminants. Concerns with this discharge surround the nutrient output potentially contributing to downstream wetland eutrophication. Future corrections could potentially include chemically removing nitrogen and phosphorous containing compounds from the aquaculture effluent. Downstream site 11 is visible from Third Street. Water quality here was similar to the source quality; however the substrate here was clouded with organic slime that resembles the bottom of a fish tank. This is potentially a result of nutrient loading from upstream aquaculture activities. There were no benthic invertebrates here that indicate a healthy stream, however numerous juvenile leaches were observed clinging to the rocks.

Photo 4) DRC Site 11, nutrient loading and leeches
