Parker Road Monitoring program

Water level graphs to September 2018

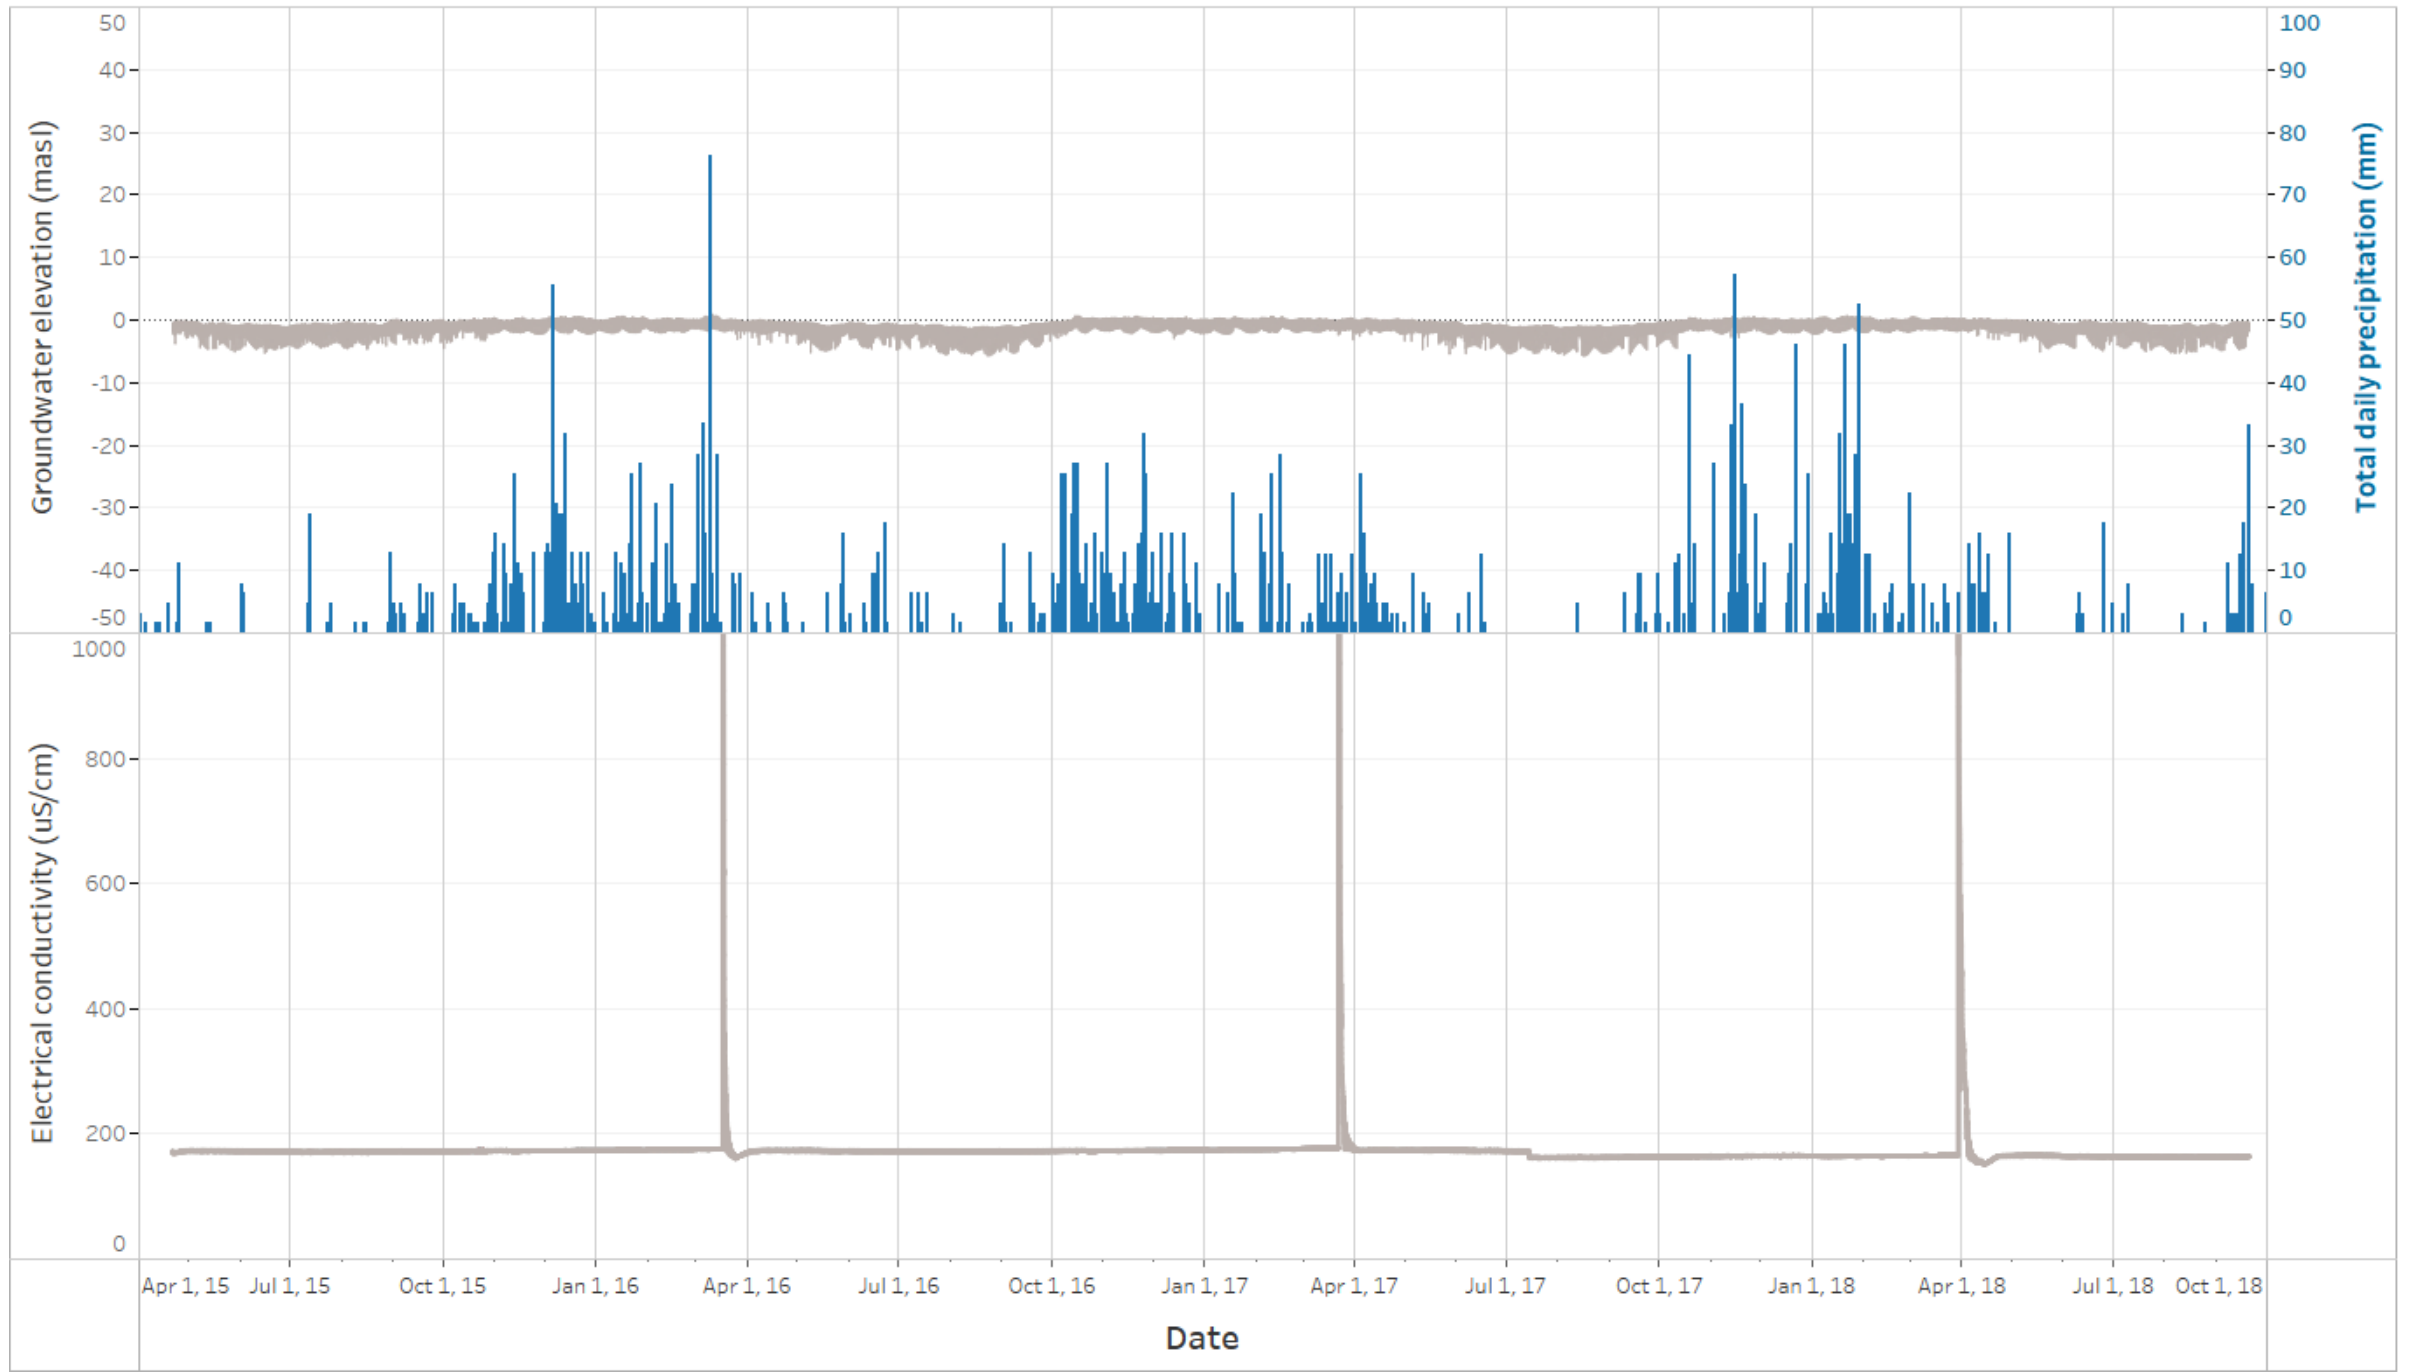
Groundwater elevation and electrical conductivity in O3, Precipitation in Fairwinds

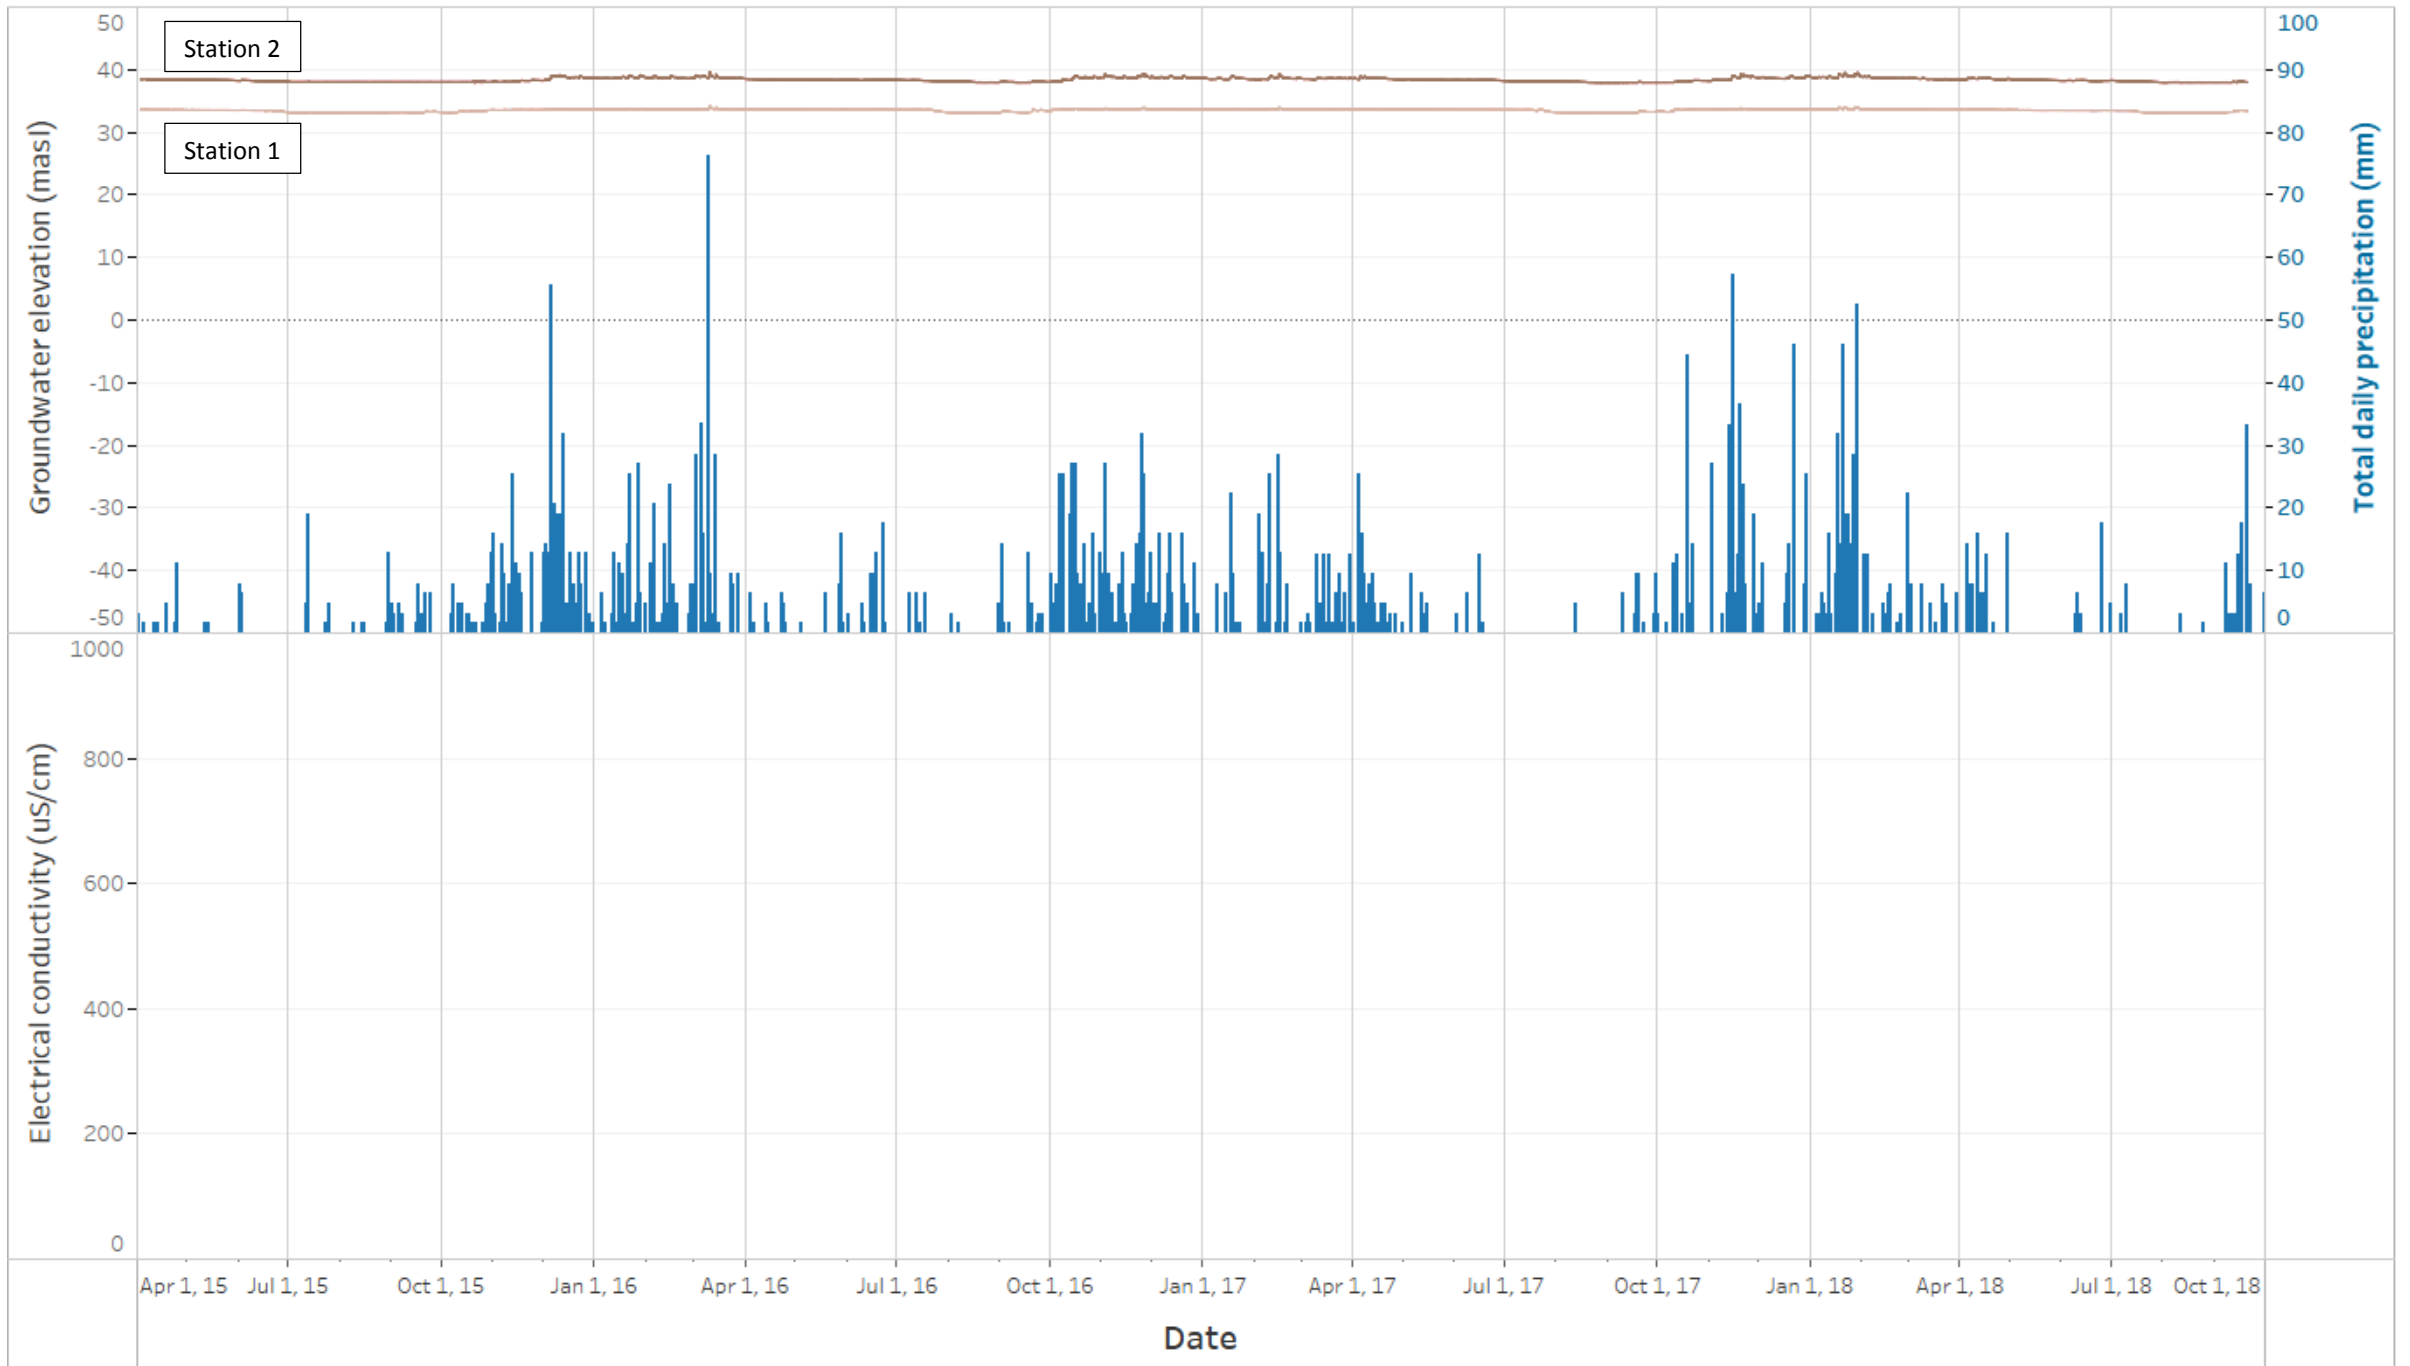
Groundwater elevation in Melstrom Creek, Precipitation in Fairwinds
