# Regional District of Nanaimo Biosolids Management Program

## TimberWest Properties Surface Water Quality Report 2019

March 2020

SYLVIS DOCUMENT #1289-20

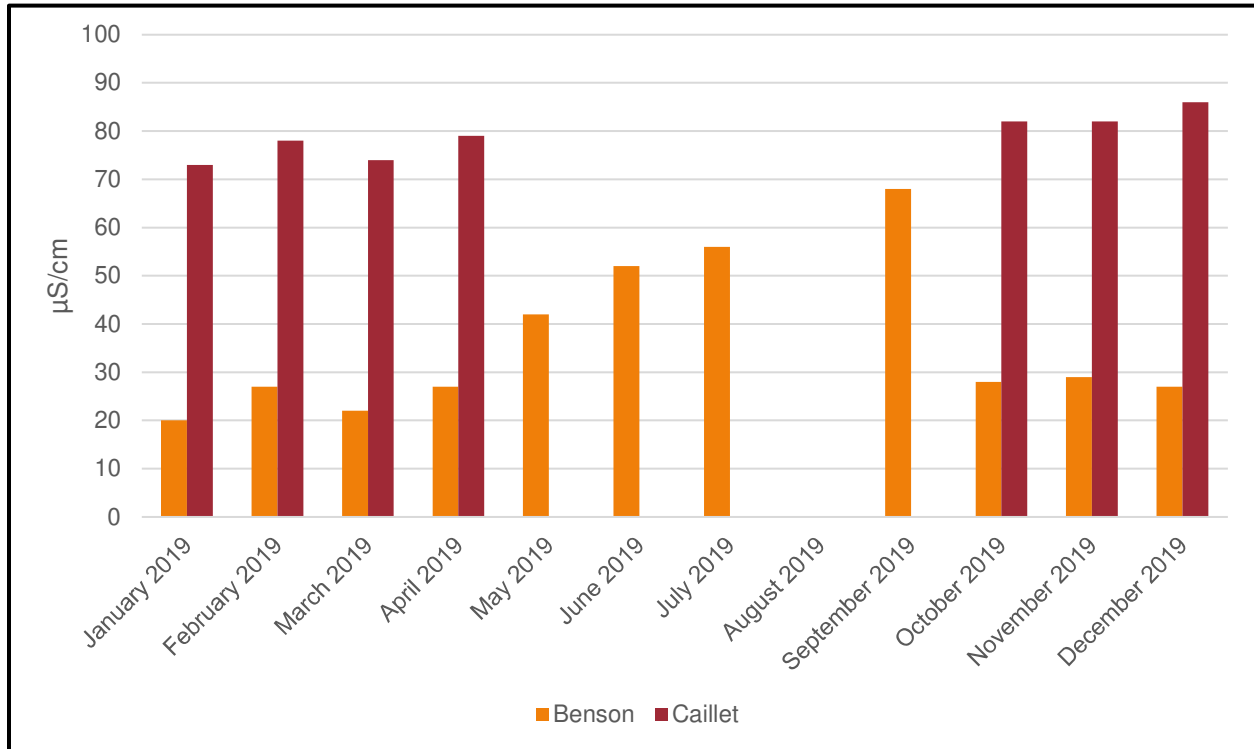
**Figure 4:** Monthly electrical conductivity in Benson and Caillet Creeks with reference value, 2019 (no chronic long-term BC Approved Water Quality Guideline for protection of aquatic life available).

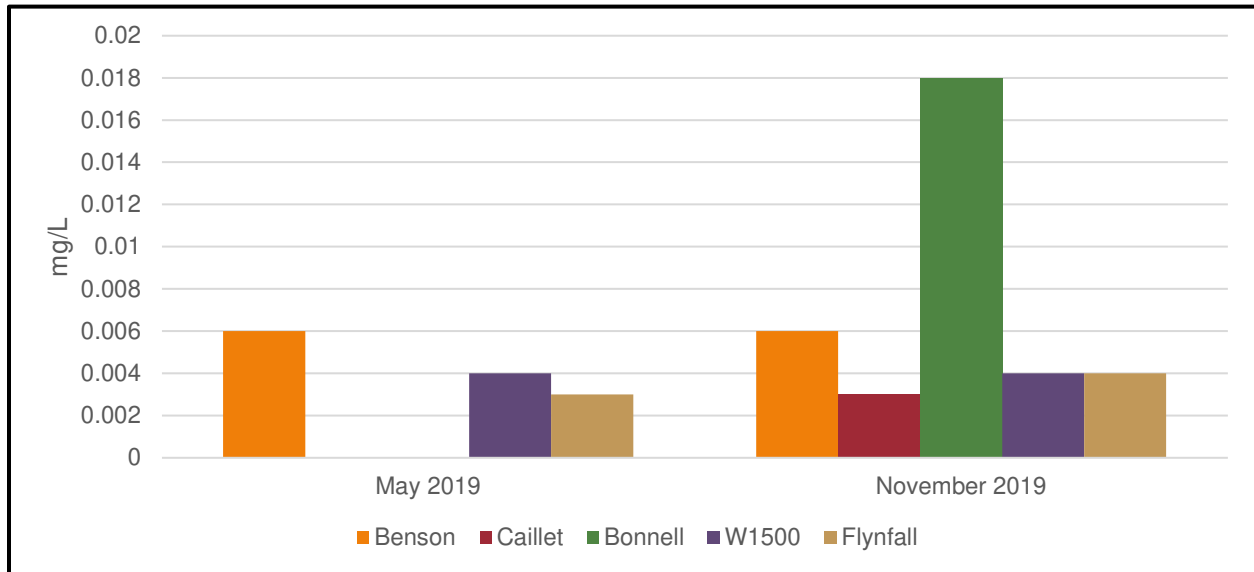
**Figure 6:** Total phosphorus concentrations in Biosolids Area creeks and Benson Creek, 2019 (no chronic long-term BC Approved Water Quality Guideline for protection of aquatic life available).

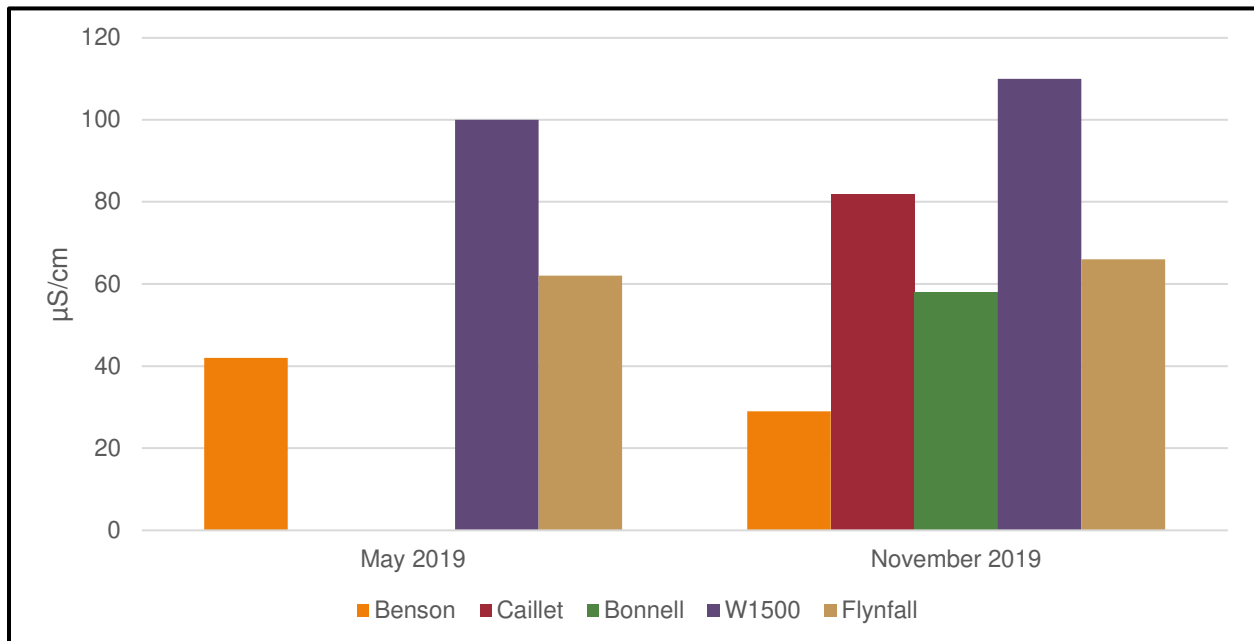
**Figure 7:** Electrical conductivity in Biosolids Area creeks and Benson Creek with reference value, 2019 (no chronic long-term BC Approved Water Quality Guideline for protection of aquatic life available).

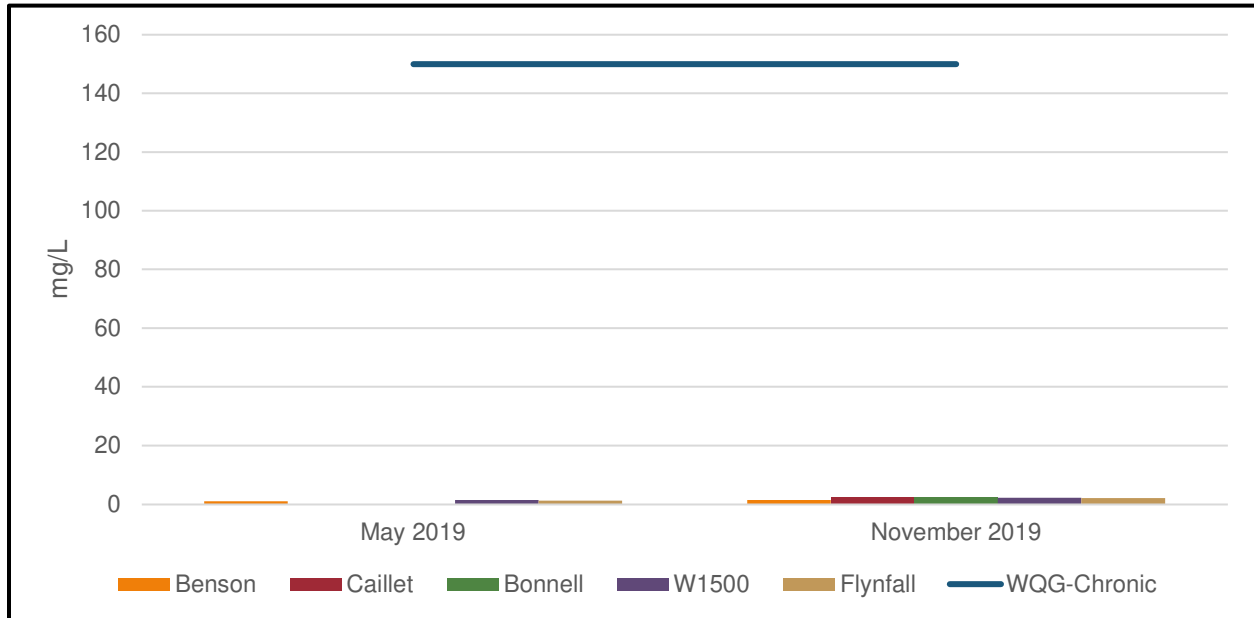
**Figure 8:** Dissolved chloride concentrations in Biosolids Area creeks and Benson Creek with chronic (long-term) BC Approved Water Quality Guideline for protection of aquatic life, 2019.
