Regional District of Nanaimo Biosolids Management Program

TimberWest Properties Surface Water Quality Report 2017-2018

February 2019

SYLVIS DOCUMENT #1211-19

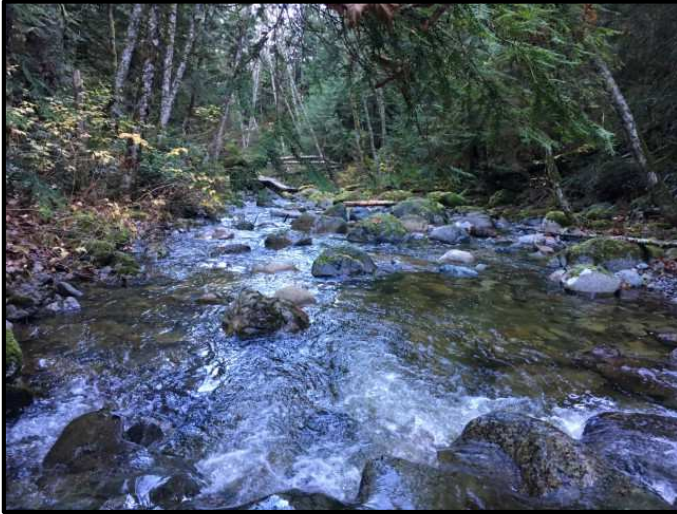
Benson Creek, the control sample location, flows north along the eastern edge of the TimberWest Properties. Biosolids fertilization does not occur upstream from the sampling location, although some logging activity does. Benson Creek and its sampling point are depicted in Figure 1, Appendix Two, and Photograph 1, Appendix Three.

All water quality data for Benson Creek were below relevant guidelines. As a control sampling location, samples are not collected from an upstream/downstream location. Nitrogen forms, phosphorus forms, and chloride were well below guidelines and in some cases below analytical detection limits. For example, nitrate, a parameter of interest at fertilized sites, ranged from 0.03 to 0.10 mg/L, below any limit, guideline, or reference value. Total phosphorus was also the guideline in 2018. All analytical data for Benson Creek are presented in Table 4, Appendix One.

Photograph 1: Benson
Creek sampling location.
(November 2018)

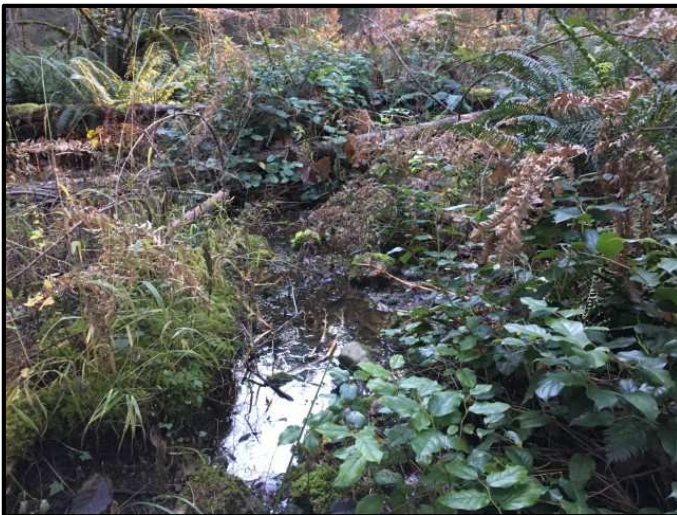
All water quality data for Flynfall Creek were below relevant limits and guidelines with the following exceptions. Nitrate at the Upper Flynfall sampling location in winter 2018 was 3.4 mg/L (guideline is 3 mg/L). The occurrence of lower nitrate at the downstream sampling location does not suggest that nitrate is leaching across this drainage. pH at the Upper Flynfall sampling location in winter 2018 was 6.4 (guideline range is 6.5 – 9.0). Low pH surface water is common on Vancouver Island in forest environments due to high precipitation and the acidic nature of forest soils. While the BCAWQG for pH recommends 6.5 – 9.0 as a range over which unrestricted change in pH is permitted without risking harm to aquatic freshwater life, it also recognizes that many areas of Coastal BC have naturally occurring pH below this range. *Escherichia coli* concentration at the Upper Flynfall sampling location in winter 2018 was 173 most probable number per 100 millilitres (MPN/100 mL) (recreational guideline is 77 MPN/100 mL). The occurrence of lower *E. coli* at the downstream sampling location suggests that this is a feature of water quality where the outflow from the headwaters occurs. Previous samples collected at this sampling location did not indicate elevated microbiology.

Photograph 2: Upper Flynfall
Creek sampling location.
(November 2018)

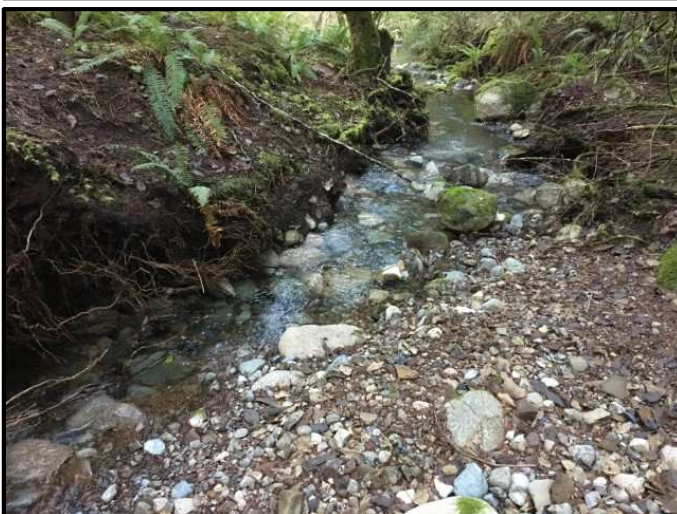
Photograph 3: Lower Flynfall
Creek sampling location.
(November 2018)

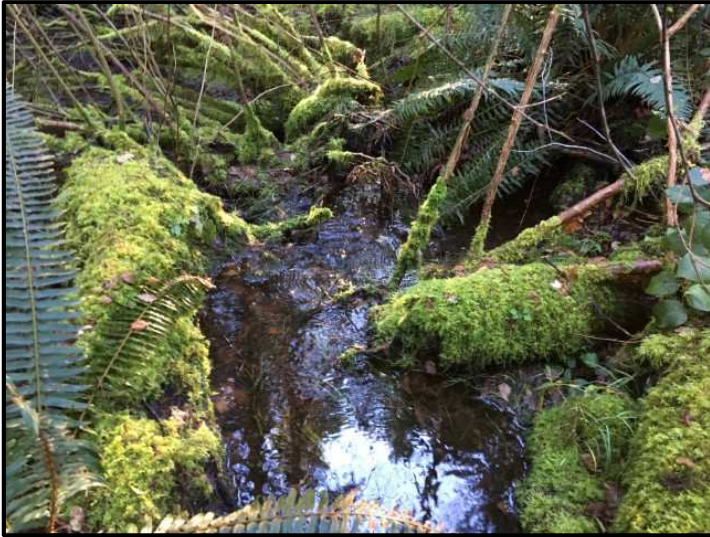
All water quality data for Caillet Creek were below relevant limits and guidelines.

Photograph 4: Upper Caillet Creek sampling location. (November 2018)

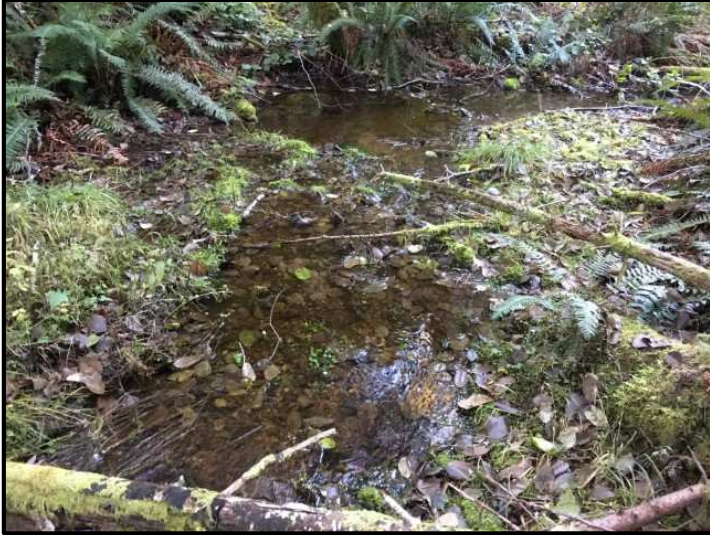
All water quality data for Bonnell Creek were below relevant limits and guidelines with the following exceptions. Total phosphorus at upstream and downstream locations was up to four times the quality objective of 0.01 mg/L on multiple sampling dates, with no clear pattern of downstream increases. Total silver at the downstream location in fall 2018 was 0.13 mg/L, above its limit of 0.1 mg/L. This parameter has not been found in exceedance during any other sampling event at this creek or any other creek at the site. pH at upstream and downstream locations in the fall was below the guideline range of 6.5 – 9.0. As mentioned previously, low pH surface water is common on Vancouver Island in forest environments.

Photograph 7: Lower Bonnell Creek sampling location. (November 2018)

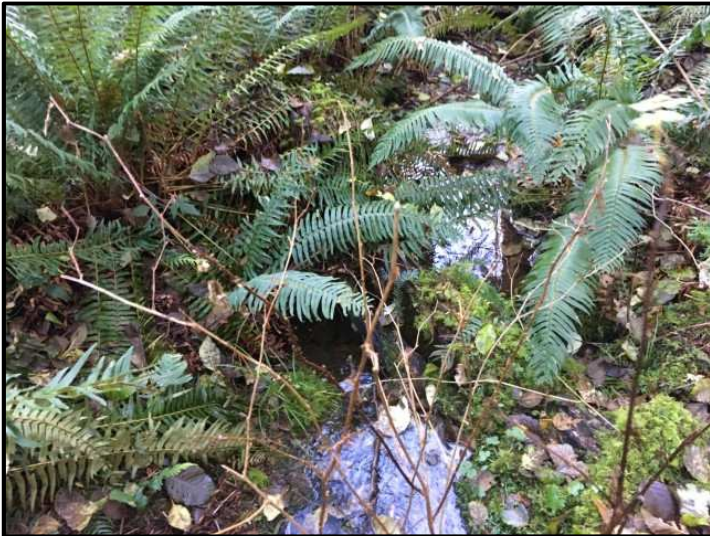
All water quality data for W1500 Creek were below relevant limits and guidelines with the following exceptions. Nitrate at the Lower W1500 sampling location in fall 2018 was 3.9 mg/L (guideline is 3 mg/L). Total phosphorus at the upstream location was over twice the quality objective of 0.01 mg/L in spring 2018; no clear pattern of downstream increases is observable for this parameter. pH at upstream and downstream locations in the fall was below the guideline range of 6.5 – 9.0. As mentioned previously, low pH surface water is common on Vancouver Island in forest environments.

Photograph 8: Upper W1500 Creek sampling location. (November 2018)

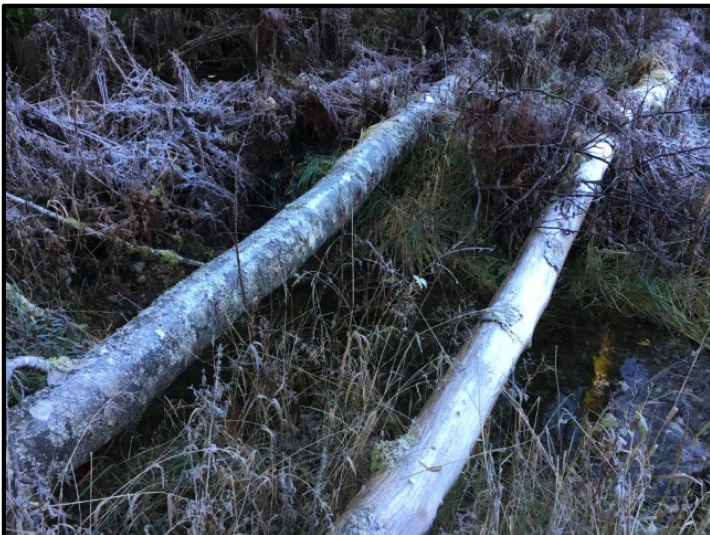
Photograph 9: Lower W1500 Creek sampling location. (November 2018)
