Community Watershed Monitoring Network 2020 Results by Water Region

CWMN Sample Sites in WR 2:

WR2: Little Qualicum

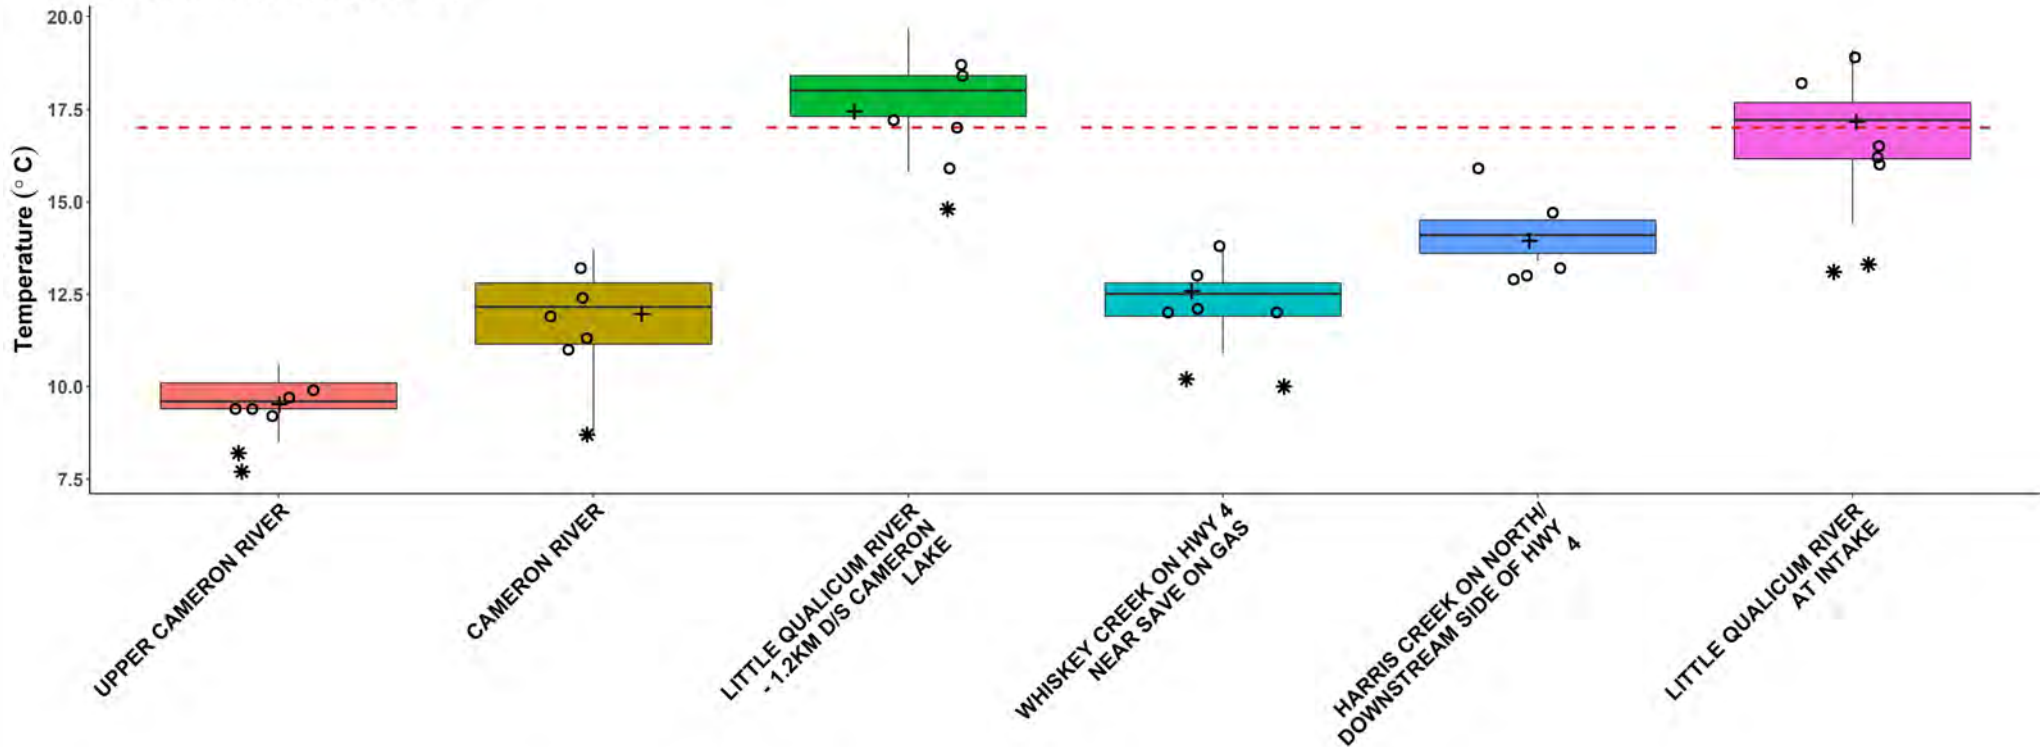
WR2 Summer Temperature

- 2020 Samples
- * Outlier 2011-2019
- + 2020 30 Day Avg

Guideline
 - - Aquatic Life Guideline for Coho Rearing (17°C)

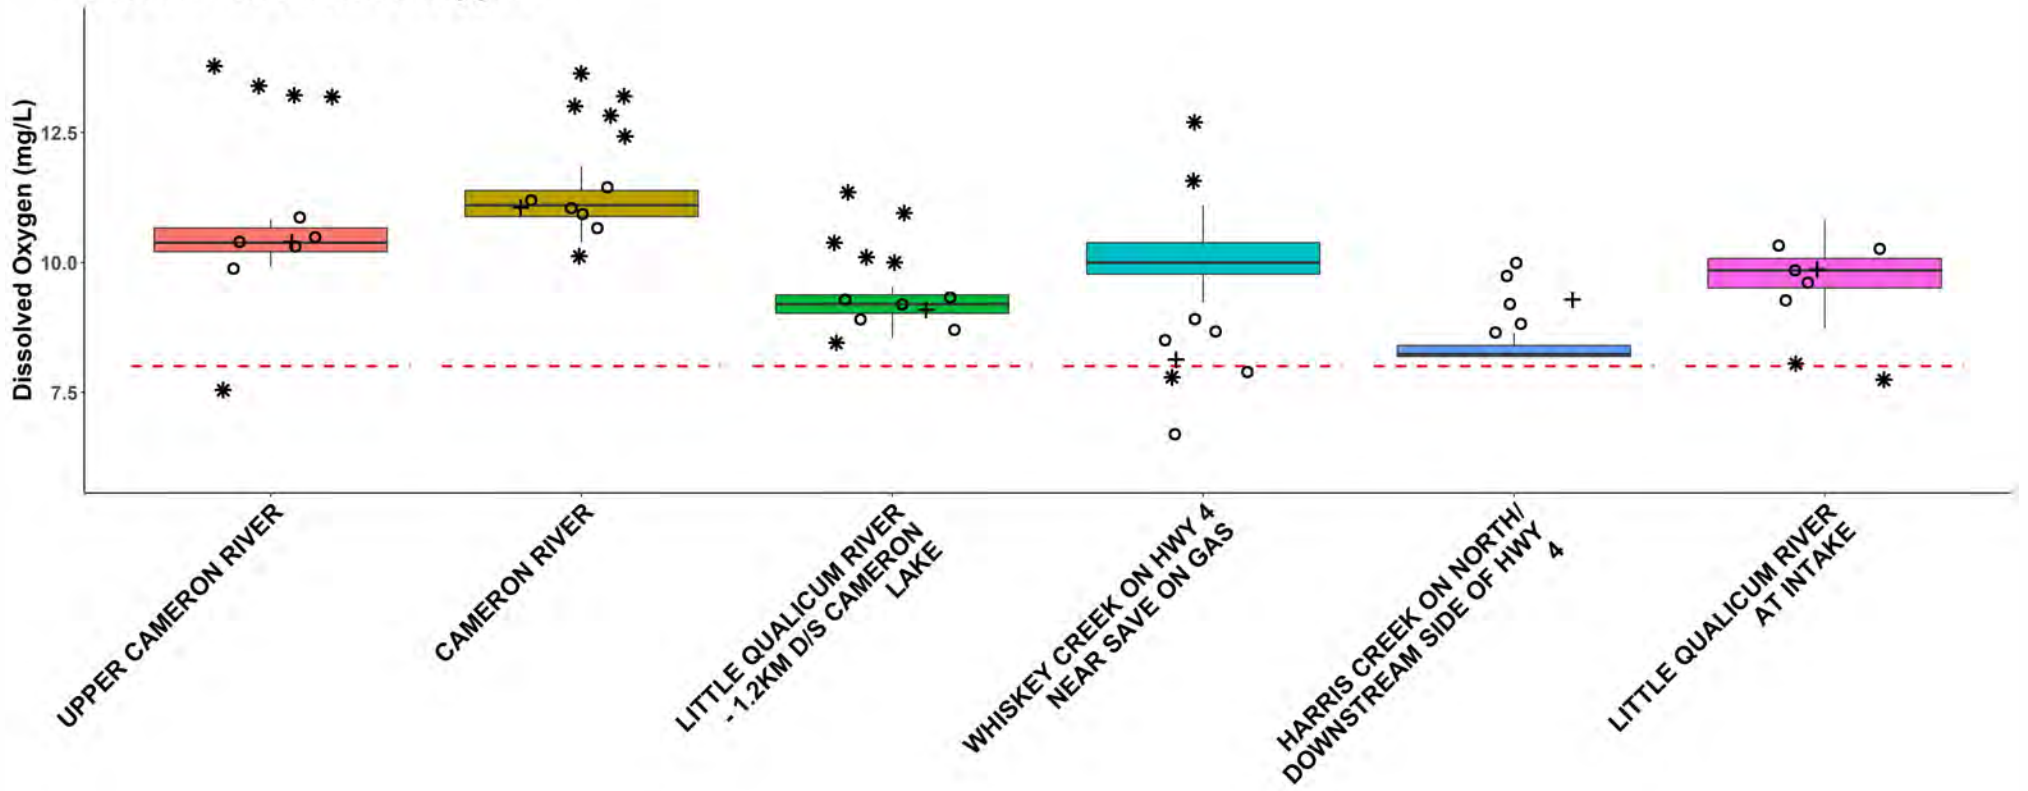
WR2 Summer Dissolved Oxygen

○ 2020 Samples
 * Outlier 2011-2019
 + 2020 30 Day Avg

Guideline
 - - 30 Day Average (<math>< 8 \text{ mg/L}</math>)
 - - Instantaneous Minimum (<math>< 5 \text{ mg/L}</math>)

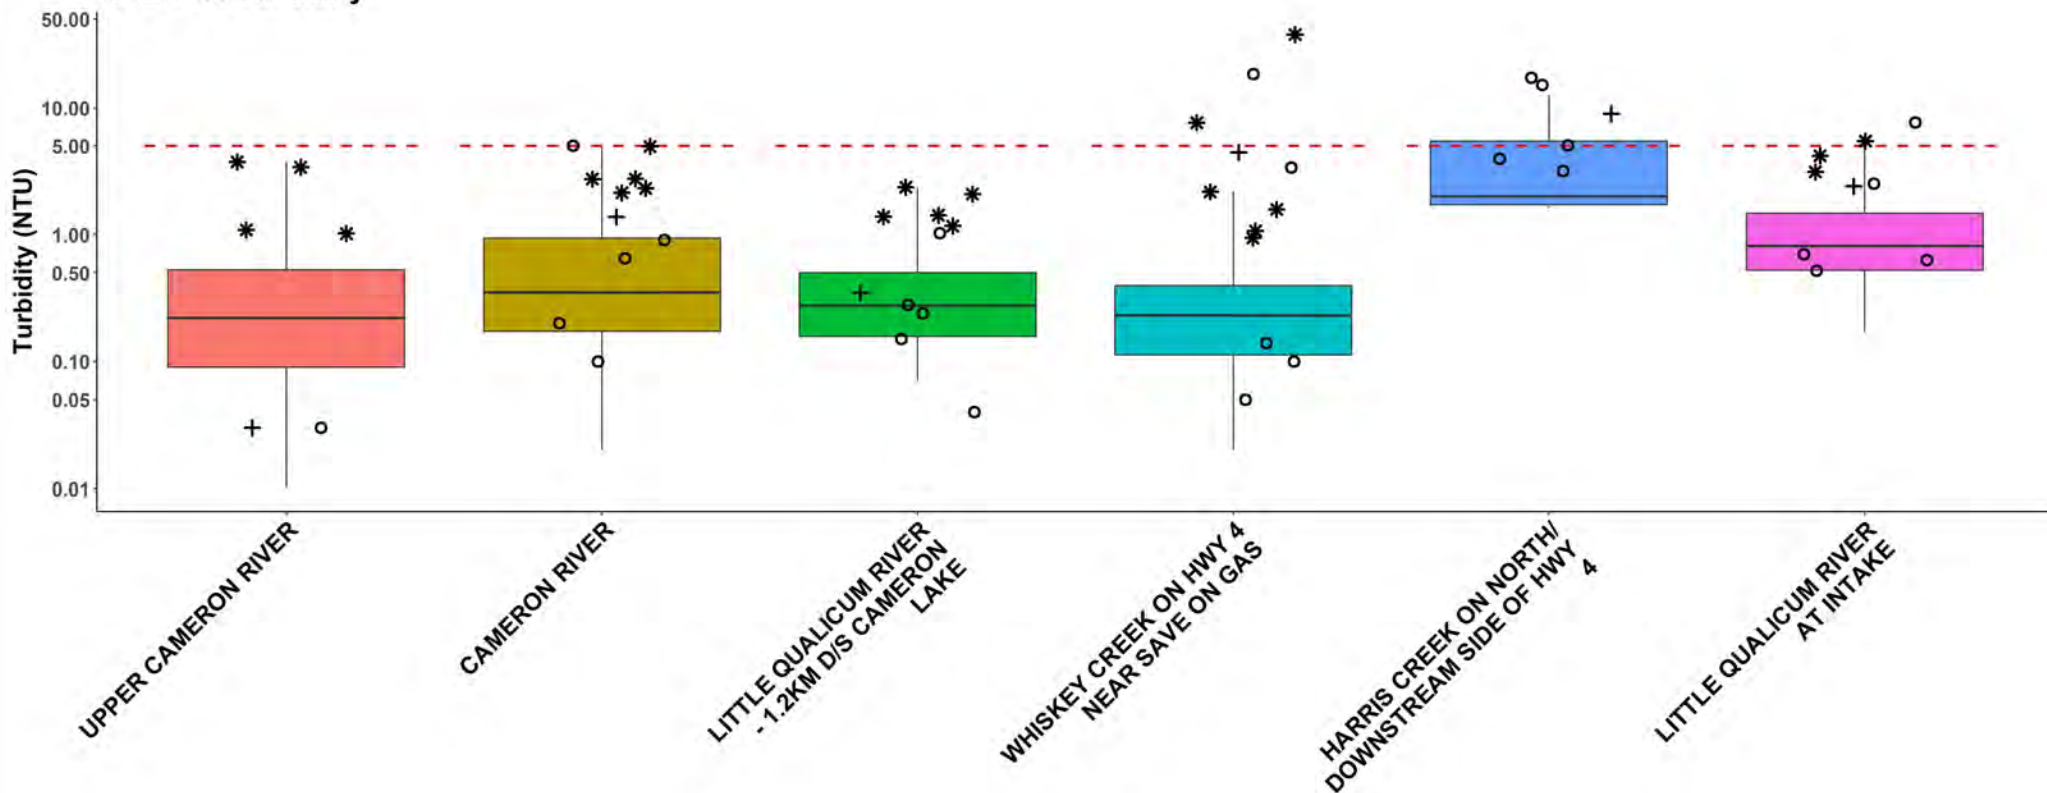
WR2 Fall Turbidity

Guideline

-- Oct-Dec Max (5 NTU)

o 2020 Samples

* Outlier 2011-2019

+ 2020 30 Day Avg

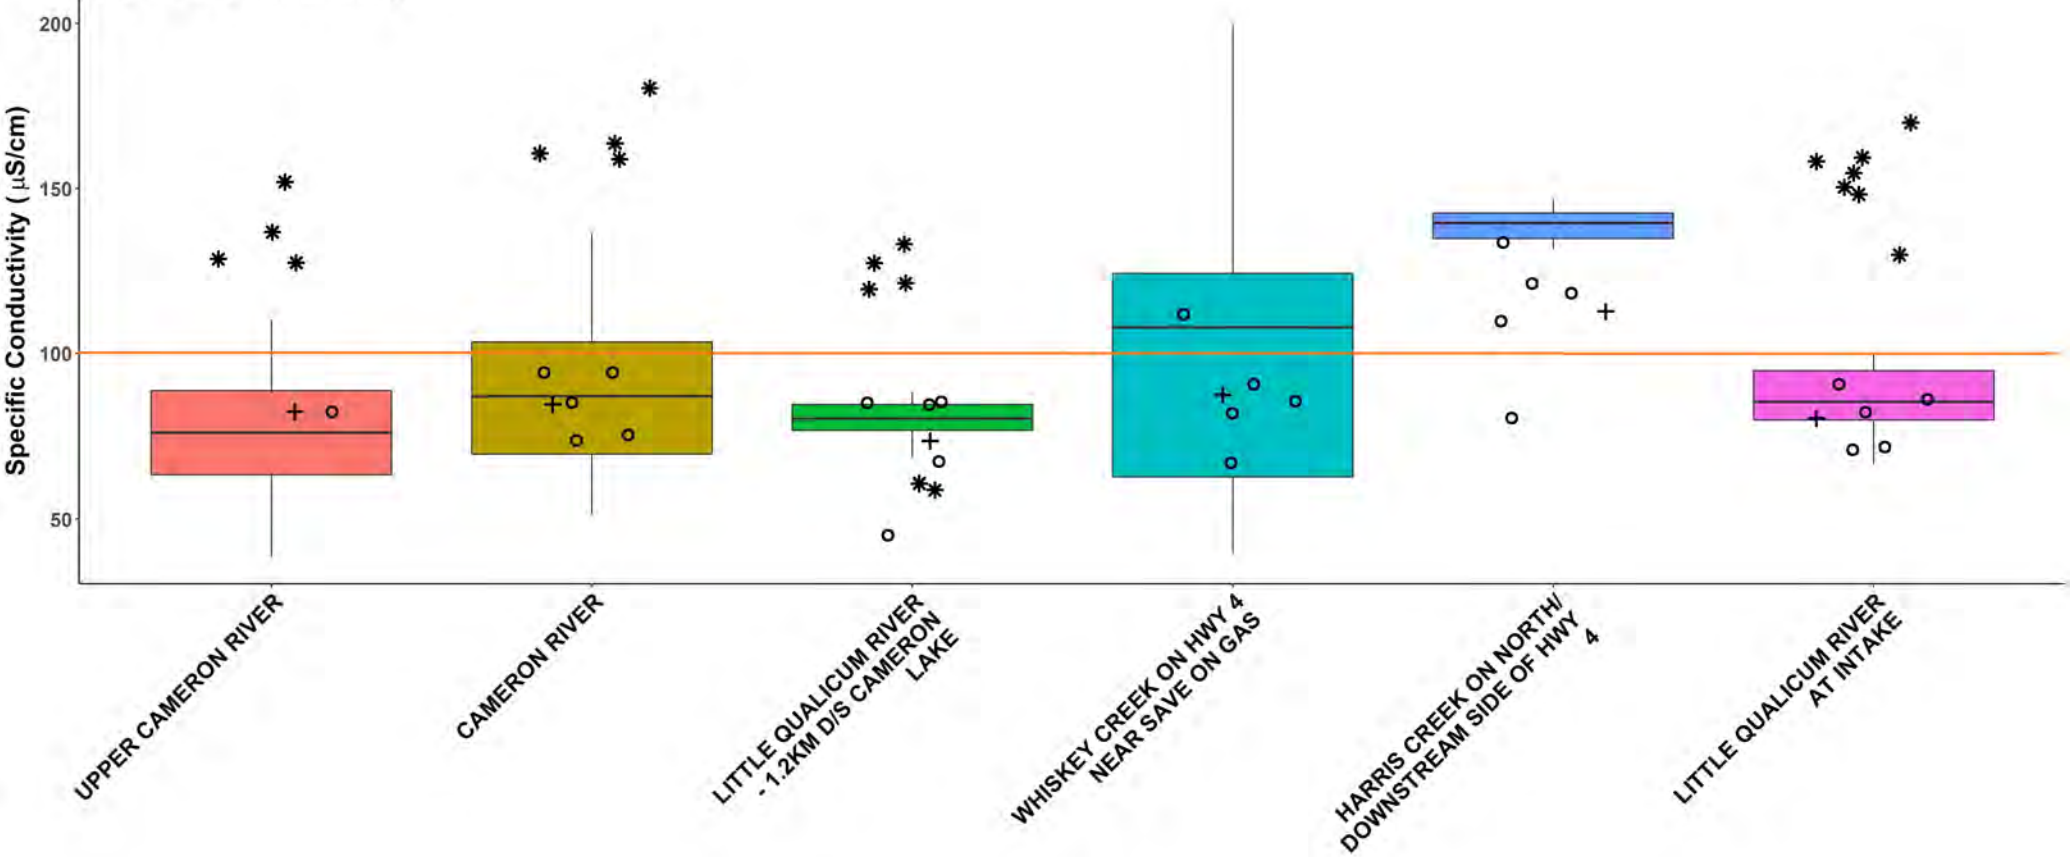
WR2 Fall Conductivity

○ 2020 Samples * Outlier 2011-2019 + 2020 30 Day Avg — 100 $\mu\text{S}/\text{cm}$

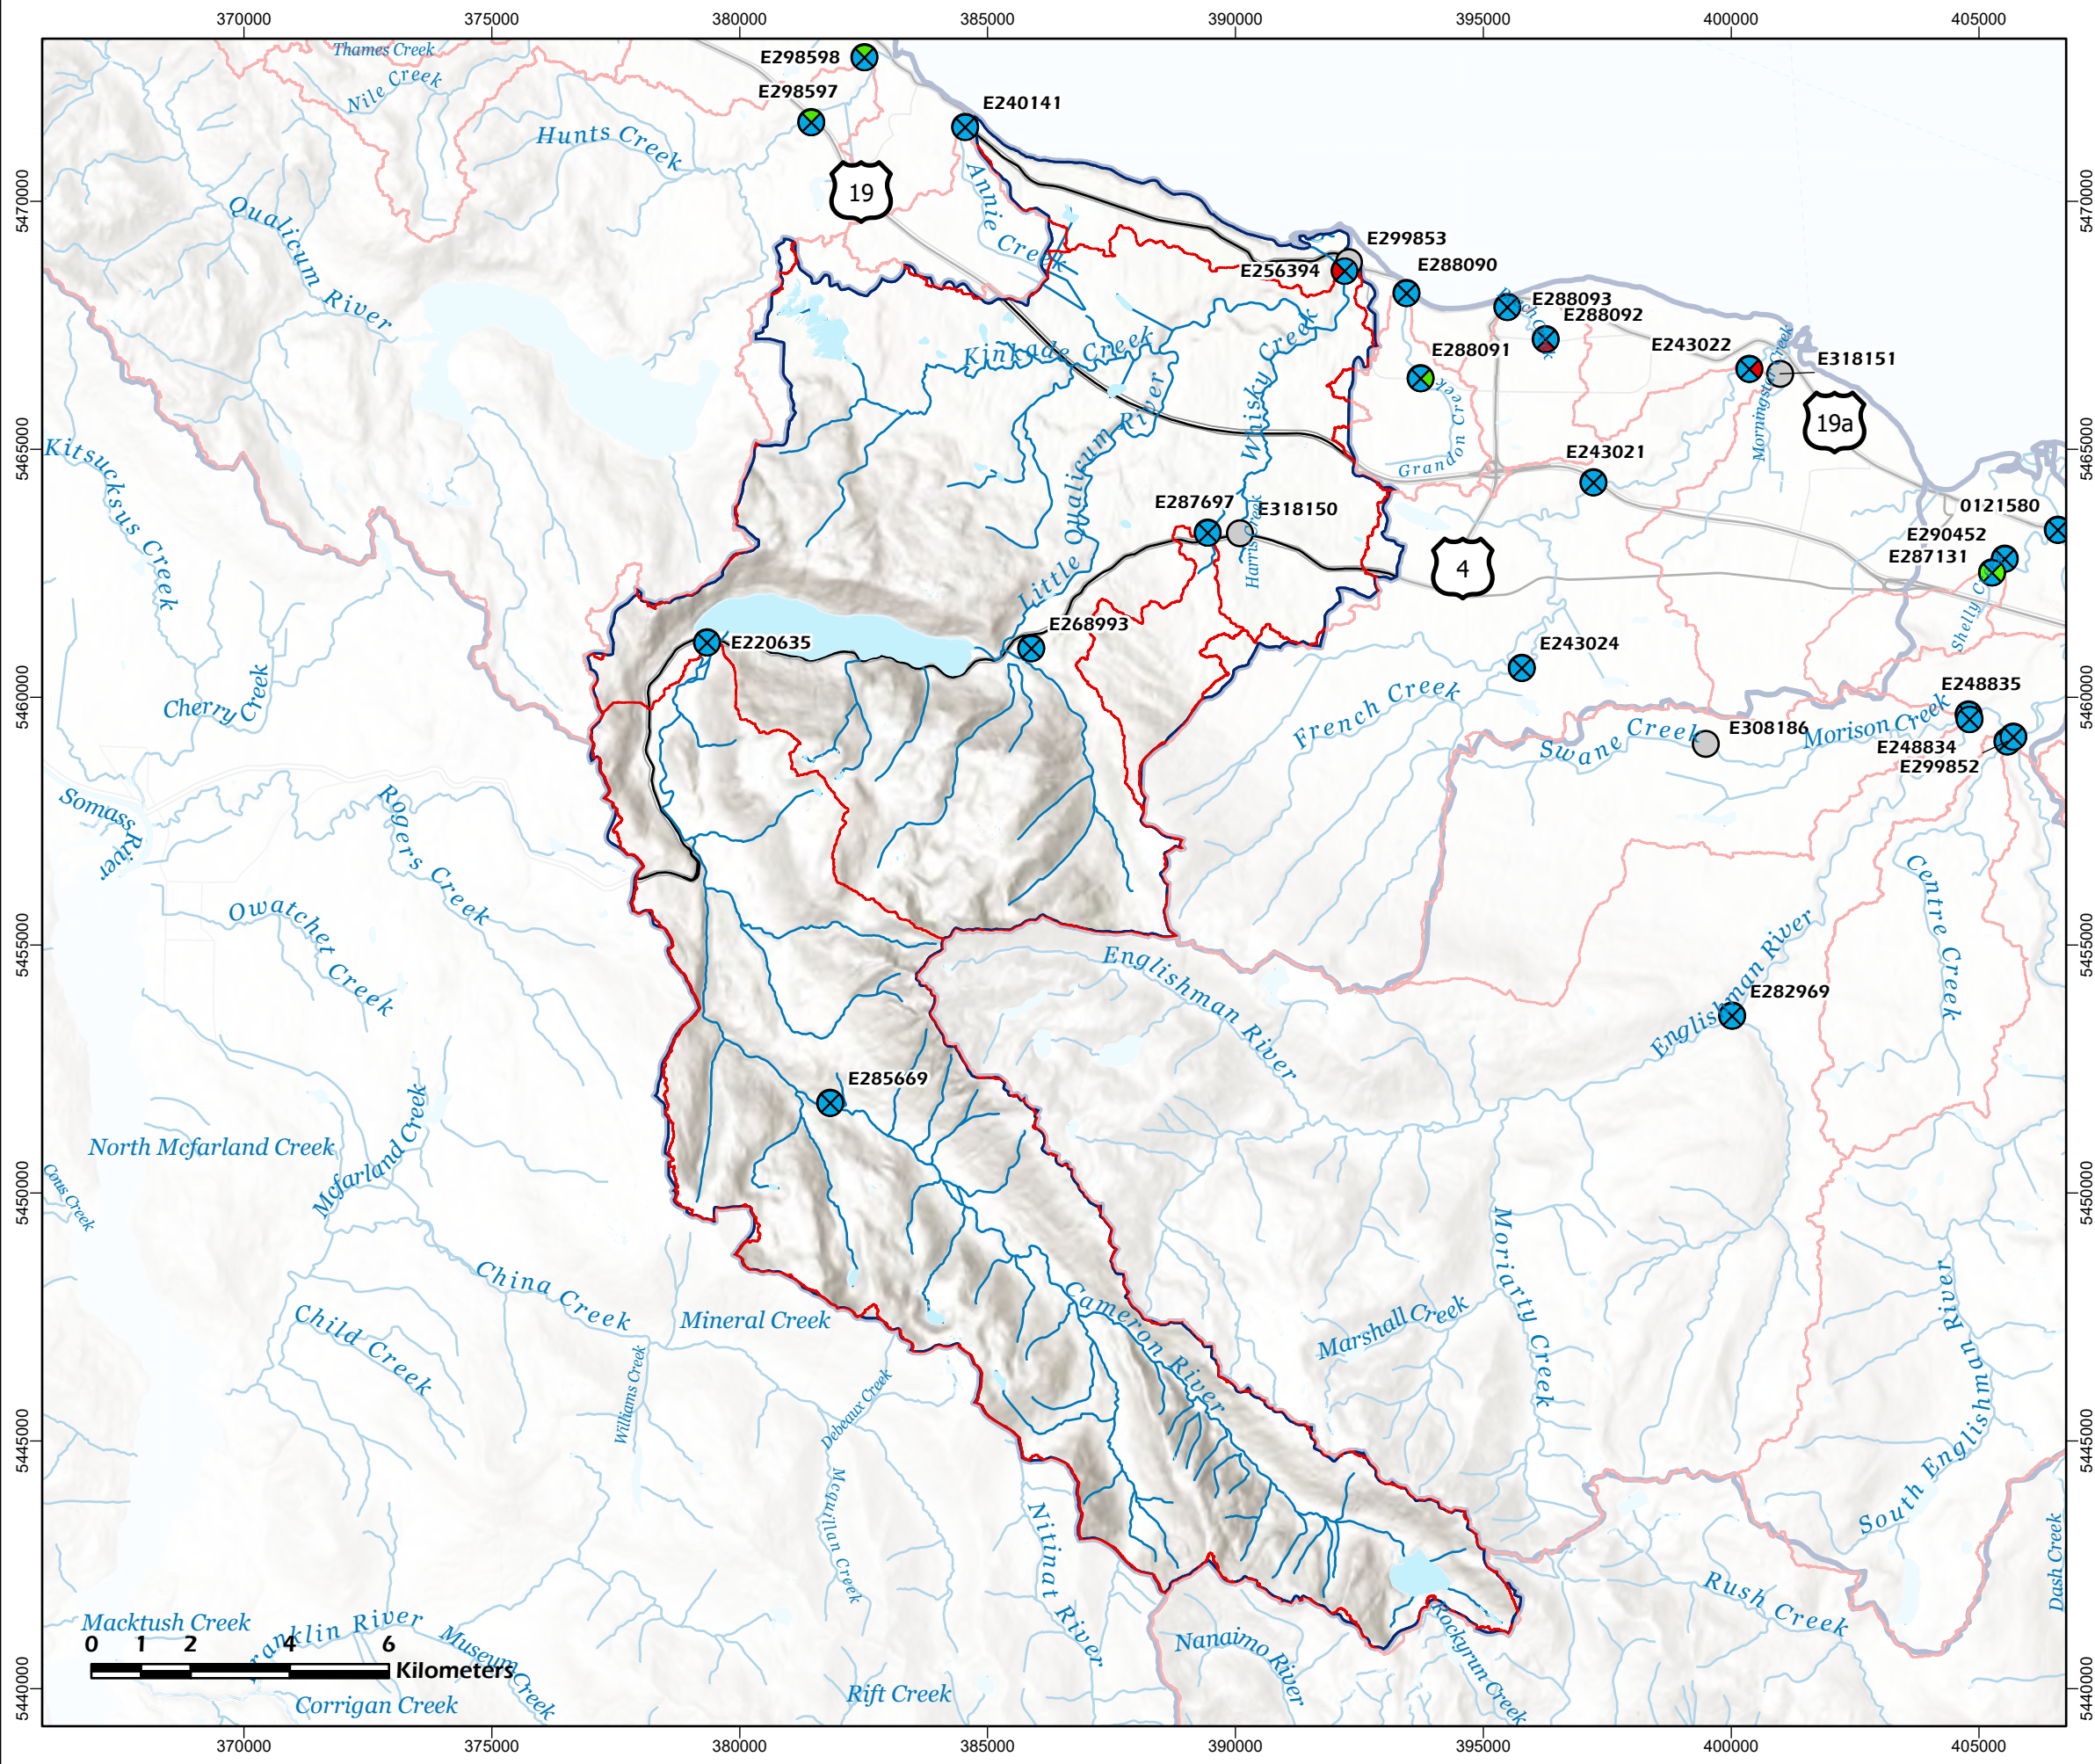
CMMN Water Quality Trend Analysis 2011-2020

Conductivity can be influenced by factors such as groundwater and ocean spray that are not necessarily indicative of a degrading condition. For simplicity, an increase in conductivity is categorized here as degrading.

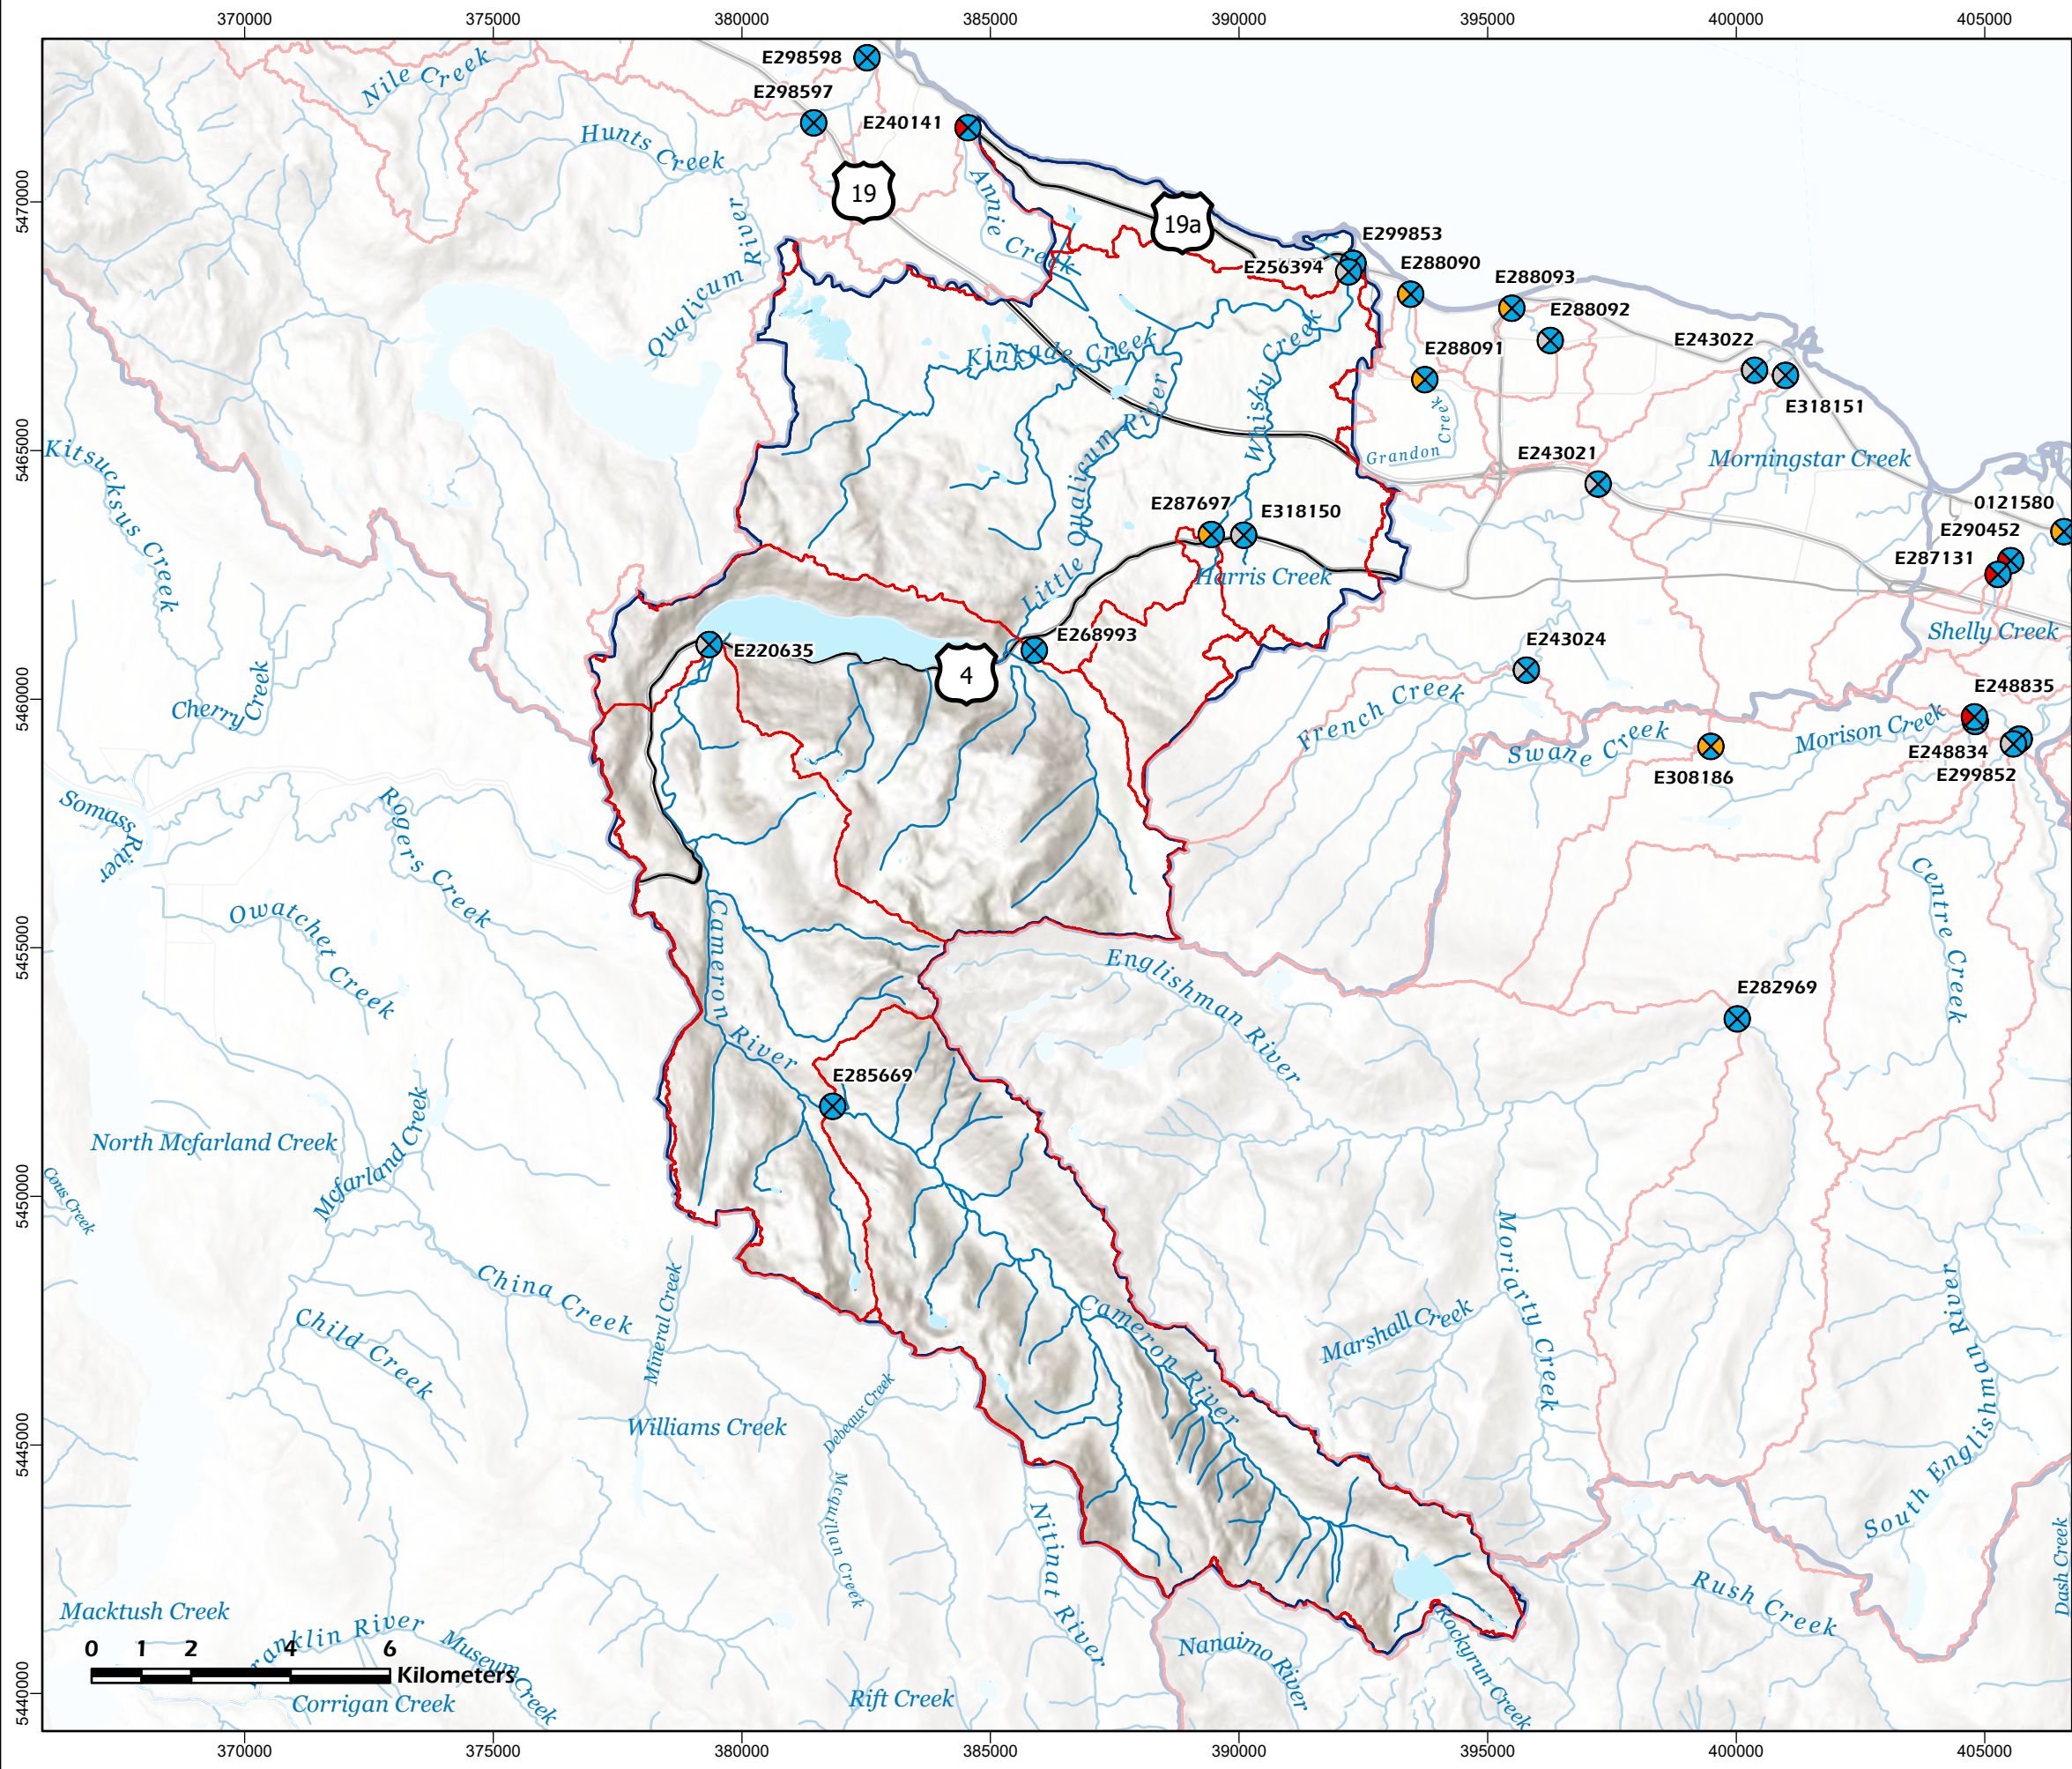
CMMN 2011-2020 Fall Exceedance Assessment

Note the exceedance frequency categories are reflective of the number of sample periods with exceedances, not the number or values of the exceedances.

The summer and fall exceedance frequency maps included in this package express the number of sample periods (summer low-flow / fall flush) with exceedances for each site. There are four frequency categories for the number of sample periods with exceedances: no exceedance recorded (0), low (1 – 2), moderate (3 – 4), and high (5 or more). The exceedance categories are for the three parameters with aquatic water quality guidelines and objectives based on the following thresholds: temperature $\geq 17^{\circ}\text{C}$, dissolved oxygen $\leq 5\text{mg/L}$, summer turbidity $\geq 2\text{NTU}$, and fall turbidity $\geq 5\text{NTU}$.
