# Community Watershed Monitoring Network 2021 Results by Water Region

Included in Water Region (WR) 6 package:

## WR6 CWMN Sample Sites:

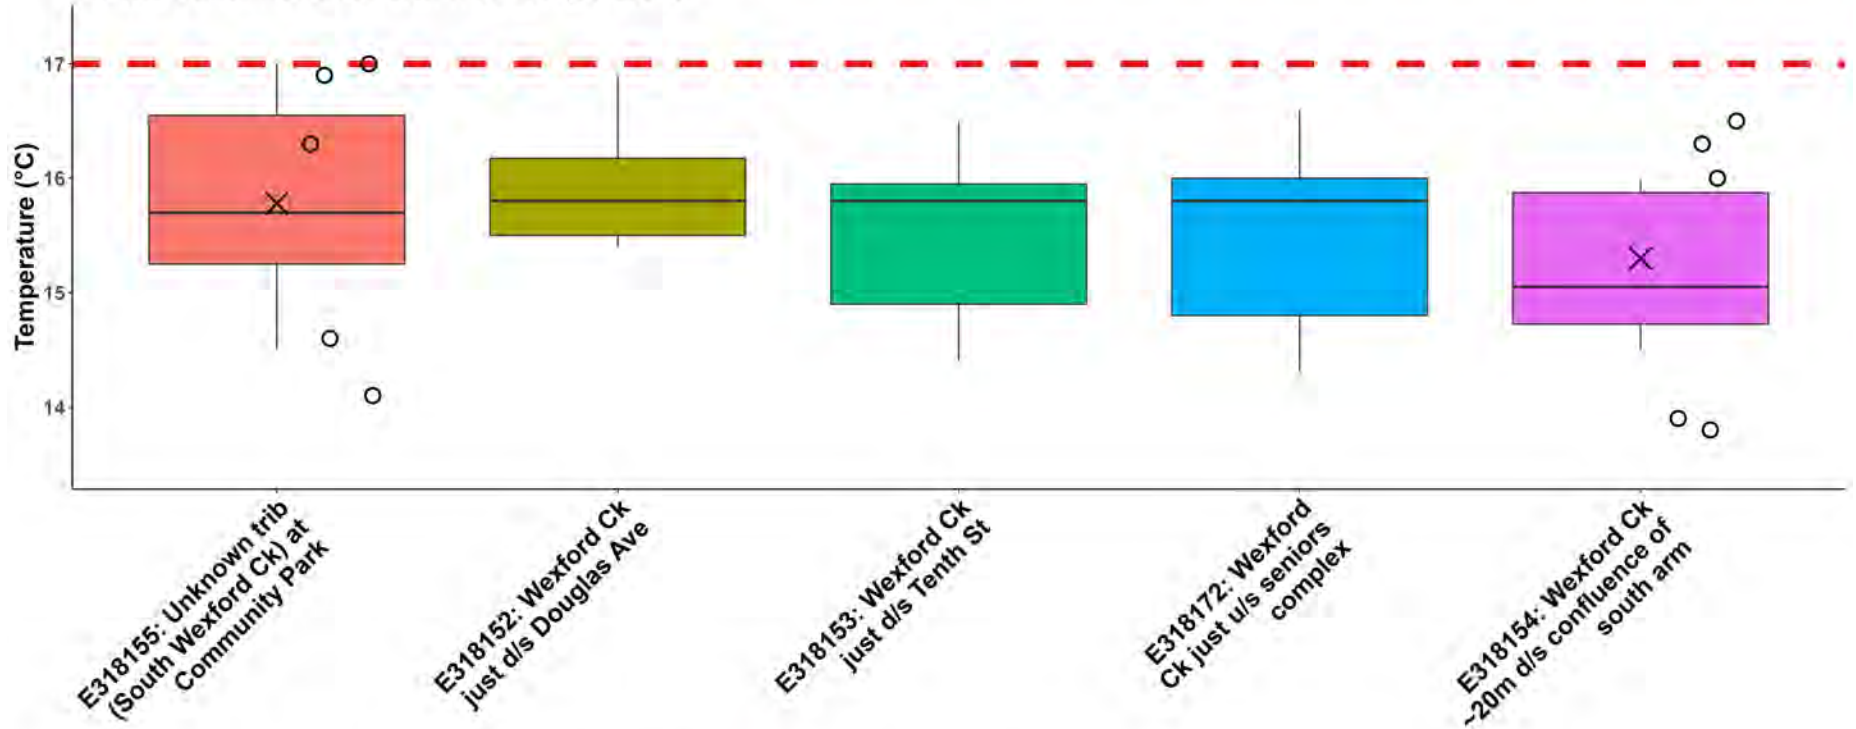
### WR6a: Nanaimo River Summer Temperature

\* Outlier 2019-2020    - Aquatic Life Guideline for Coho Rearing (17°C)  
 ○ 2021 Samples  
 × 2021 30-Day Mean

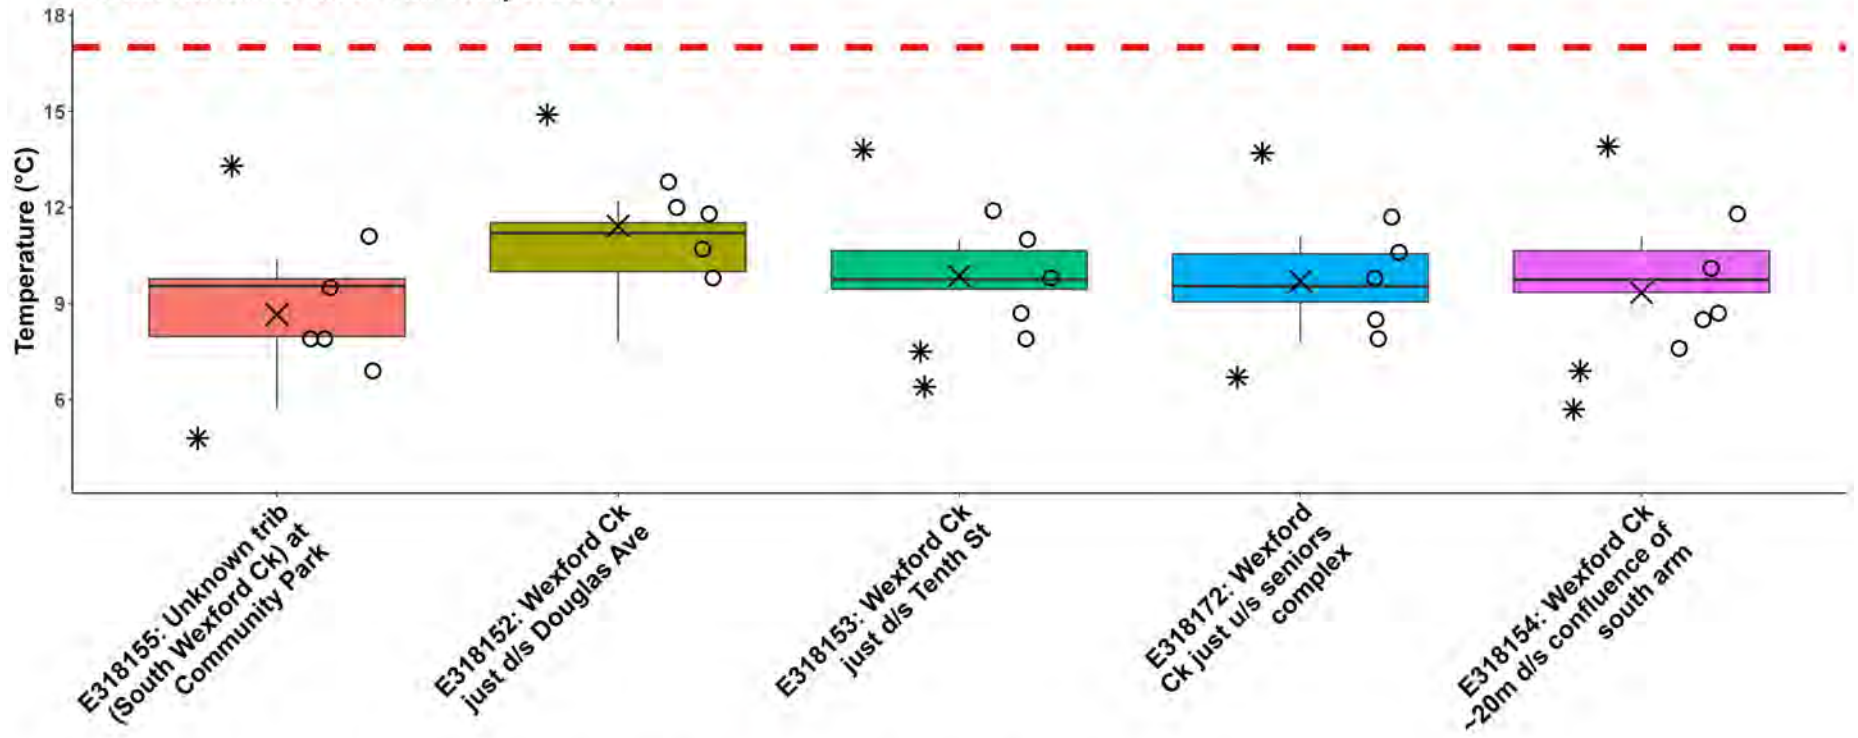
### WR6a: Nanaimo River Fall Temperature

\* Outlier 2019-2020    - Aquatic Life Guideline for Coho Rearing (17°C)  
 ○ 2021 Samples  
 × 2021 30-Day Mean

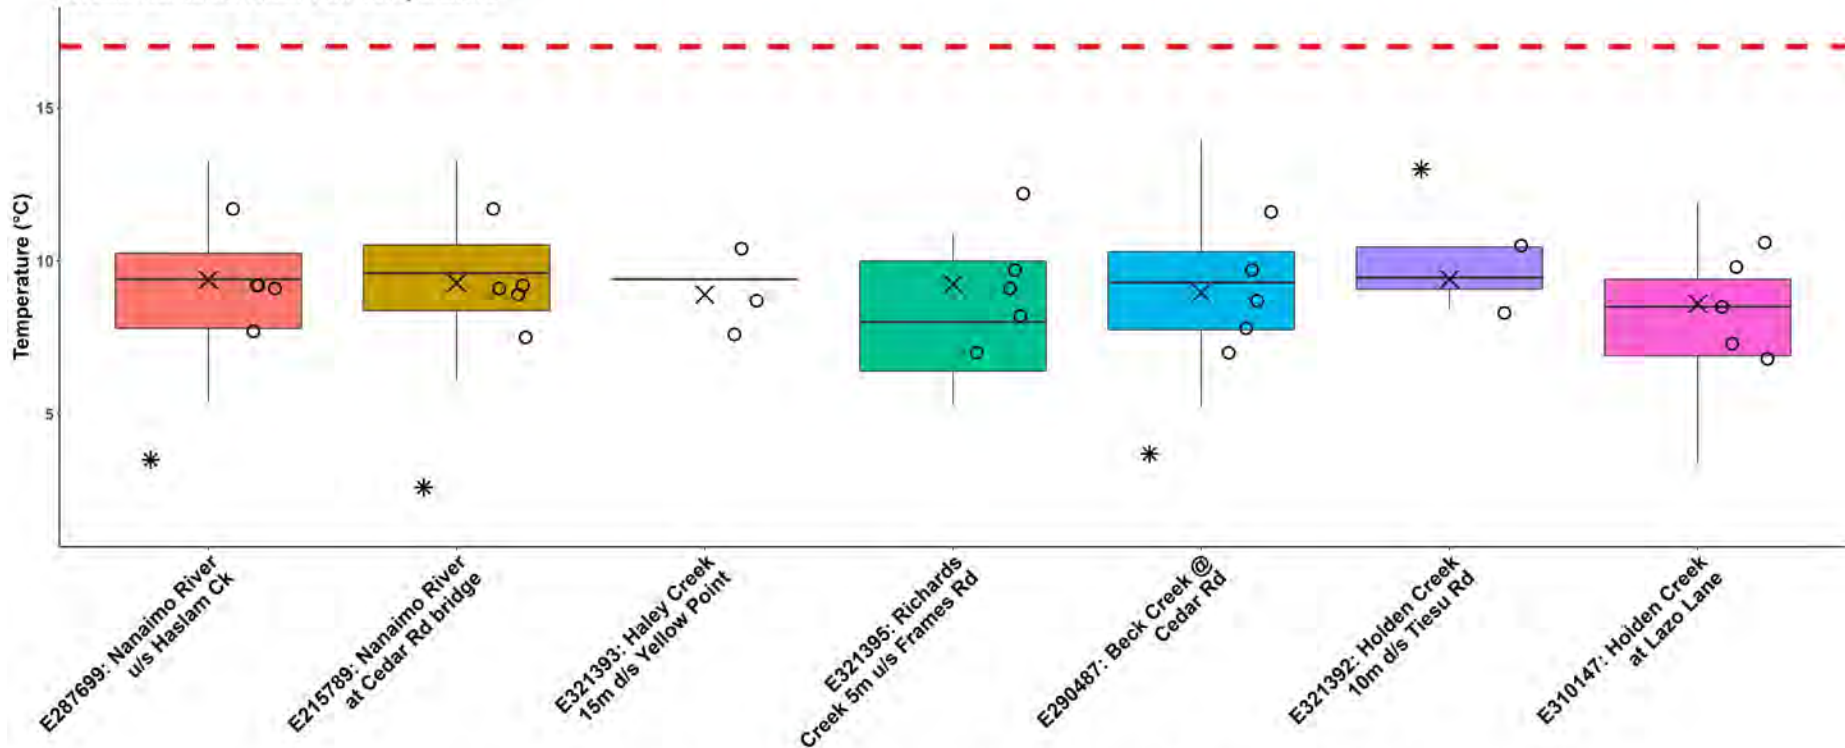
WR6b: Nanaimo River Fall Temperature

\* Outlier 2011-2020    - Aquatic Life Guideline for Coho Rearing (17°C)  
 ○ 2021 Samples  
 × 2021 30-Day Mean

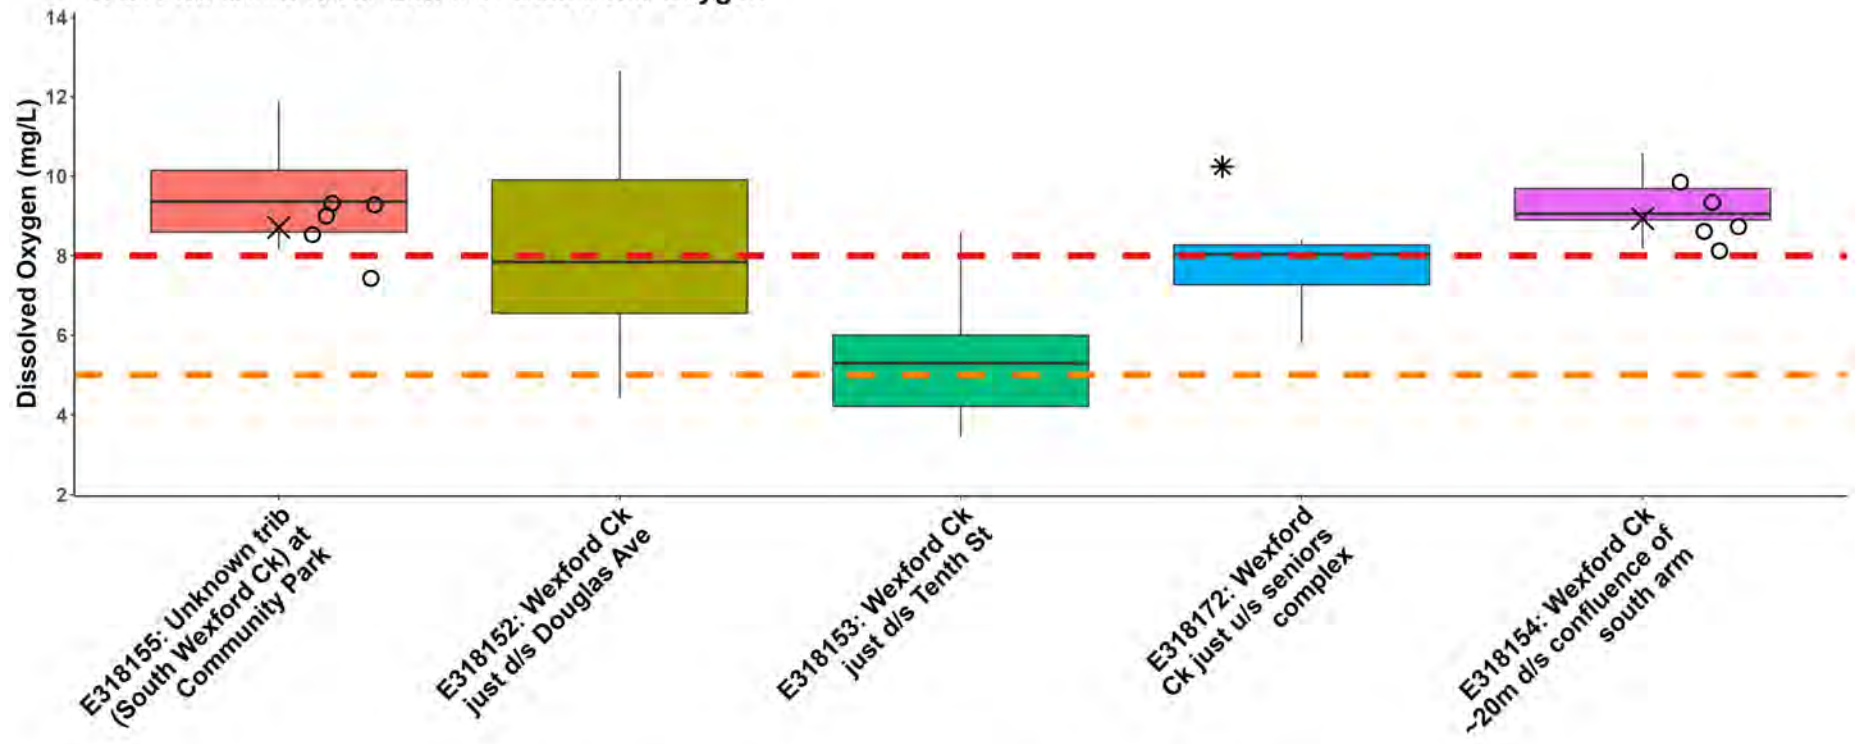
### WR6a: Nanaimo River Summer Dissolved Oxygen

\* Outlier 2019-2020      - 30 Day Average (<8 mg/L)  
 ○ 2021 Samples            - Instantaneous Minimum (<5 mg/L)  
 × 2021 30-Day Mean

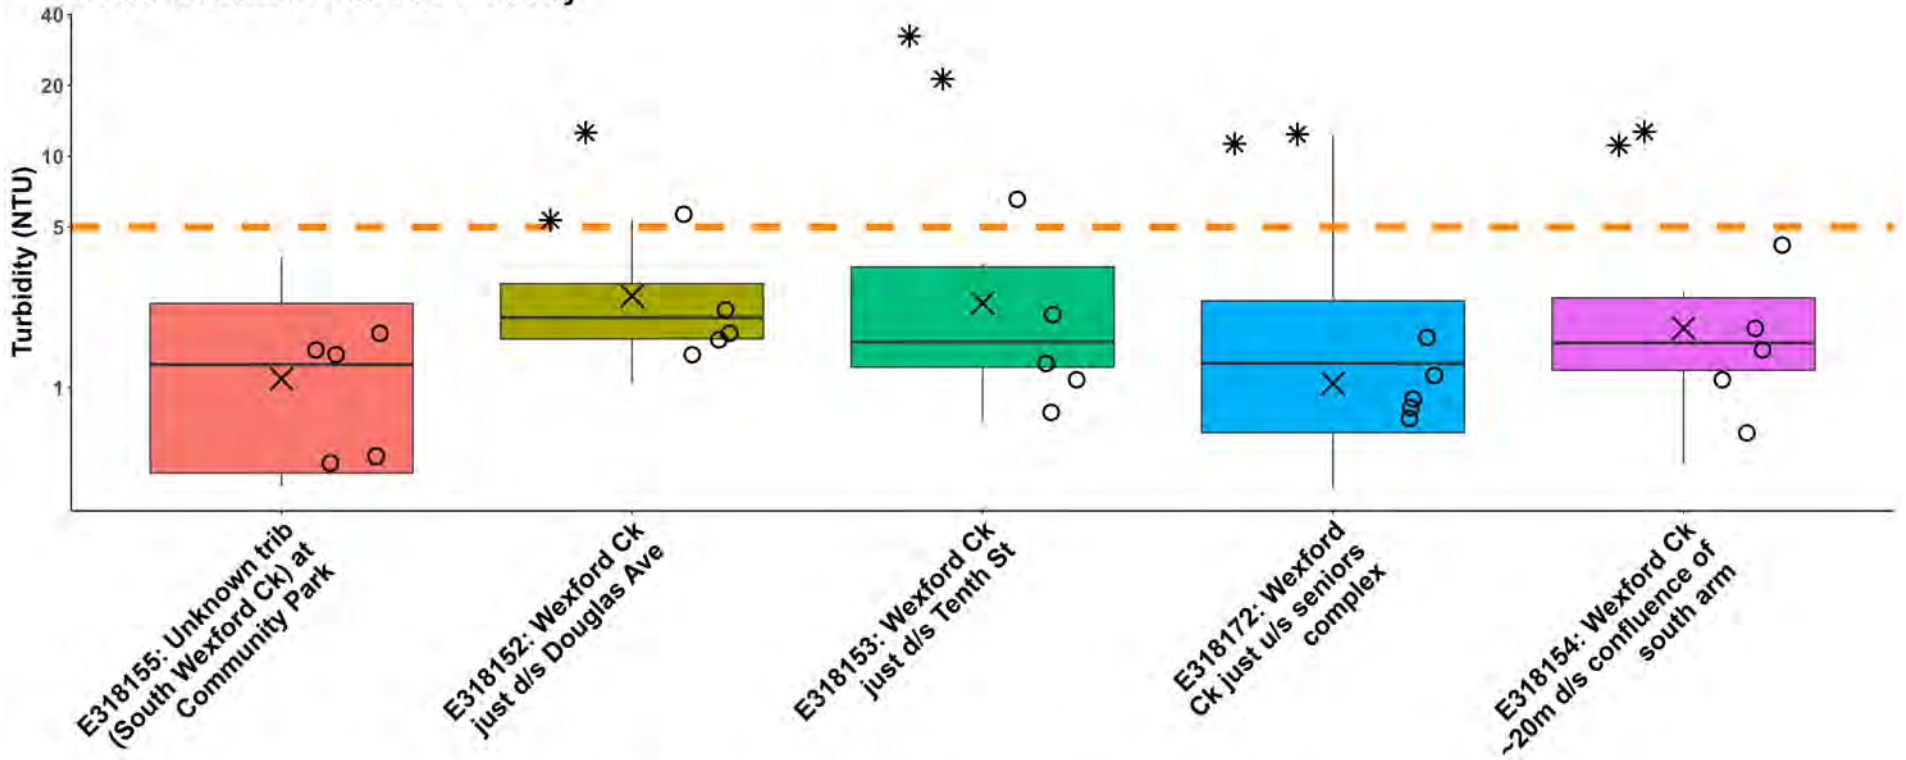
### WR6a: Nanaimo River Fall Turbidity

\* Outlier 2019-2020    — Oct-Dec Max (5 NTU)  
 ○ 2021 Samples  
 × 2021 30-Day Mean

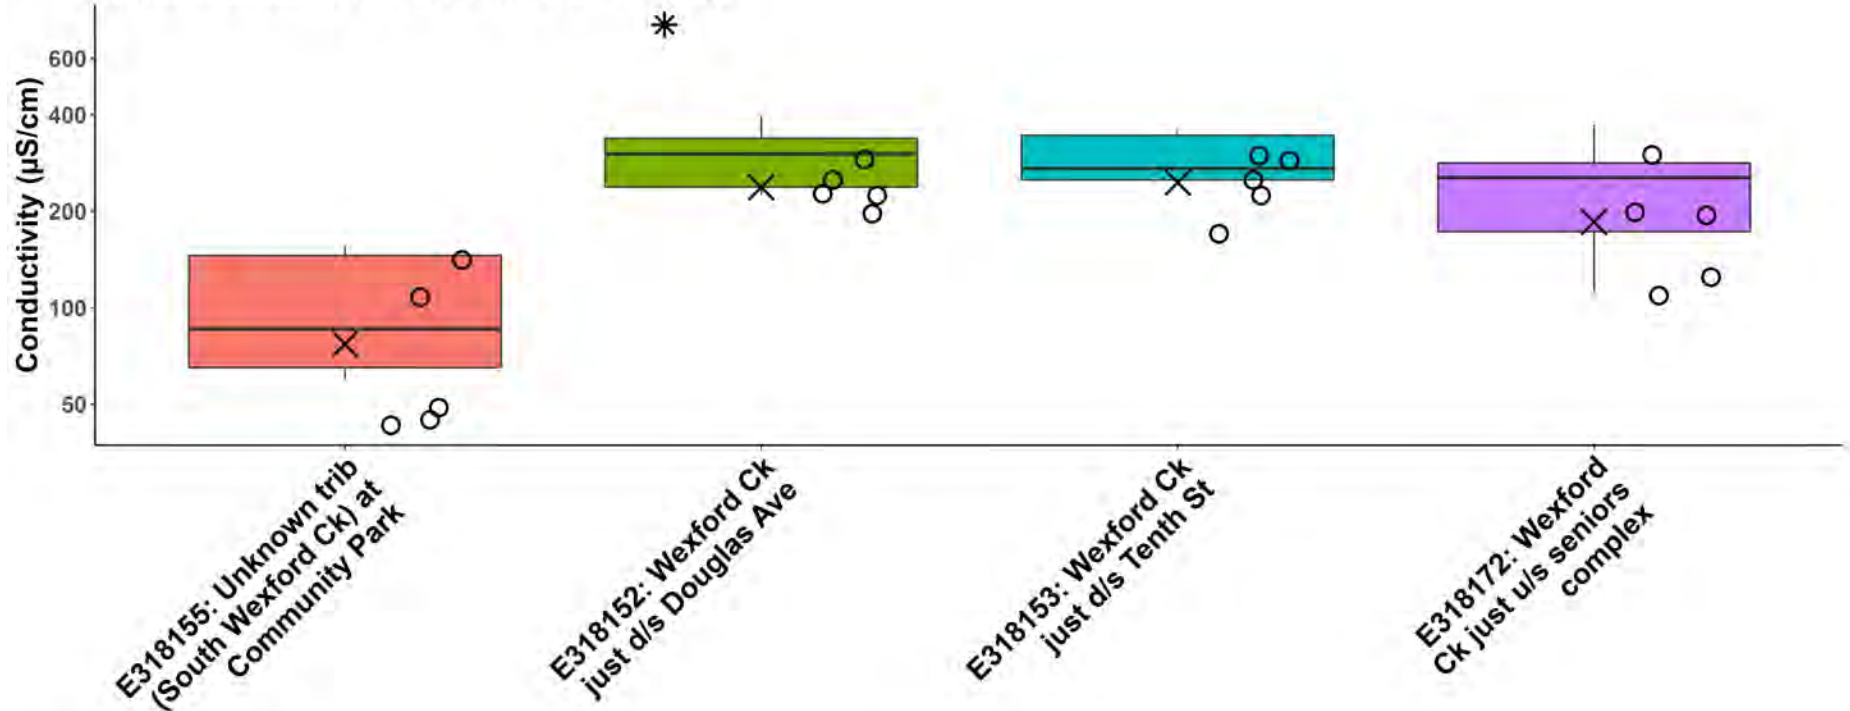
### WR6a: Nanaimo River Fall Conductivity

\* Outlier 2019-2020  
 ○ 2021 Samples  
 × 2021 30-Day Mean
