# **Englishman River Habitat Status Report**

***Mid Vancouver Island Habitat Enhancement Society***

October 31 2013

David Clough, RPBio  
D. R. Clough Consulting  
*Fisheries Resource Consultants*  
6966 Leland Road Lantzville B.C. V0R 2H0  
Ph/fax: 1-250-390-2901, email: drclough@shaw.ca

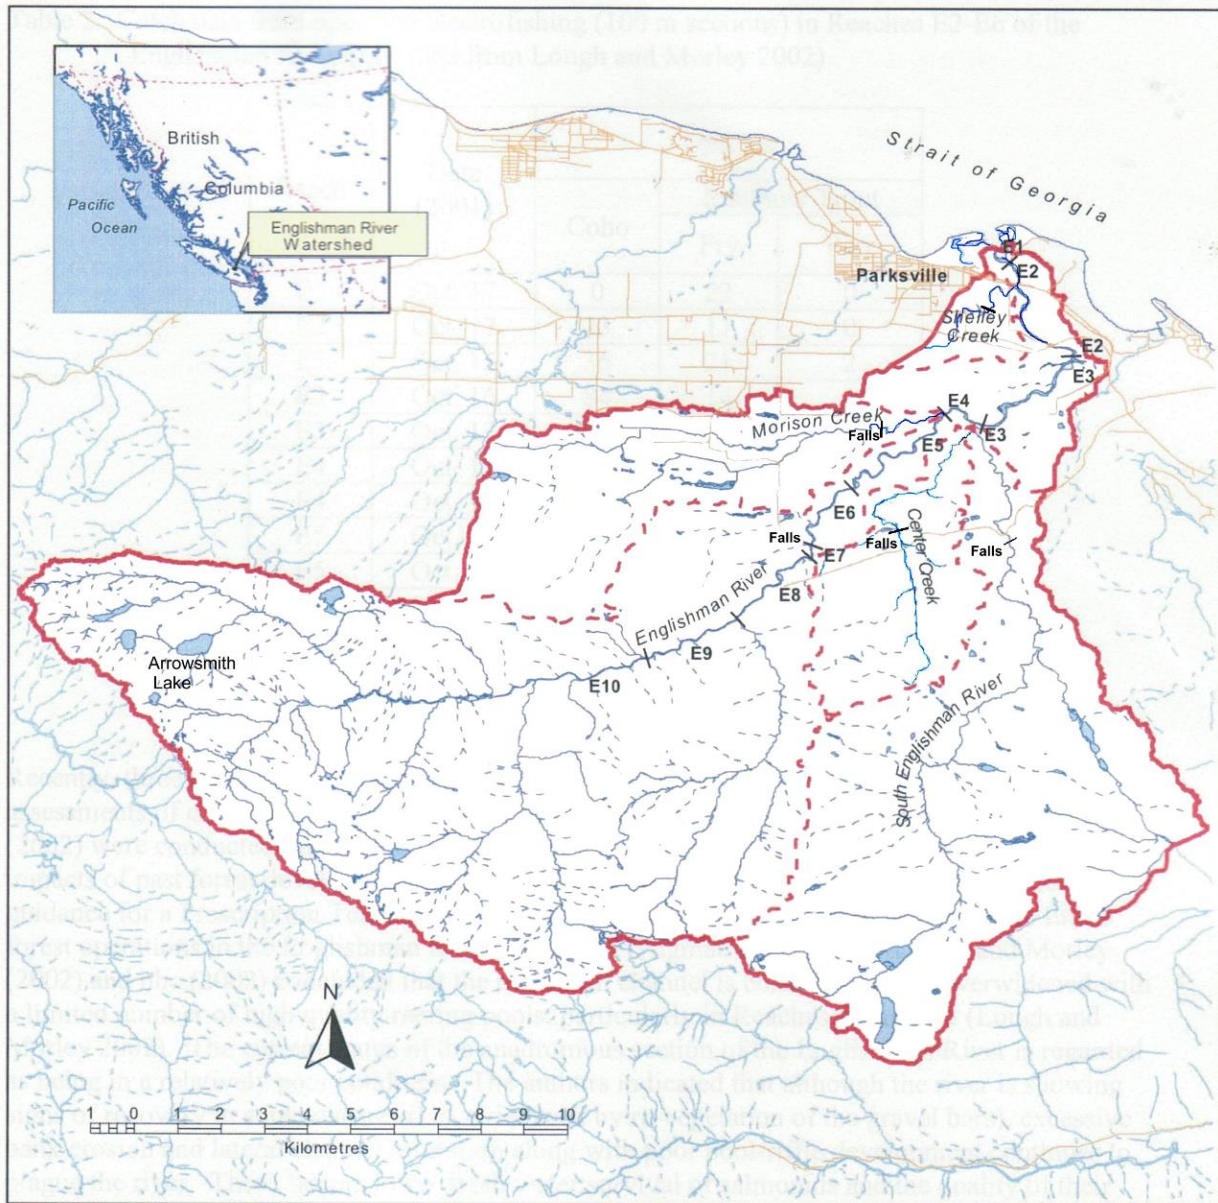
Figure 1: Englishman River Watershed with Reach Breaks.<sup>3</sup>

The Englishman River reach segments were prescribed by Rood (2002) using gradient, sinuosity and confinement as the primary determinants. The river was found to have six anadromous segments to the falls (15.2 km). Above the falls, assessments ended at the top end of reach E10 next to Moriarty Creek confluence; at 24,720 m and 288 m elevation from the estuary. The river mainstem continues upstream approximately 10,500 m to Arrowsmith Lake (812 m elevation). Lough and Morley (2002) used these reach segments in their description of fish habitat. These baseline studies were somewhat limited in scope due to the short delivery timelines; thus not the entire watershed was assessed. The entire mainstem length is approximately 35.2 km. The authors recommended the other areas be analyzed. The Estuary is part of reach E1 but was segregated for this report due to additional references.

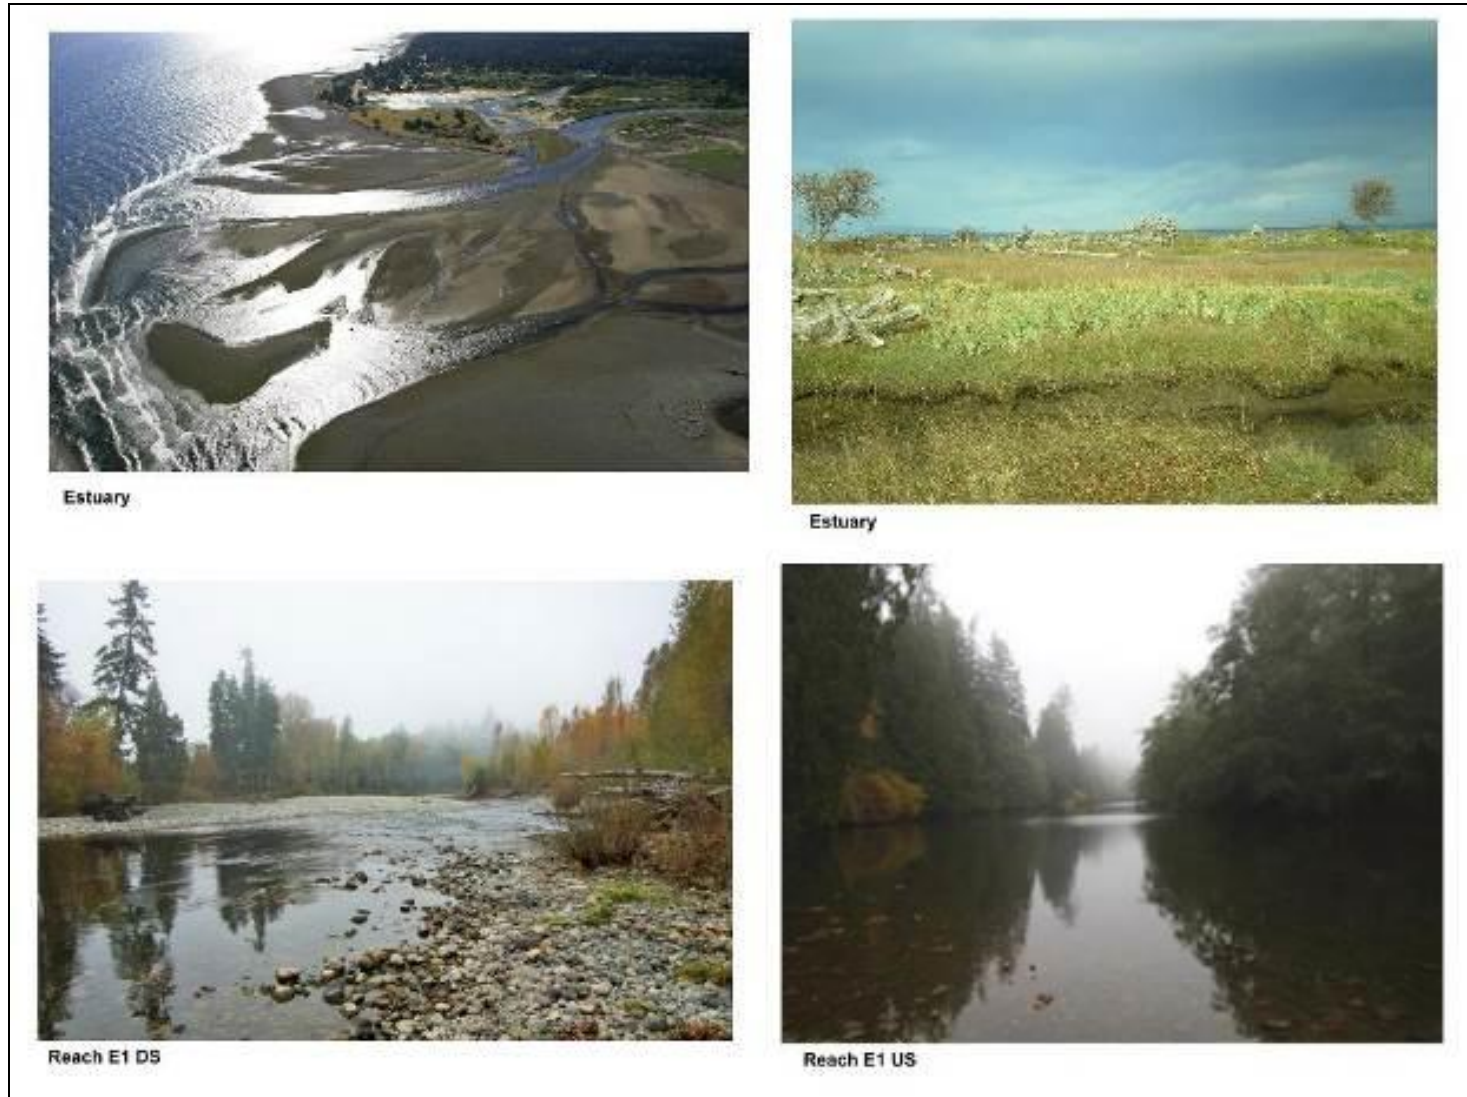
#### Estuary and Reach E1 Photographs

Lough and Morley (2002) compiled a reach description summary. Reach 1 is wide and shallow, lacking pools. Lough and Morley (2002) found the lowest pool frequency (4%) in Reach 1 of the six reaches surveyed. They report there is deposition of gravels and fines in the few pools that are found. The dominant substrate types in this reach are cobble and gravel. There are small amounts of LWD in the reach with some along the left bank and rip rap along the right bank adjacent to Plummer Road.

Lough and Morley (2002) had their highest recommendation for low flow augmentation in Reach 1. From 2000 to the present the Arrowsmith Dam reservoir has been augmenting flow during summer and fall boosting minimum average low flows from approximately 0.75 cms to 1.6 cms (AWS 2011). The MVIHES (C. Stewart, pers. comm.) addressed left bank erosion in 2004 by deactivation of the path, fencing and riparian planting.

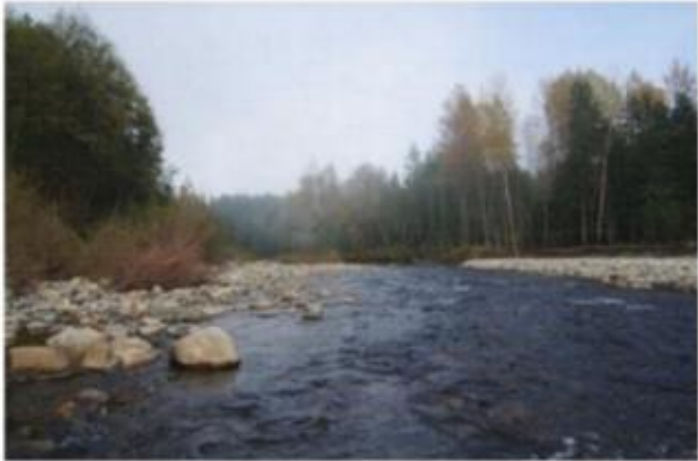
**Reach E3 DS**

Reach 3, along with Reach 2, constitutes the majority of holding water for salmonids in the Englishman River (Gaboury 2005). Beginning at 4.7 km upstream, it is a long (3,490 m) low gradient (0.6%) reach from Top Bridge to the South Englishman confluence. It is lacking in almost all habitat requirements for salmonids other than spawning gravel. Morley and Lough (2002) cited low summer flows, poor adult holding, inadequate pool frequency and lack of cover (LWD, boulders) as well as poor winter refuge.

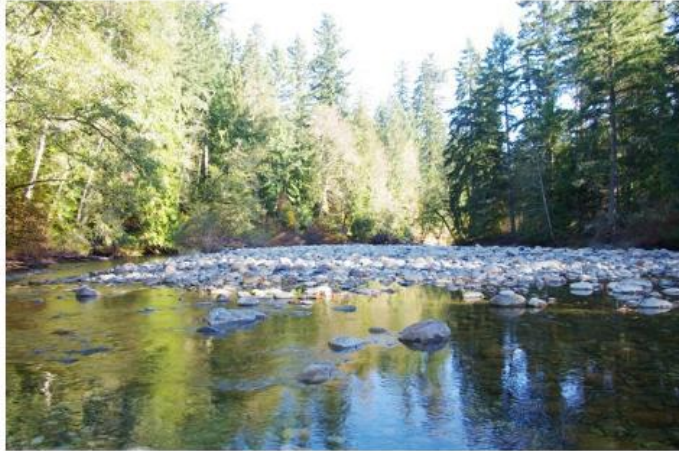
Reach E4 DS

Habitat is poor in this reach with the exception of Morison pool. It has low summer flow, erosion, lack of pools, sparse LWD and no refuge habitat, all identified by Morley and Lough/Rood, 2002. Gaboury (2005) noted the average channel width has increased from 26 m to 37 m since 1949.

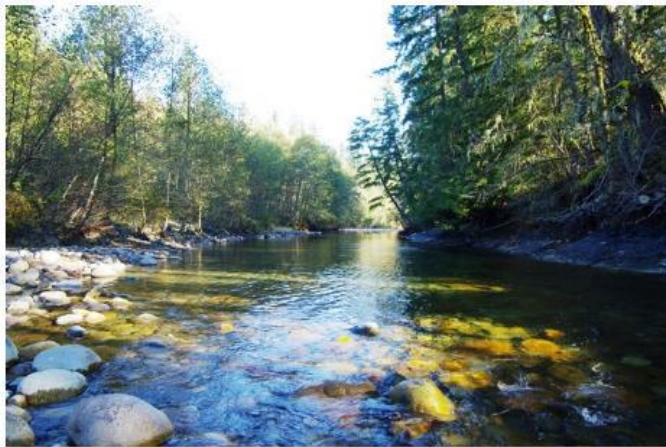
Reach E5 DS

The meandering channel results in lateral and point bars, islands and mid channel bars (Rood 2002). The many gravel deposits offer considerable spawning habitat reflected by the high number of Pink salmon found in the reach compared to E4 (Gaboury 2005).

Lough and Morley (2002) noted sparse instream cover and pools which limit adult and juvenile fish holding. Rood (2002) noted that the streamside logging impacts and associated erosion prior to the 1950's created significant sediment accumulation but many bars are now growing vegetation.

No restoration is noted and access may be a challenge. This reach is in a semi confined valley with 30 m sidewalls on the residential (left) side but much lower on the TimberWest (right) side. Blackman & Hurst (1988) noted seven natural offchannel areas in this reach for potential development. Lough and Morley (2002) suggest restoration at two sidechannel locations.

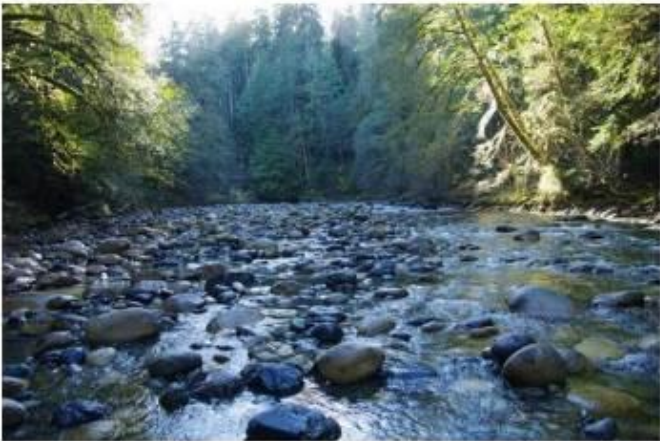
**Reach E6 US**

The uppermost anadromous reach is 2,340 m long ending at a 30 m bedrock barrier at Englishman River Falls Provincial Park at 15.8 km upstream. Rood (2002) noted it is a steep walled confined reach with a fragmentary floodplain. The channel is an average of 0.9% gradient. Gaboury (2005) noted change of an increase in average width from 22 to 28 m since 1949.

Lough and Morley (2002) noted it has a confined and stable channel with boulder cover in most habitat units.

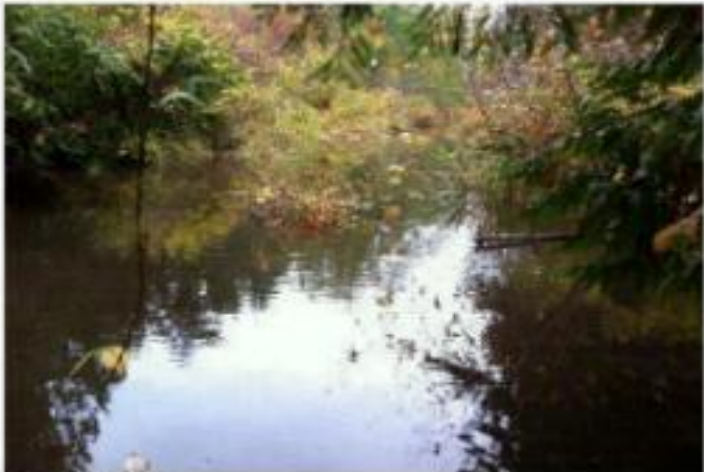
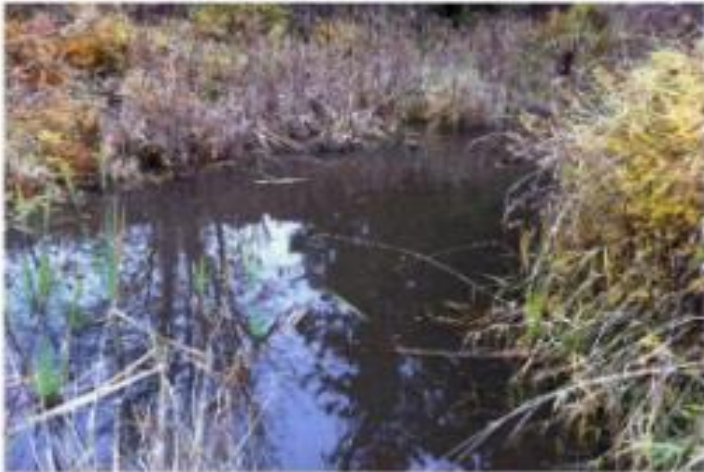
Shelly Creek R2

This is the most farm and urban developed sub basin of the Englishman watershed. The mid reach area was historically ditched and relocated from its natural channel (Burns 1995), it appears to have had anadromous access in its historic state. Buechert (1999) noted farm areas of riparian impairment where the trees were removed. Parksville Streamkeepers (2002) identified a list of restoration opportunities from a literature review. Most restoration opportunities were from Walshe (1999) which described limiting factors such as; ditching, storm water, riparian, low flow, spawning gravel, water quality and fish barriers. In 2012 the MVIHES assessment found three problem culverts for fish migration; at Martindale Road (submerged), hanging culverts in Reach S2 (5.0 m ht.) and Blower Road crossing (1.2m). The reach S2 ponds have critically low oxygen in spring as the last Coho smolts leave<sup>6</sup> which is likely due to the high nutrient loading (detritus) and lack of high riparian cover adjacent to the farm pasture. The high nutrients and sun exposure are also the reasons why the Coho smolts stay and rear in spring long after the floods are over in the mainstem.

There has been no documented restoration on this creek. The assessments (gps mapping, barrier locations and smolt trapping) from 2011 to 2013 by the MVIHES indicate it is important off channel habitat to the mainstem Englishman River that should continue to be protected. There are barrier culverts on the creek at almost every road crossing that, if repaired, could offer further improvements to migration for both salmon and resident trout.

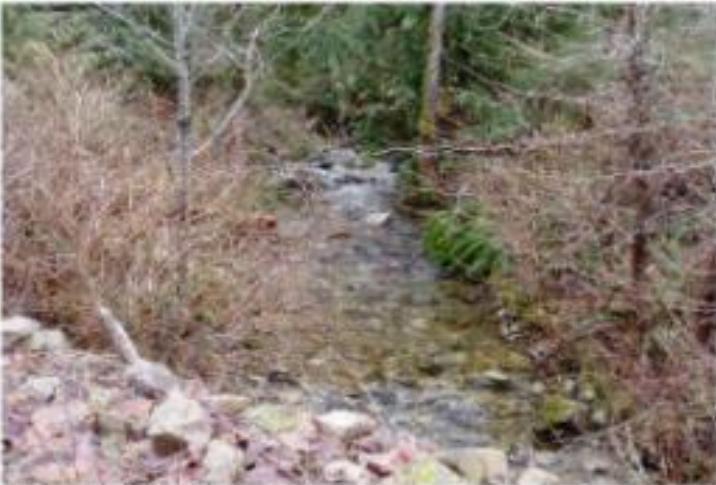
Morison Creek R1

The stream has two low gradient reaches of anadromous access of 2,050 m ending at "Triple Falls" (local name). An unpublished assessment noted the falls are one 8 foot and two 6 foot drops onto bedrock<sup>8</sup>. Reach M1 is a short (135 m) initial reach of boulder riffle (2%). Reach M2 is 1,855 m long on 0.7% gradient with more riffle (40%) glide (53%) than pool (7%) based on samples by Lough and Morley 2002. These accessible reaches have Coho, Cutthroat and Steelhead utilization<sup>9</sup>. This section of the creek is in a treed gully 100-250 m wide with rural properties and access road on the outside of the riparian area. There is one recreational trail crossing at the lower reach near the mouth.

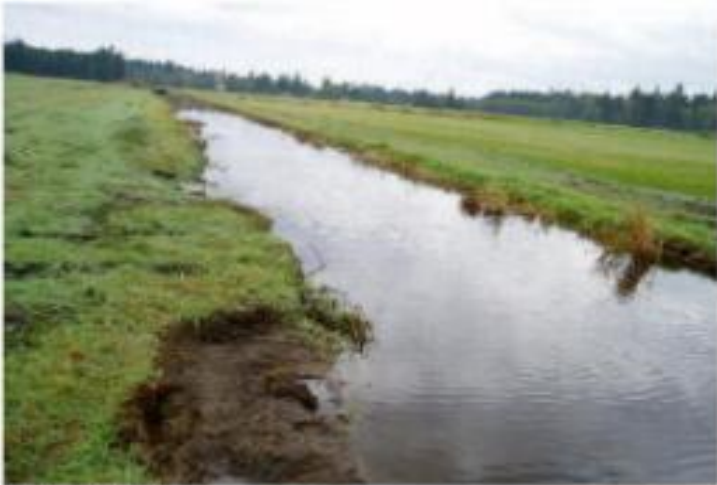
Morison Ck R2

Boulder and bedrock dominated substrates limit spawning locations. Pools are limited in number. Flow is limited (Lough and Morley, 2001). Trail access may result in quad damage to the channel and riparian. There may have been historic fish access over Triple Falls prior to logging and degradation of the jump pool crests.

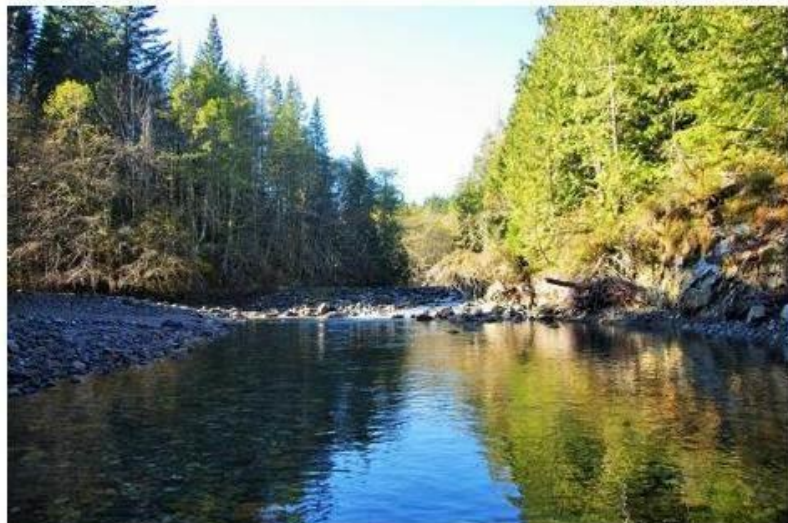
S. Eng. R. DS

This short lowest reach is wide and unconfined. Centre Creek enters at the top end of the reach. It is noted for sparse LWD, gravel deposits and lack of summer pools.

The lower reach is accessible to Chum and Coho and has plenty of spawning gravel, but it was not highly recommended by Lough & Morley (2002) for restoration due to instability. They recommend cabling standing trees as an opportunity to control loss of LWD adjacent to unstable banks. Blackman & Hurst (1988) noted 52,000 m<sup>2</sup> of the wetted habitat in Ferguson Swamp.

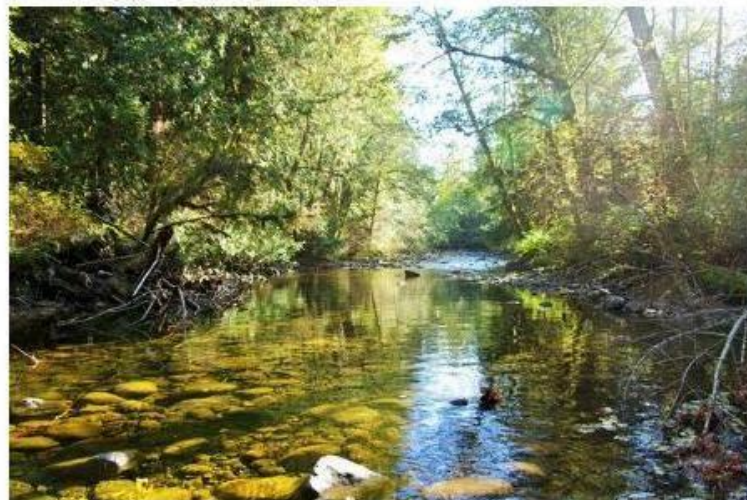
S. Eng. R. US

These reaches are located upstream from Centre Creek to the logging road mainline. They are similar in habitat with steadily increasing gradient; 1,000 m on 0.8%, 1,820 m on 1.3% and 1,600 m on 4.3% respectively. Among the three reaches they were described by Rood (2002) as confined steep valley walls that were historically logged and are now vegetated. They were noted as now generally stable with some sidewall instability in Reach SE4.

Lough & Morley (2002) offered similar prescriptions for the three reaches due to similar limiting factors; summer drying, lack of LWD and lack of winter refuge habitat. Lough & Morley (2002) recommend cabling standing trees, adding LWD and stabilizing the SE3 debris jam. They also suggest investigating improving the barrier at 4.5 km to access 6.0 km further habitat. Gaboury (2005) noted no high priority restoration opportunities, and Lough & Morley (2002) ranked restoration as moderate.

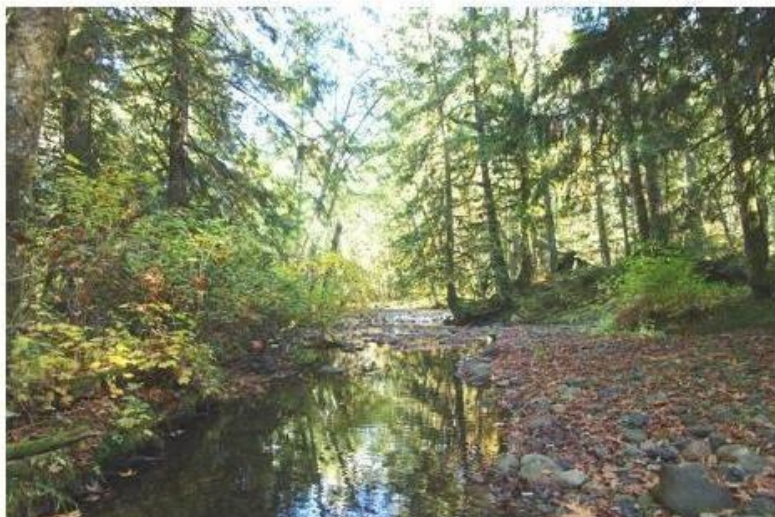
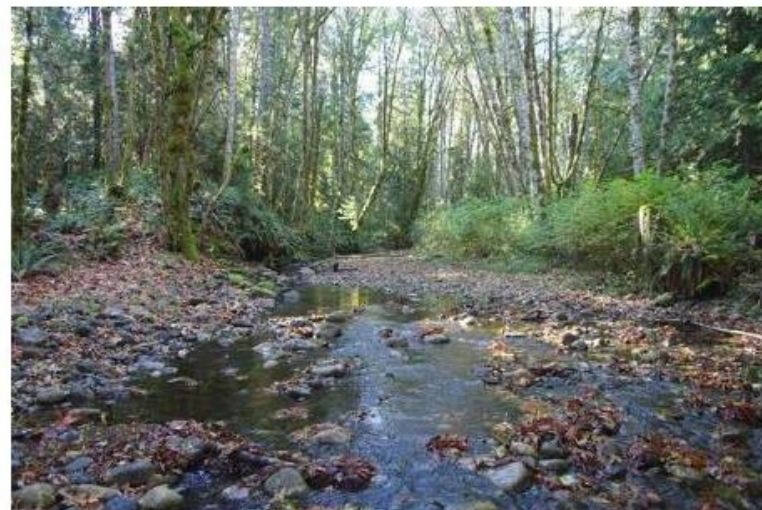
Centre Ck US

The stream channel was historically logged to its banks and the resultant changes to the channel width, sediment transport and resulting loss of habitat diversity are identified by Rood (2002) and Lough & Morley (2002). The detailed habitat assessment proved the previous overview assessments were not incorrect in their poor habitat predictions. Warttig and Clough (2004/2008) found LWD and instream cover was well below provincial fish habitat standards (Johnston & Slaney, 1996)

This long flat tributary lacks cover, pool depth and habitat complexity throughout its length. The Restoration Plan (Warttig & Clough, 2004, 2008) identified opportunities for the entire anadromous length with template prescriptions. The work has been almost annual since 2004 and more is planned in 2013 by the MVIHES and the Pacific Salmon Foundation Community Salmon Program.
