**SAN
PAREIL**

**Water Local Service Area
Annual Report**

2006

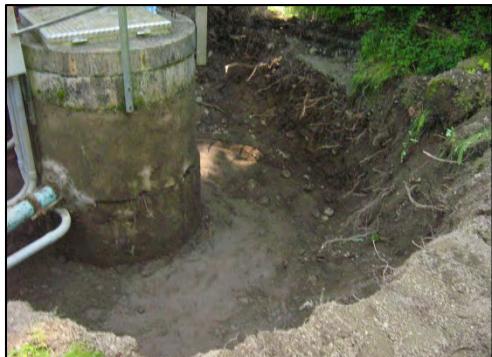
San Pareil
Well #1
Surface Seal
Installation,
July 2011
