# MELROSE

## Water Service Area Annual Report 2011

**REGIONAL DISTRICT OF NANAIMO**  
*Water Services Department*  
June 2012

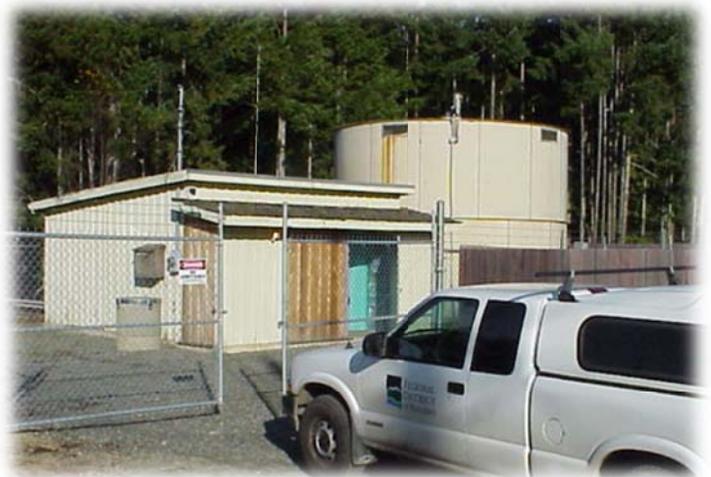
**Melrose Pumphouse and Reservoir**

One groundwater production well is present at the reservoir site on Melrose Road, west of Coombs, B.C.

One service reservoir (steel structure) is present at 3853 Melrose Road, and has a capacity of 136 m<sup>3</sup> (30,000 imperial gallons).

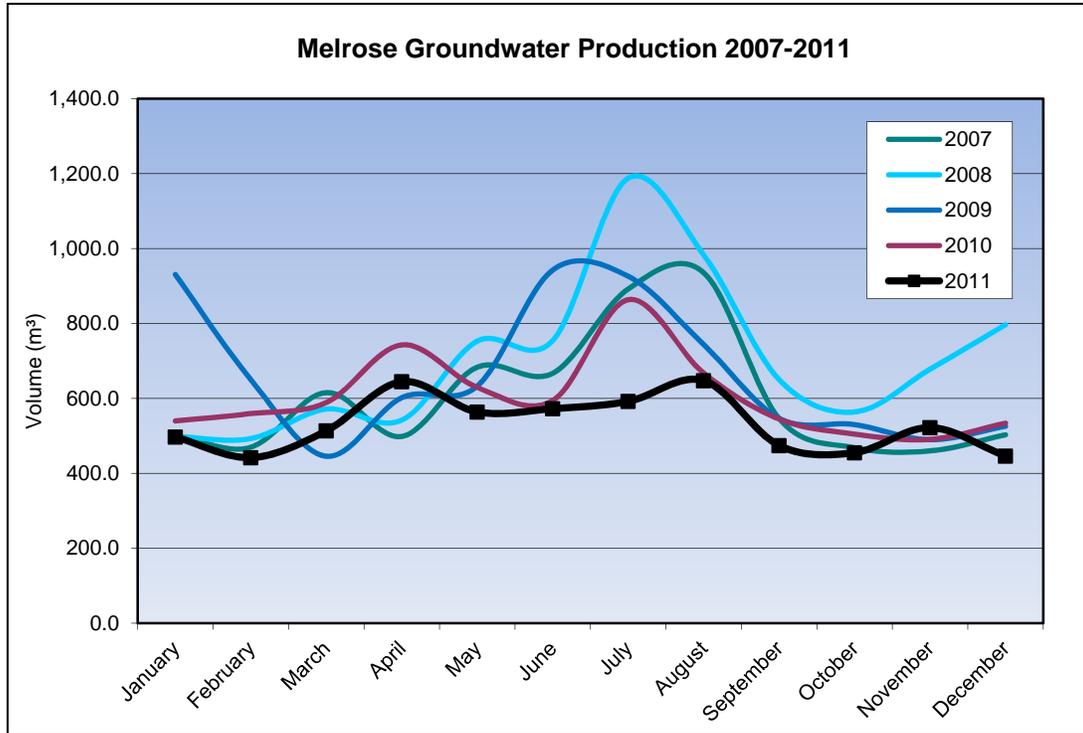
The monthly groundwater production in the Melrose system for the past 5 years is shown in the chart below. Groundwater production in 2011 was typically lower than previous years.

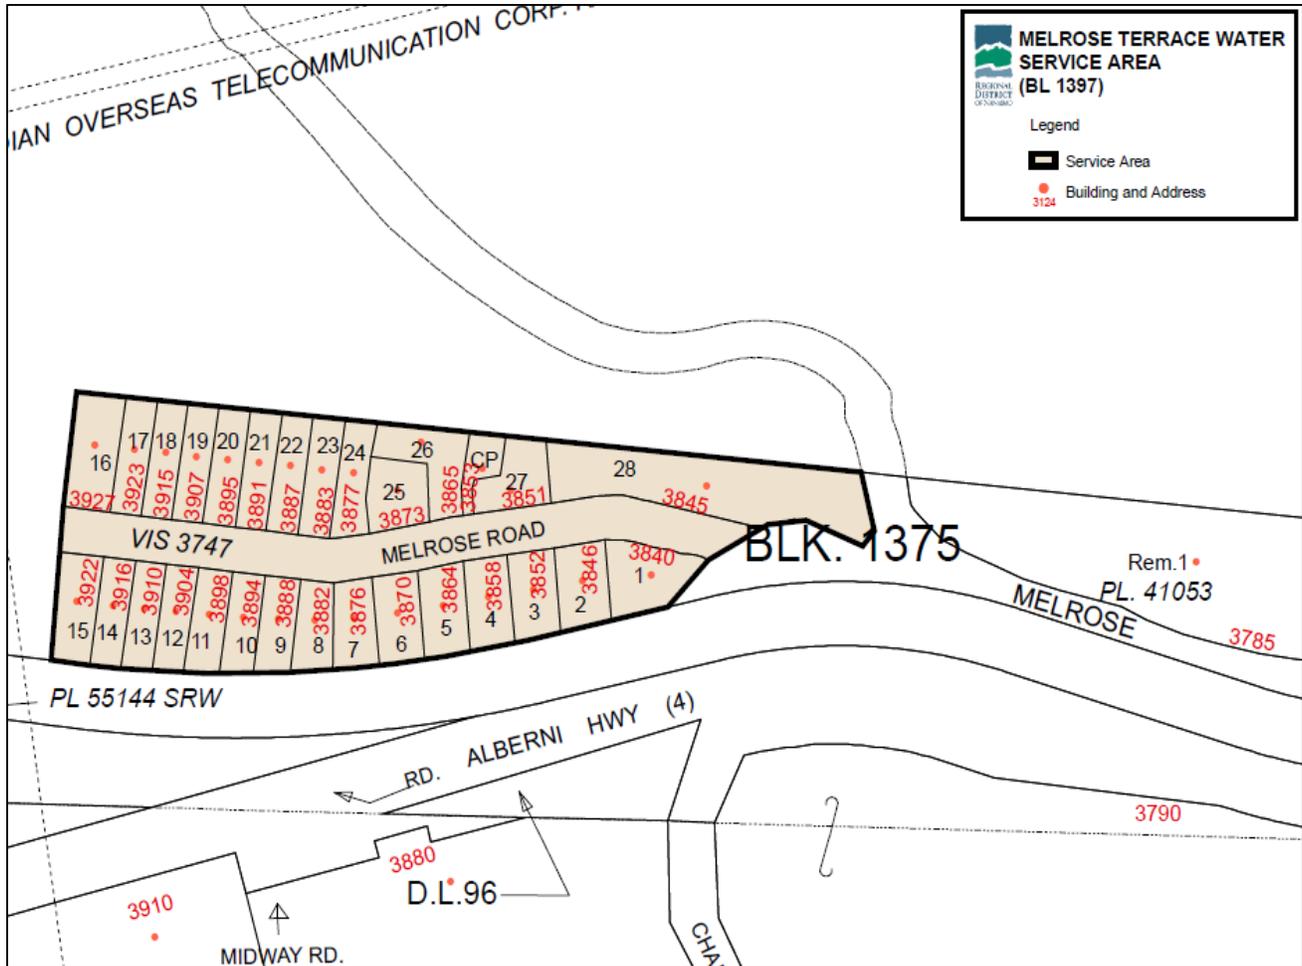
**MAP OF MELROSE  
WATER SERVICE AREA**

The water distribution system in Melrose is comprised of 0.3 km of 150mm PVC watermains. There are no fire hydrants located within the system.
