REGIONAL DISTRICT OF NANAIMO

Water Service Area Annual Report 2017

Horne Lake Regional Park

Water System

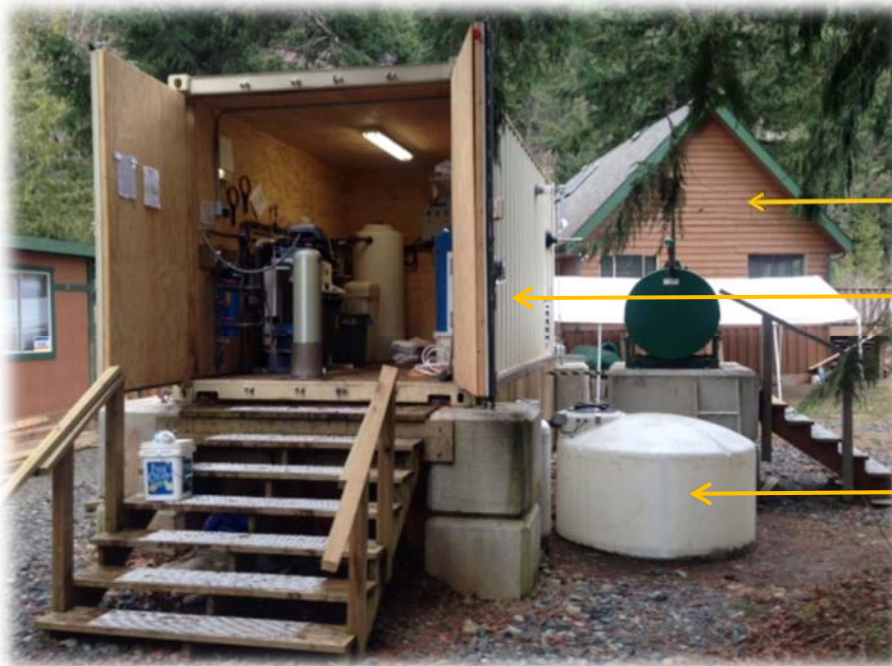
Horne Lake Regional Park

← Staff Residence

← Sea Can for water filtration and chlorination units

← Summer water storage tank

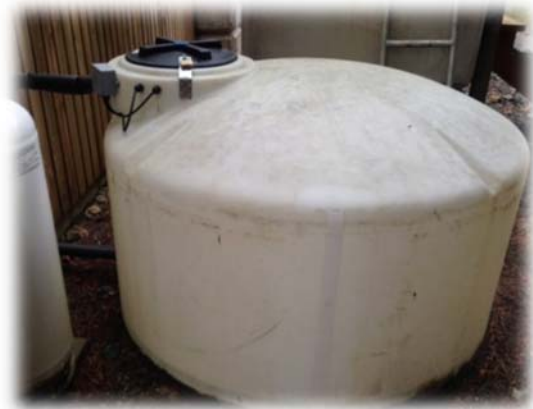
An alternate, larger, 500 gallon outdoor water storage tank is present on the ground outside and adjacent to the Sea Can container. This reservoir is used in the summer when the demand for water is greater. Both the summer and winter storage reservoirs are composed of white PVC plastic. These reservoirs are drained and cleaned alternately before use each season.

**Summer water storage tank at
Horne Lake Regional Park**

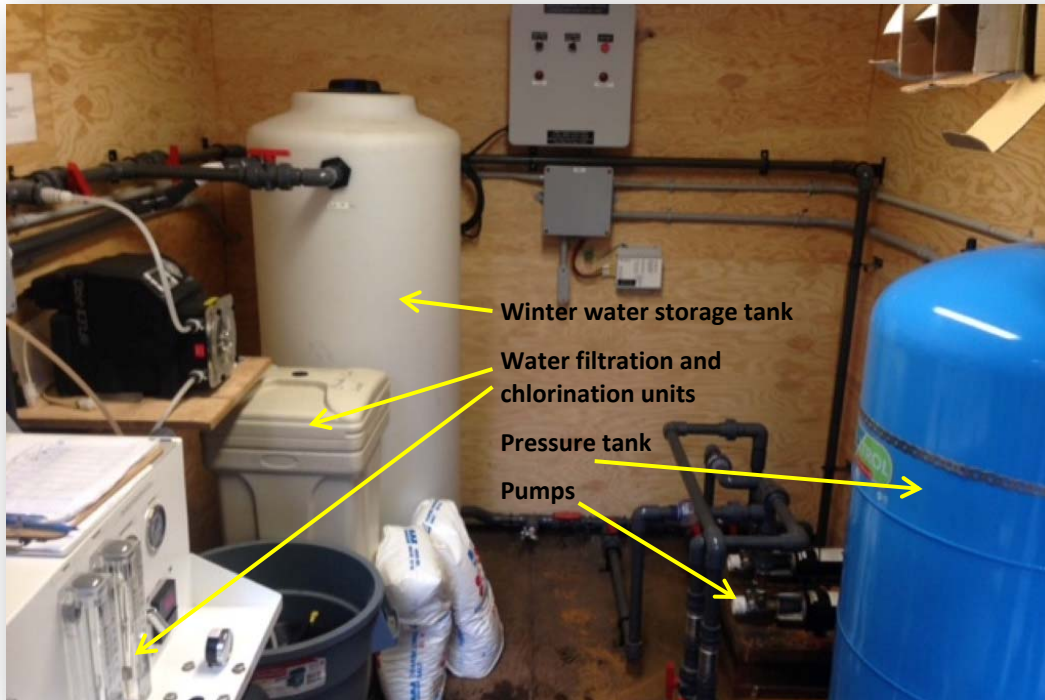
Two small water storage reservoirs are present at Horne Lake Regional Park. Drinking water from the well near the staff residence is filtered, chlorinated, and pumped to a small 50 gallon holding tank inside the Sea Can container during the winter. Then the drinking water is pumped via a pressure tank to the staff residence and yard hydrant on demand.

Photo depicting the inside of the Sea Can container at Horne Lake Regional Park

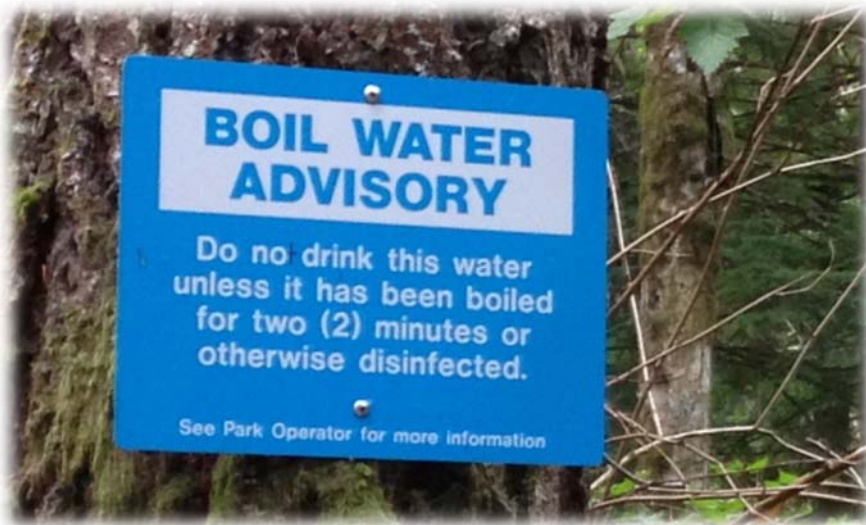
There is one hand-pump for the campground, located in the South Park. The water supply to the hand pump comes from a shallow well directly under the hand pump. The water available from this hand-pump is not potable, and there are posted signs indicating the hand-pump water is not to be used for drinking or cooking. Potable water is only available in the North Park at the staff residence and yard hydrant. The North Park hand-pump well was closed in July 2015 by a qualified well driller. Please see the well closure log attached in Appendix B.

Sign above the hand-pump
in the South Park
campground

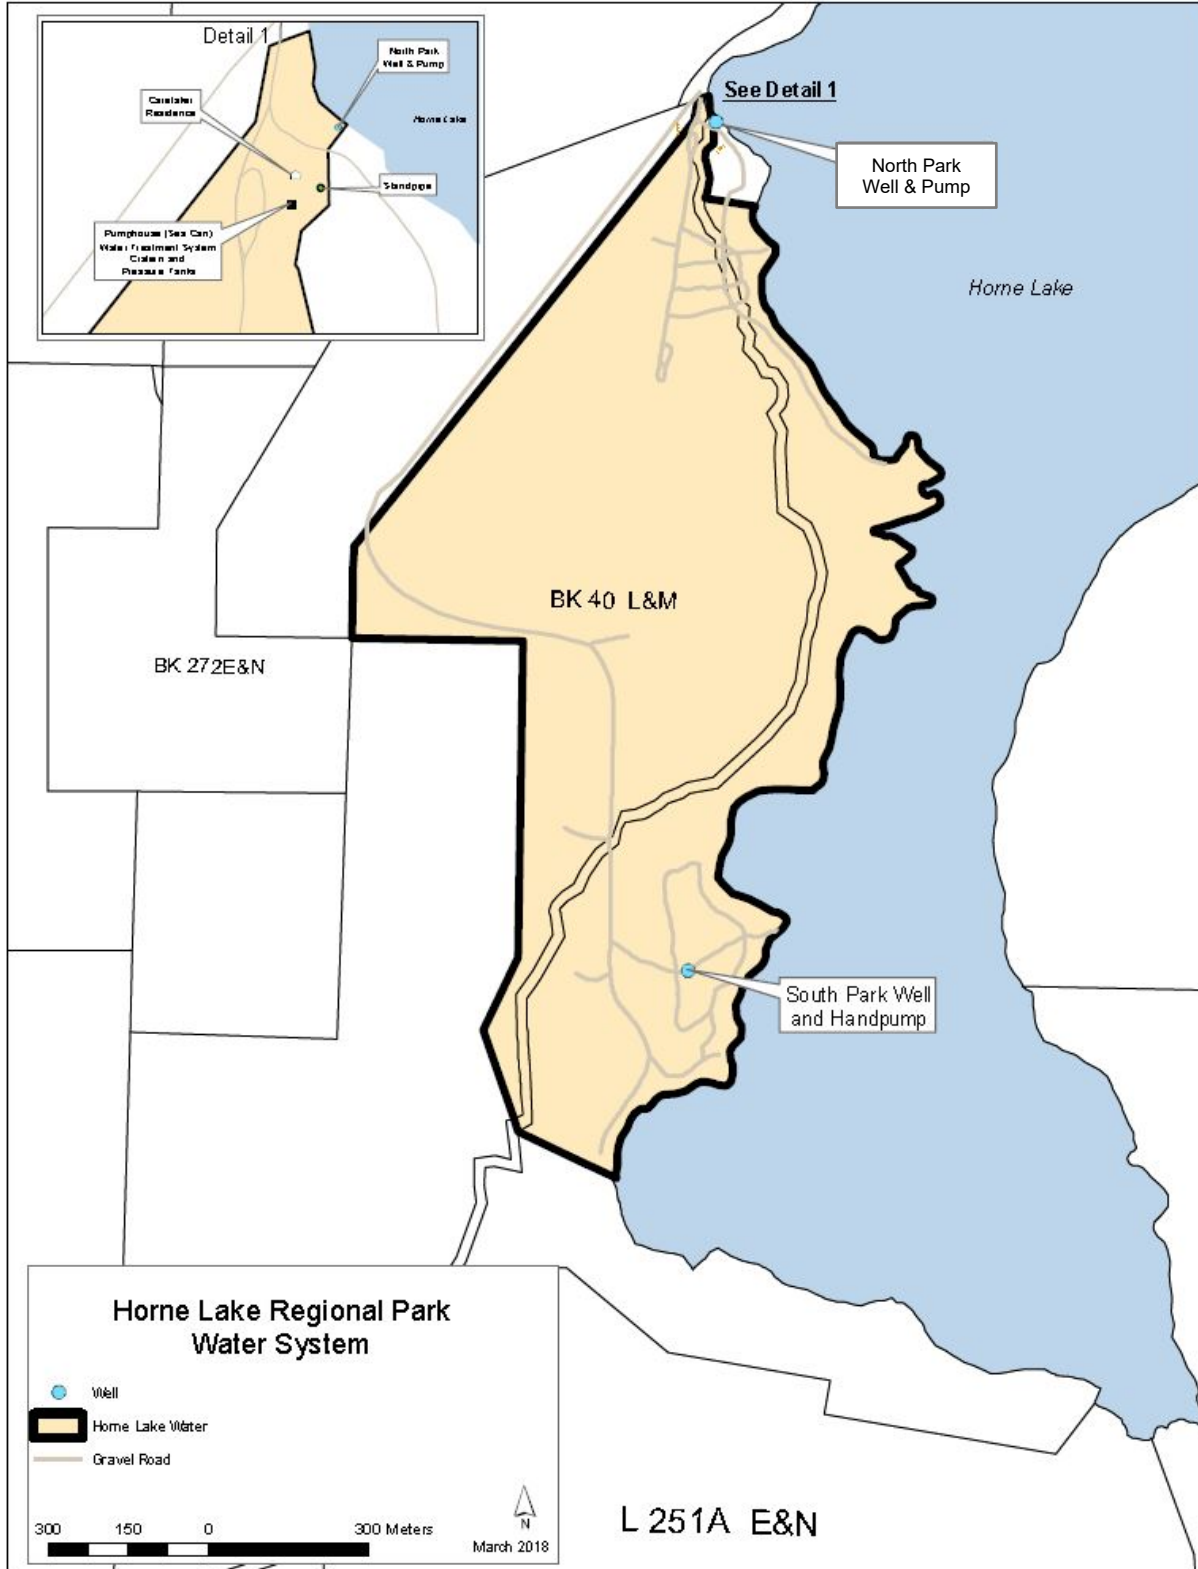
**MAP OF HORNE LAKE REGIONAL PARK
WATER SYSTEM**

HORNE LAKE REGIONAL PARK WATER SYSTEM
