REGIONAL DISTRICT OF NANAIMO Water Service Area Annual Report 2019

The following annual report describes the Englishman River Community Water Service Area and summarizes the water quality and production data from 2019. This report also includes a summary of inquiries and complaints, completed and proposed maintenance activities, Operator Certification, the Emergency Response Plan, and the Cross Connection Control Program.

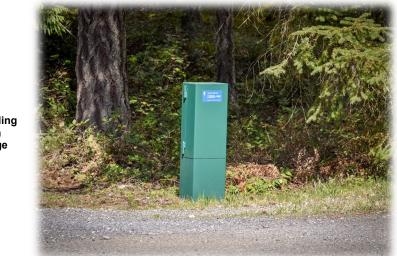
Water Sampling Station in Rivers Edge

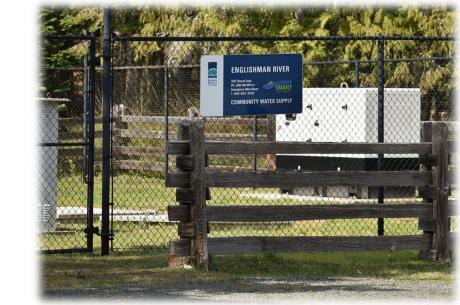
Rascal Lane Well Site (Well #2 and

Well #3)

Groundwater production wells ER #2 and ER #3 are located at 2231 Rascal Lane, Parksville, B.C. Test well PW #1 is located on Peterson Road, and was converted to a monitoring well in 2005. Test Well PW #4 is located on Rivers Edge Drive and was converted to a provincial monitoring well in 2012.
