Re: Field Reconnaissance of Stage One of Nearshore Marine Assessment in Schooner Cove at Fairwinds, Nanoose Bay, BC

Attached is our report for the February 13, 2009 field reconnaissance of the Schooner Cove marina and surrounding lots. The report consists of an overview and description of the current shoreline features of the area, and is intended to provide materials to assist in your discussions for the Schooner Cove neighbourhood planning process.

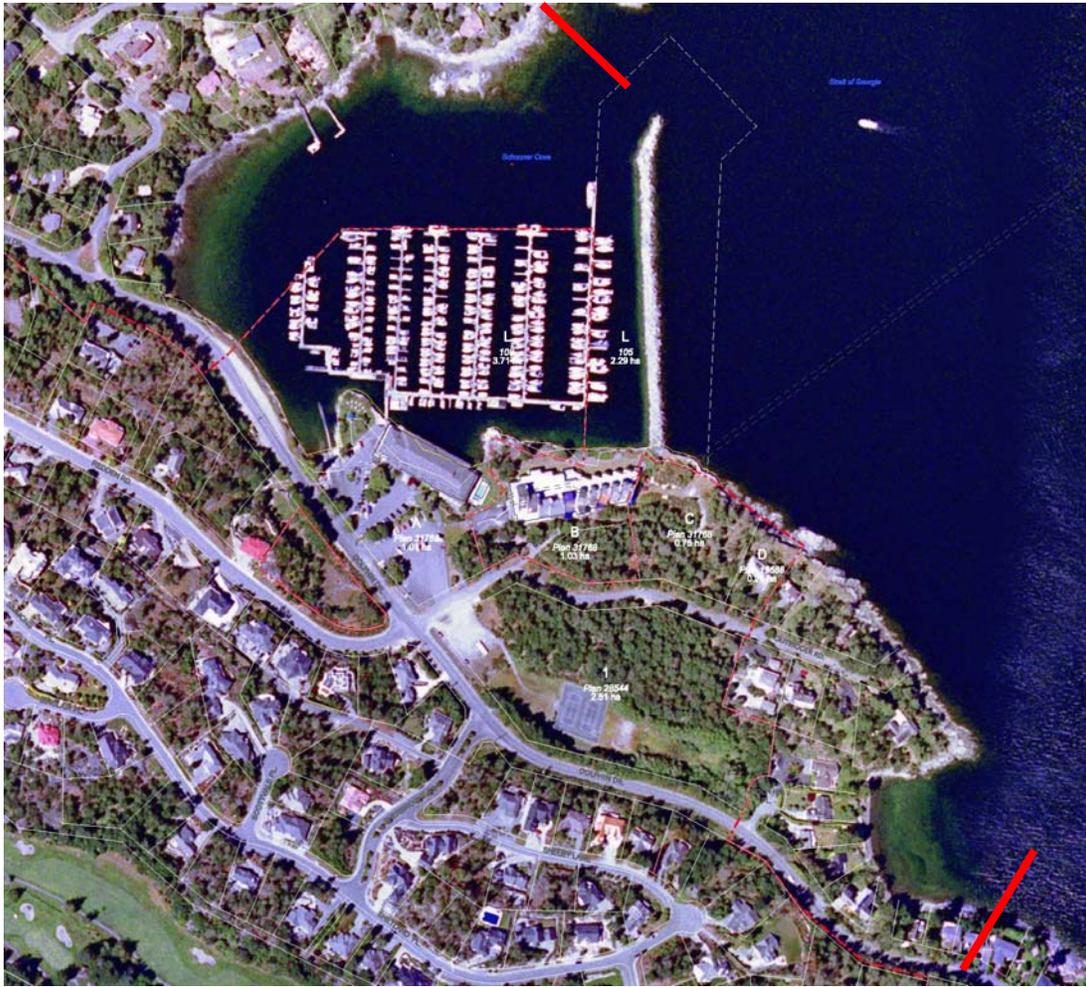
Figure 1. Overview of Schooner Cove and extent of shoreline south of the cove included in review. Thick red lines show extent of study area

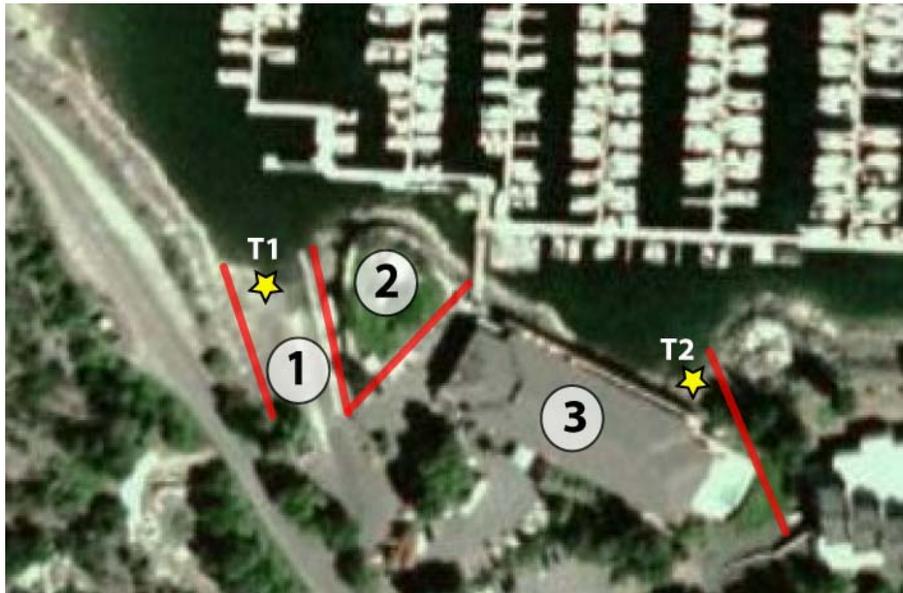
Figure 2: Southwest Schooner Cove shoreline showing segments 1, 2 and 3; showing the locations of Transects T1 and T2.

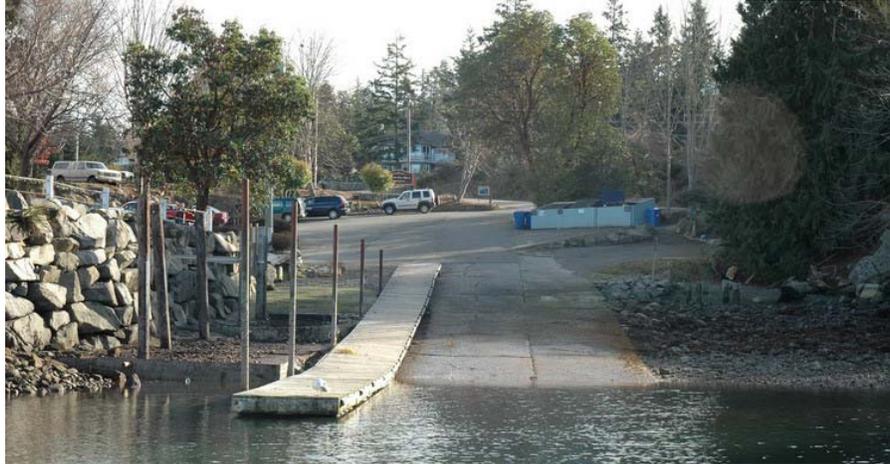
Figure 3: View of beach, boat ramp and marine ways in Segment 1, showing paved concrete ramp, floating dock, metal piles of the marine ways. Transect T1 was surveyed across the beach area at the right of this photo.

Description	The boat ramp segment is low-slope shoreline, made up with approximately half of the alongshore width as cobble beach, and half as concrete boat ramp and marine ways. The segment has been significantly altered, with concrete, pilings and paving associated with the boat ramp, float and marine ways. West side of segment bounded by fill from road bank. This is the only shore segment within the study area with low-bank, water access across a low-gradient beach.
Wave energy	Very protected
Supratidal and Upper Intertidal Features	Substrate: concrete and paving in upper ramp and ways, fill and terrestrial grasses at beach Biota: Riparian vegetation of mature cedar tree, terrestrial grasses, few sprigs of salt-tolerant grasses on upper beach, concrete bare
Intertidal Features	Substrate: paving and concrete at boat ramp and ways, boulder/cobble/pebble over sand/fines on beach, with more fines on lower beach. Old pilings on mid-beach, concrete at boat ramp and ways, metal pilings and paving at ways Biota: scattered rockweed, barnacles, oysters on lower beach, filamentous greens on concrete boat ramp, shell debris at ways

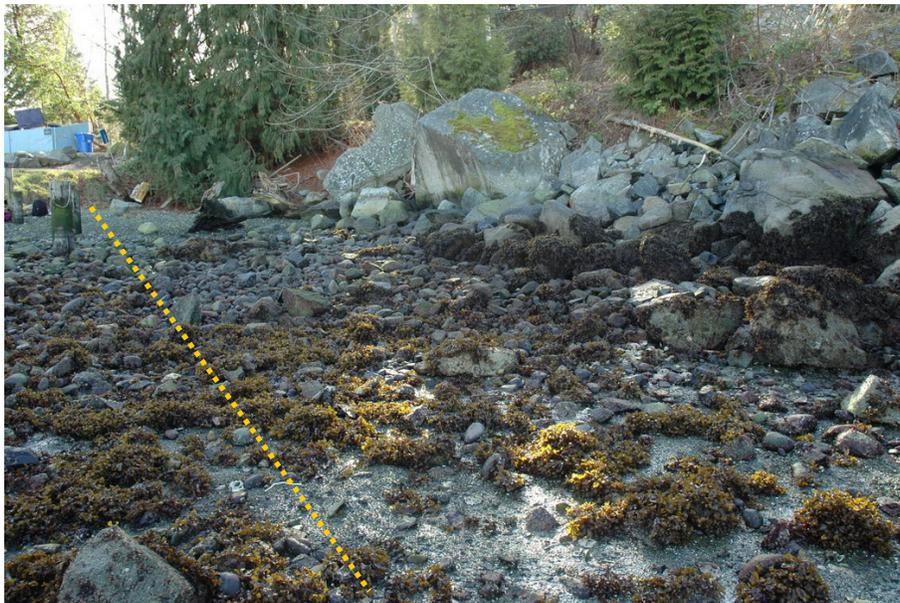
Figure 4: Lower beach at boat ramp segment, with dotted line showing approximate location of the measured profile. Scattered rockweed and barnacles were observed, and substrate consisted of a cobble/boulder veneer over fine materials.

Photos	Figure 3, Figure 4
Transect	T1: shallow-gradient beach. See Figure 4 and profile in Appendix A.

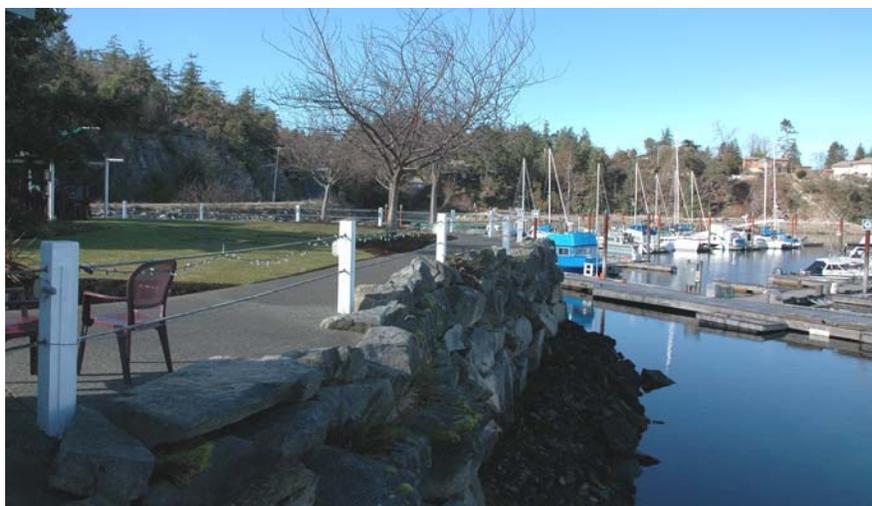
Figure 5: Grassy picnic area (Segment 2) showing vertical block wall and riprap fill.

Description	The walled picnic shore segment is a section of filled shoreline, with vertical stone blocks in the upper intertidal over riprap and fill in the lower intertidal. Shoreline segment is man-modified.
Wave energy	Very protected
Supratidal and Upper Intertidal Features	Substrate: Stone block wall Biota: Riparian vegetation is absent. Splash zone and upper intertidal is on vertical stone block wall
Intertidal Features	Substrate: Stone wall and riprap fill. Biota: Barnacle, rockweed and filamentous green algae on the lower half of the wall/ fill
Nearshore Subtidal Features	Substrate: rubble with cobble/pebble and silt. Some sections with subtidal bedrock ramp below fill. Biota: scattered bladed kelp, numerous leather stars, few sunflower star
Figure	Figure 5, Figure 6
Transect	No transect in this segment

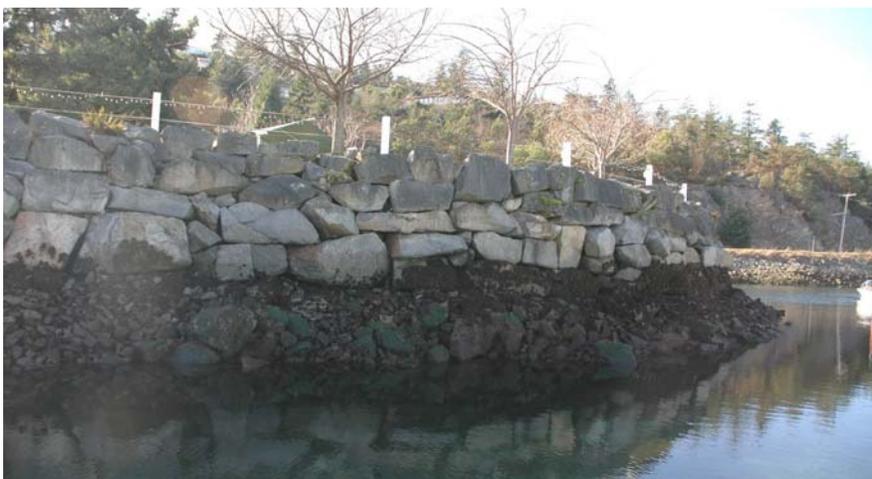
Figure 6: Shore Segment 2, with rockweed and green algae along the lower wall and riprap fill.

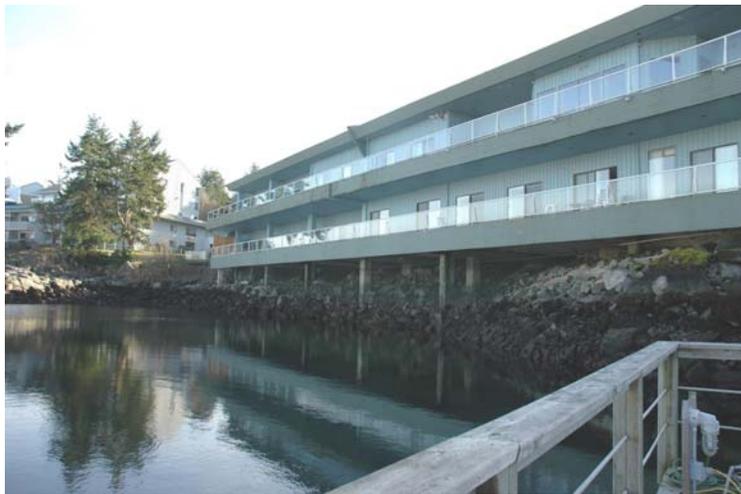
Figure 7: View of hotel building, showing pilings over the intertidal zone.

Description	The hotel building is built out on concrete pilings into the intertidal zone. The shoreline under the building has been modified with fill and riprap material. Segment shoreline is man-modified.
Wave energy	Very protected
Supratidal and Upper Intertidal Features	Building covers upper intertidal and splash zone. Biota: bare, shaded under building
Intertidal Features	Substrate: Rubble fill and riprap. Biota: low turf of filamentous brown and green algae, barnacles
Nearshore subtidal Features	Substrate: shell hash/ sand. Riprap does not extend much beyond building footprint Biota: scattered bladed kelp
Figure	Figure 7, Figure 8, Figure 9
Transect	T2: located at the east corner of the hotel building, across riprap and fill section. See Figure 8 and Appendix A.

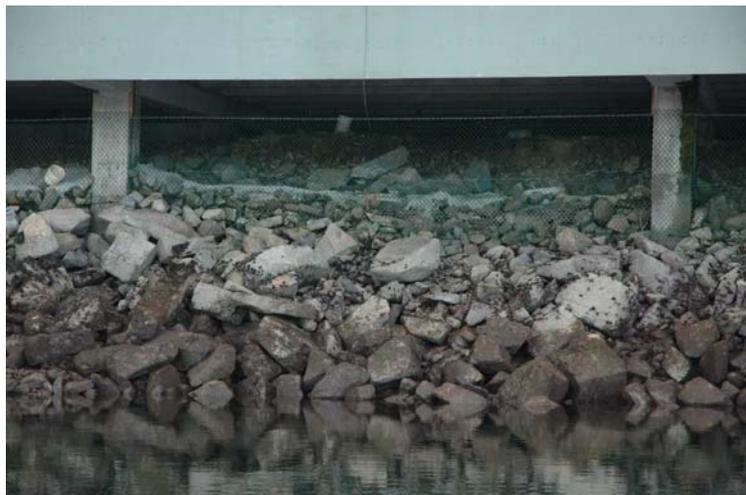
Figure 8: Rubble and fill under hotel pilings.

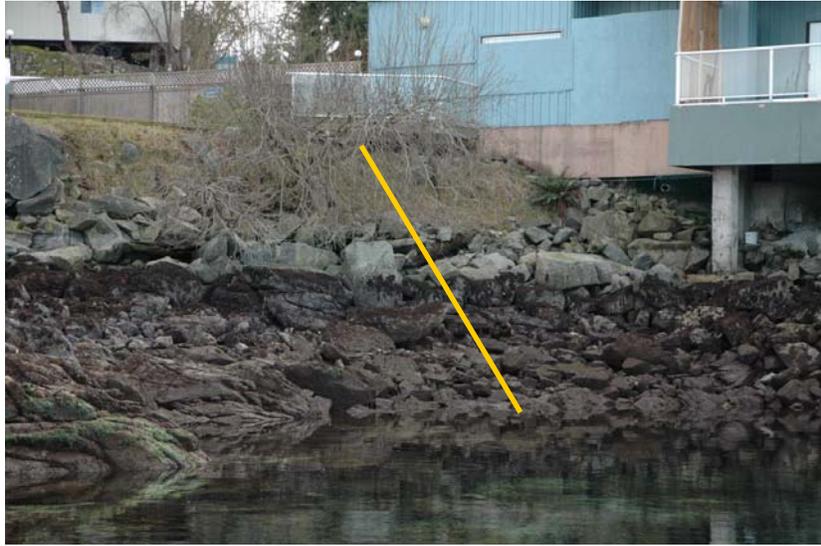
Figure 9. Approximate location of profile measured in Transect T2 at east corner of hotel building shown in dotted line. Riparian shrubs in upland and low turf of biota across the intertidal zone.

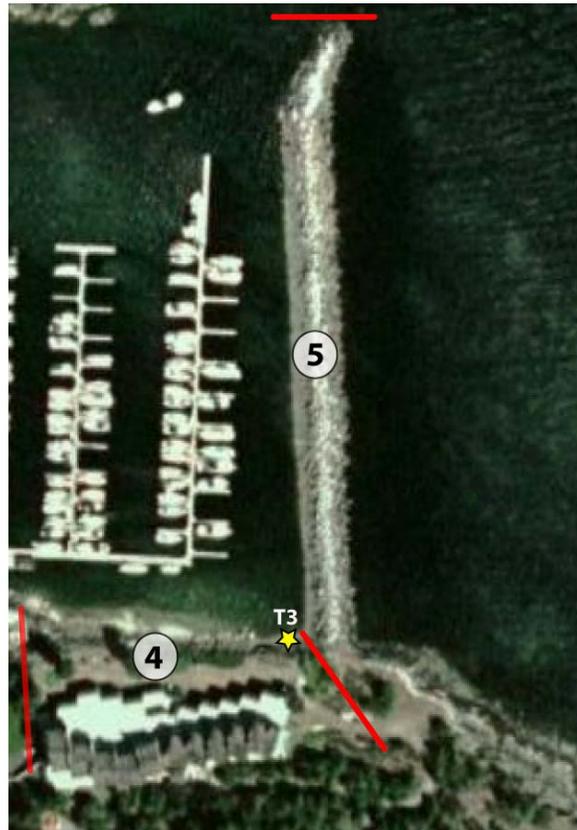
Figure 10: Schooner House and breakwater shoreline segments 4 and 5, showing the location of transect T3.

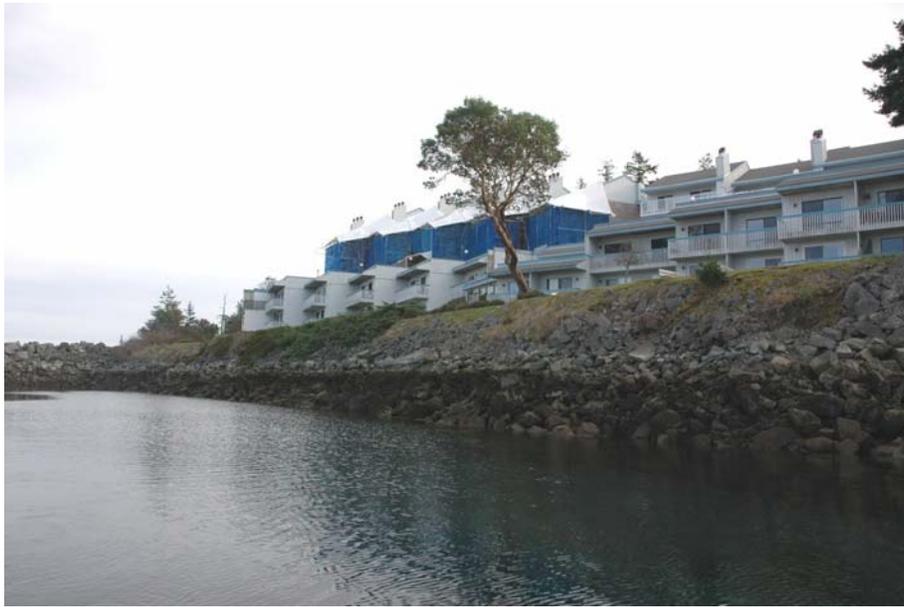
Figure 11: View of steep bedrock and fill shoreline in Schooner House segment.

Description	The north-facing shoreline in the Schooner House segment is a combination of natural bedrock cliff and ramp (shallow sloped bedrock ledge), with rubble-filled sections. Most of the segment is steep, however the waterline is accessible across the natural bedrock ramp near the west end of the segment. Segment is partly modified and partly natural shoreline.
Wave energy	Very protected
Supratidal and Upper Intertidal Features	Substrate: fill over bedrock, landscaping, bedrock Biota: mature <i>Arbutus</i> and Douglas fir, landscape plantings in riparian. Splash zone lichen, barnacles in upper intertidal
Intertidal Features	Substrate: rock rubble or natural bedrock cliff and ramp. Nearshore subtidal zone observed to have bedrock platforms and shell hash/fines Biota: Rockweed, barnacles, green algae; along with <i>Mastocarpus</i> (red alga), oysters, periwinkle snails, amphipods, purple sea star in lowermost intertidal.

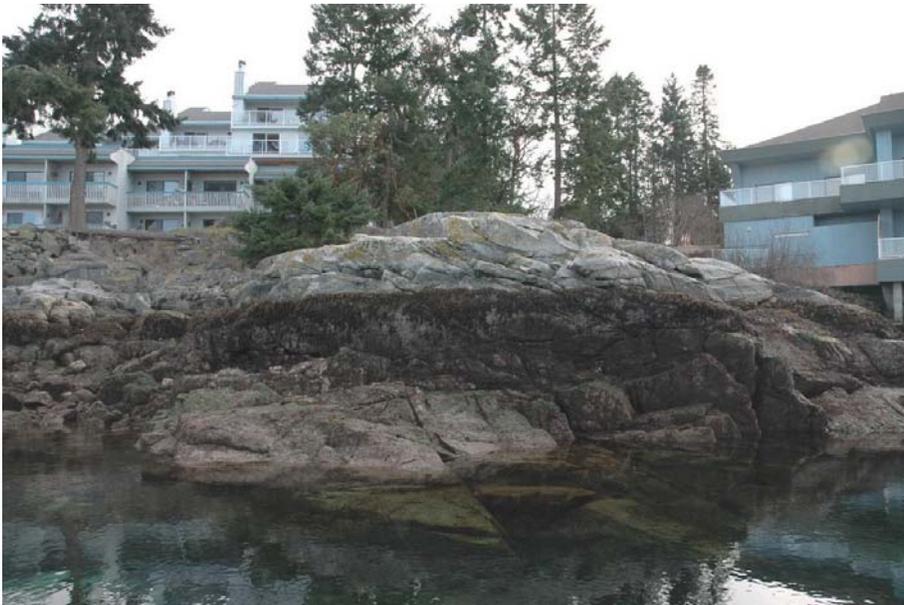
Figure 12: Natural bedrock outcrop at west end of Schooner House segment.

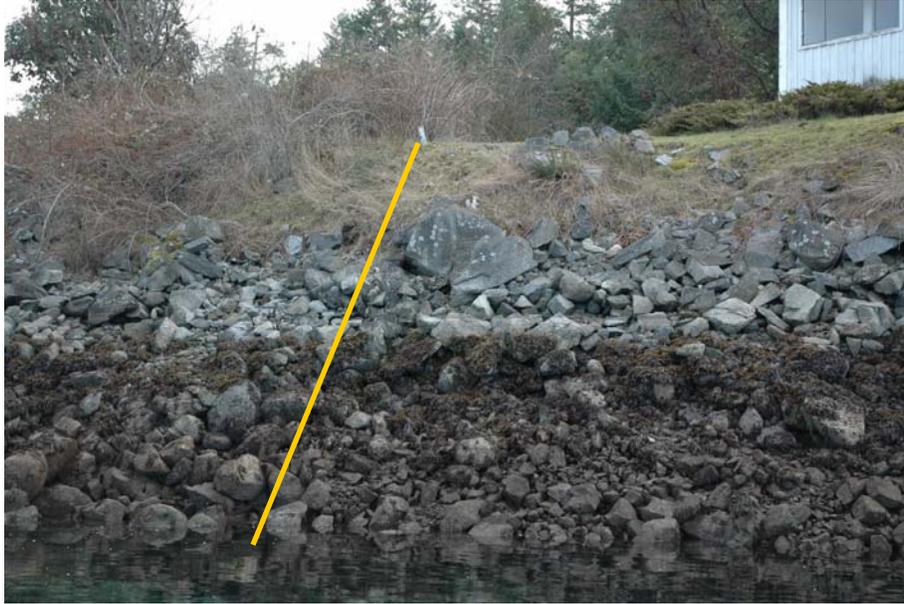
Figure 13. Approximate location of profile measured in Transect 4 shown in dotted line, on rubble fill bank at east end of Schooner Cove segment.

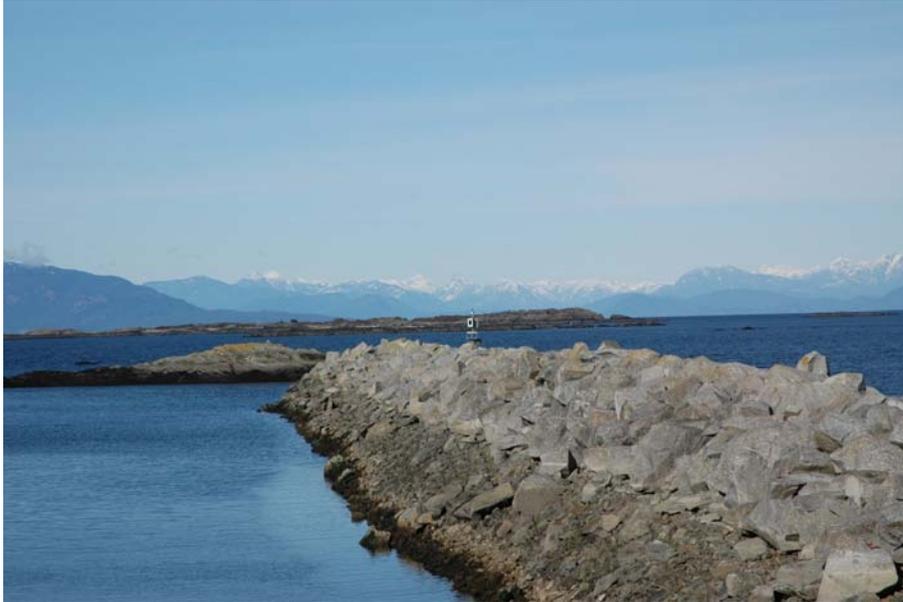
Figure 14: View of the protected southwest side of the breakwater, looking north from Schooner House. Note slightly finer fill material on the lower slope of the breakwater.

Intertidal Features	Substrate: riprap and rubble over fill. The exposed east side of the berm was much coarser material throughout than on the sheltered west side, where the substrate is cobble/pebble/boulder in the lower intertidal. Biota: Rockweed, barnacles, green algae; along with <i>Mastocarpus</i> (red alga), oysters, periwinkle snails, amphipods, purple sea star in lowermost intertidal
Figure	Figure 14, Figure 15
Transect	No transects on breakwater, however south inside of breakwater would be very similar to Transect 3.

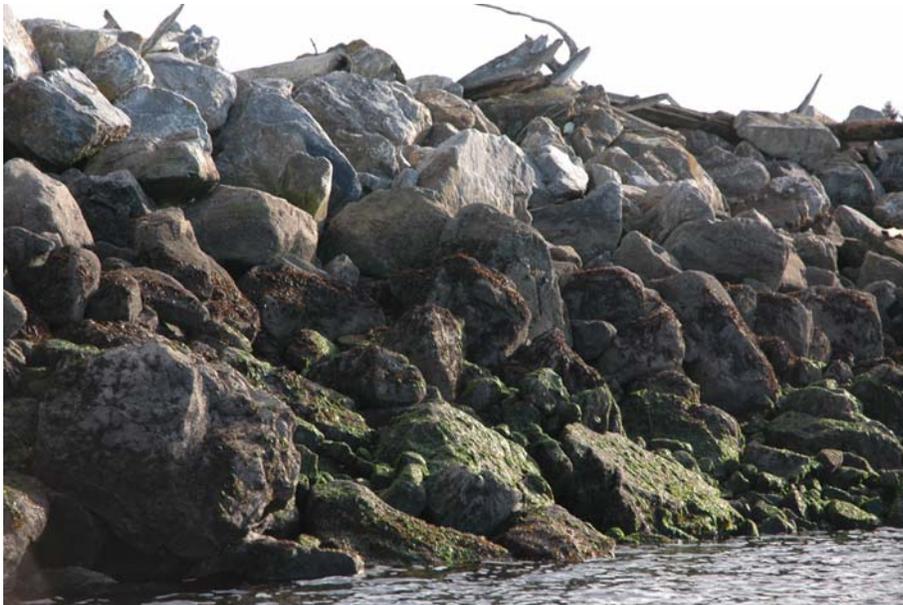
Figure 15: East facing, high-energy side of the breakwater, showing coarse riprap and log debris on the top of the berm.

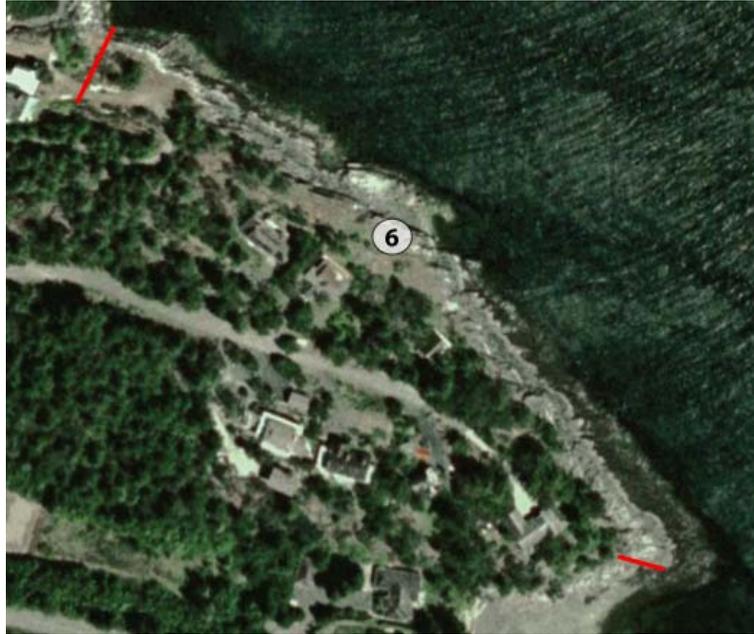
Figure 16: Shore Segment 6, along the outer south shore, near Schooner Cove.

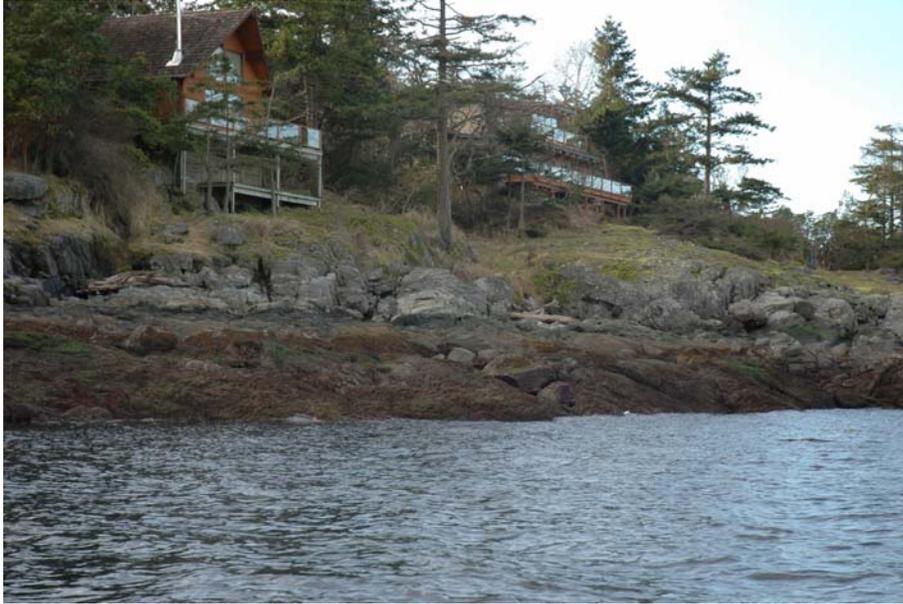
Figure 17: View of bedrock shoreline along outer south shoreline segment, showing zonation of biota, natural riparian, and setback of buildings from the marine limit.

Description	The northeast-facing shoreline outside the breakwater and south from Schooner Cove is primarily natural bedrock shoreline. Several houses are built along this section but no shore modifications were observed.
Wave energy	Semi-exposed
Supratidal and Upper Intertidal Features	Substrate: natural bedrock ramp and cliff, east facing Biota: mostly natural riparian Douglas fir, arbutus and other shrubs and herbs Splash zone lichen, barnacles in upper intertidal
Intertidal Features	Substrate: natural bedrock ramp and cliff, east facing Biota: Rockweed, barnacles, green algae observed from the skiff-survey; no on-the-ground observations were made in this segment
Nearshore Subtidal	Substrate: Shell hash/ fine sediment between bedrock Biota: scattered bladed kelps
Figure	Figure 17, Figure 18
Transect	No transects on this segment

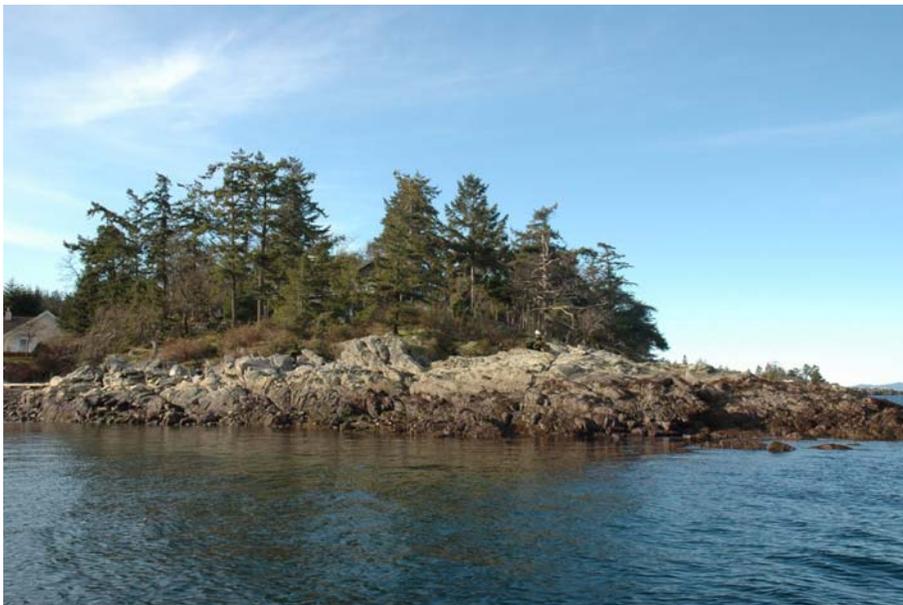
Figure 18: Southern point of segment 6, at north entrance to pocket beach in segment 7, showing bedrock ramp and natural riparian vegetation.

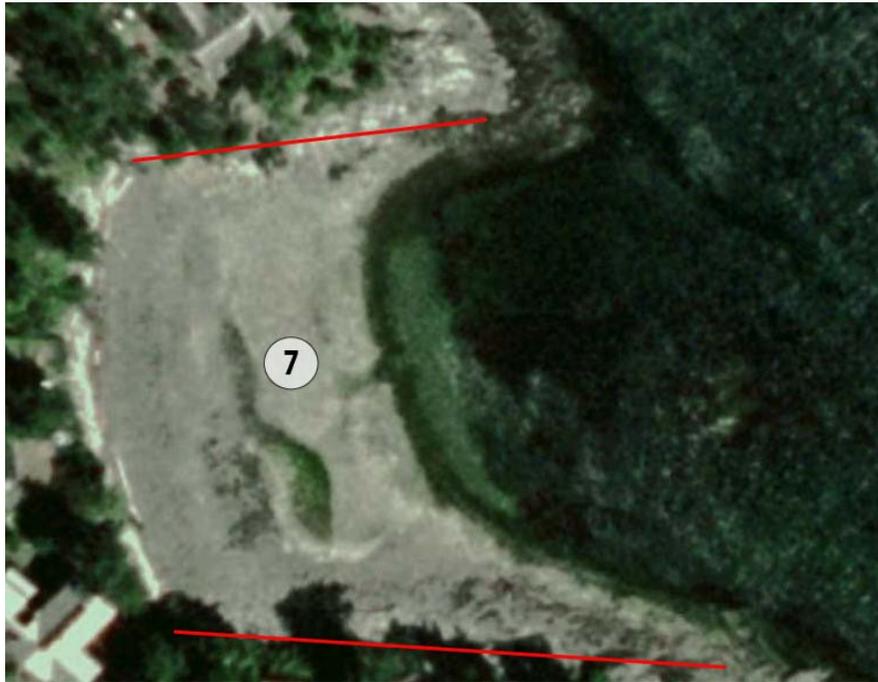
Figure 19. Shore Segment 7, in pocket beach, south of Schooner Cove.

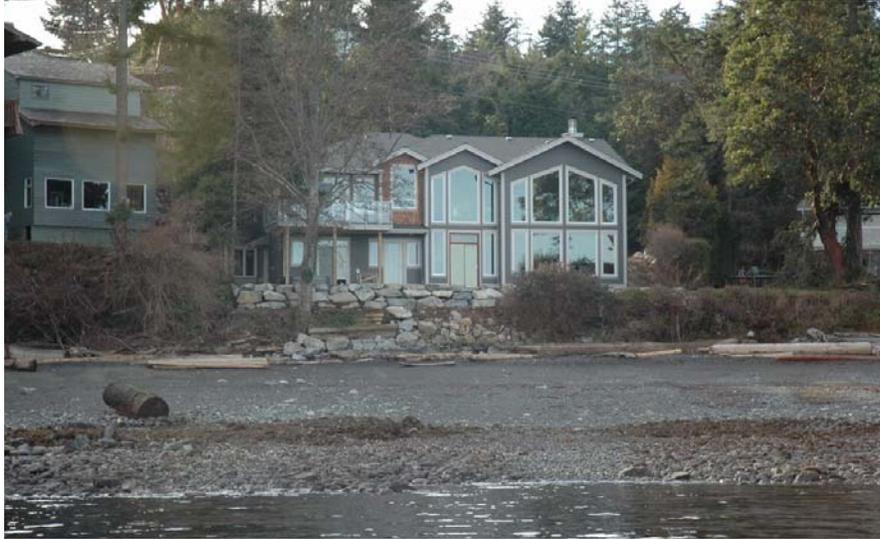
Figure 20: South pocket beach, showing log line on upper beach and man-made seawall at private property.

Description	The small pocket beach is open to the east, and located between adjacent bedrock headlands. Some man-made seawall and fill at private properties along supratidal zone/ marine limit, with sections of natural shoreline. Modification in this segment is in the upper intertidal/ splash zone. Uncertain of estimate of alongshore length of modification and a site visit would be required to confirm which properties have seawall or fill in the supratidal. Rock ramp on bedrock headlands included as natural shoreline.
Wave energy	Semi-exposed to Semi-protected
Supratidal and Upper Intertidal Features	Substrate: pebble/cobble beach face, with driftwood accumulated in the log line on the beach berm. Biota: scattered rockweed on larger cobble in mid-beach
Intertidal Features	Substrate: Natural pebble/cobble/boulder beach Biota: Rockweed, barnacle, oyster observed from skiff-survey, no on-the-ground observations in this segment

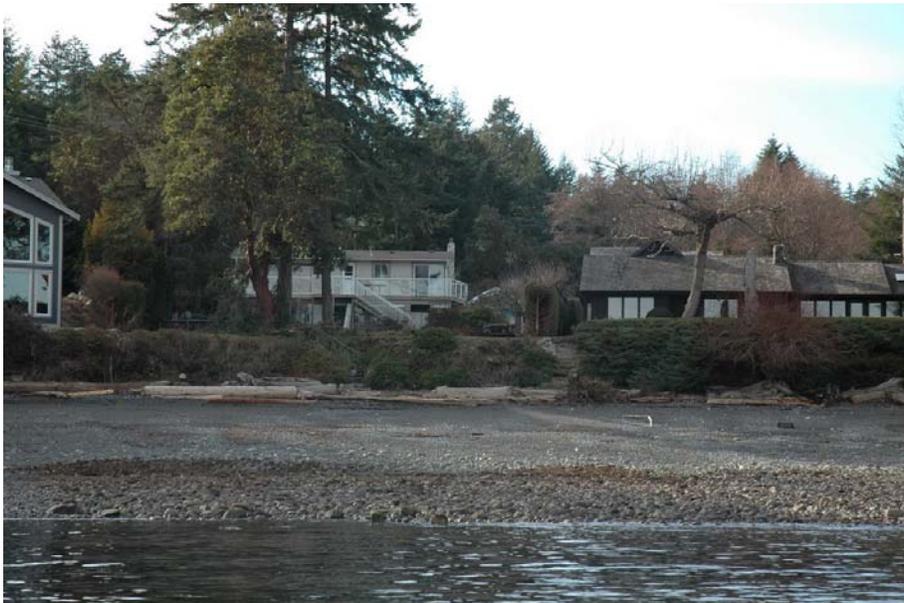
Figure 21: South pocket beach, showing vegetated scarp in supratidal zone (possibly natural?), pebble/cobble zonation on beach face and in mid-intertidal zone.

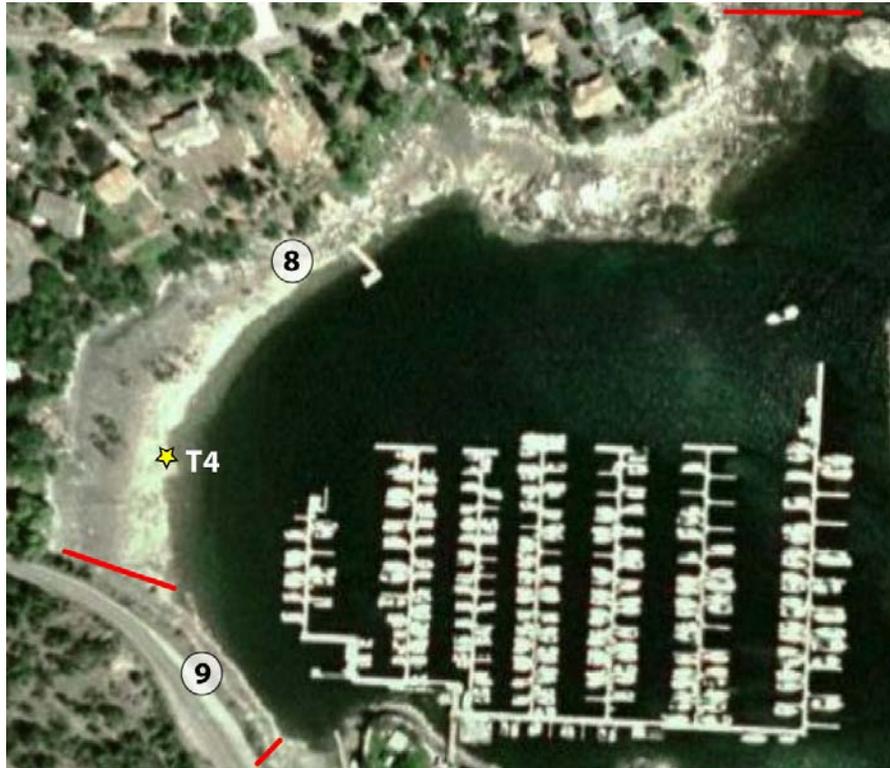
Figure 22: North and west shore of Schooner Cove, shoreline segment 8 and 9

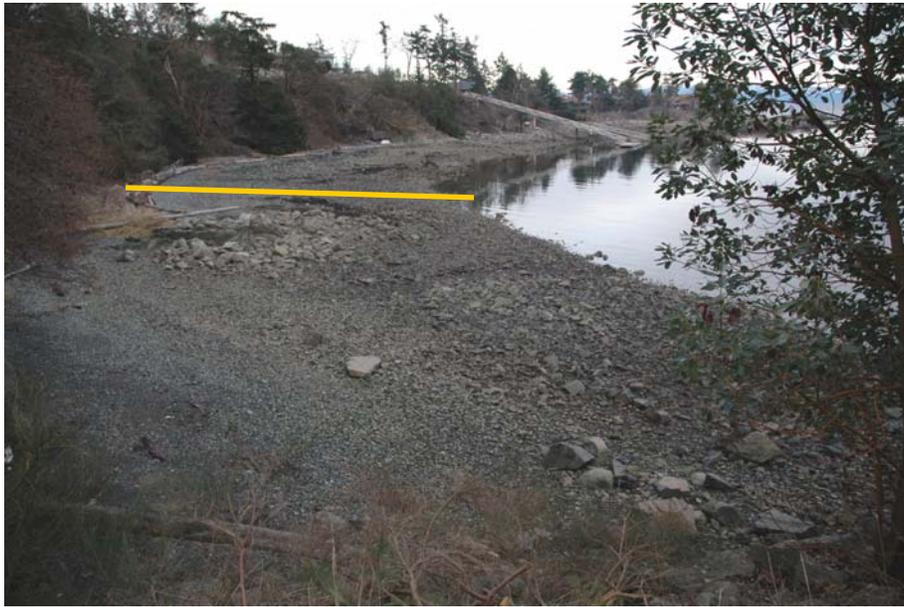
Figure 23: View from western end of north shore Schooner Cove, showing boulder/cobble/pebble beach, with steep, forested backshore. Approximate location of profile measured on Transect 4 indicated by dotted line.

Description	<p>The north shoreline of Schooner Cove is characterized in the eastern half by bedrock ramp (shallow sloped ledge) with the western half dominated by cobble/boulder/pebble beach. The backshore is steep, forested bank along the west half, and more than 50 m high along much of its length. Private properties with buildings occur along the segment, however all are setback from the natural boundary.</p> <p>Several docks and wharves are present and some partly cleared paths across the lower cobble beaches were seen, however the shoreline in the segment is largely unmodified.</p> <p>No public access was seen except from the roadway at the easternmost end of the segment.</p>
Wave energy	Semi-exposed (at the east end) to Semi-protected to the west, inside the Cove
Supratidal and Upper Intertidal Features	<p>Substrate: pebble/cobble with fines and driftwood in logline, natural bedrock ramps</p> <p>Biota: on beaches, patches of salt marsh vegetation in splash zone, dune grass and gumweed in the logline. East end of segment observed from skiff-survey, with no on-the-ground survey</p>

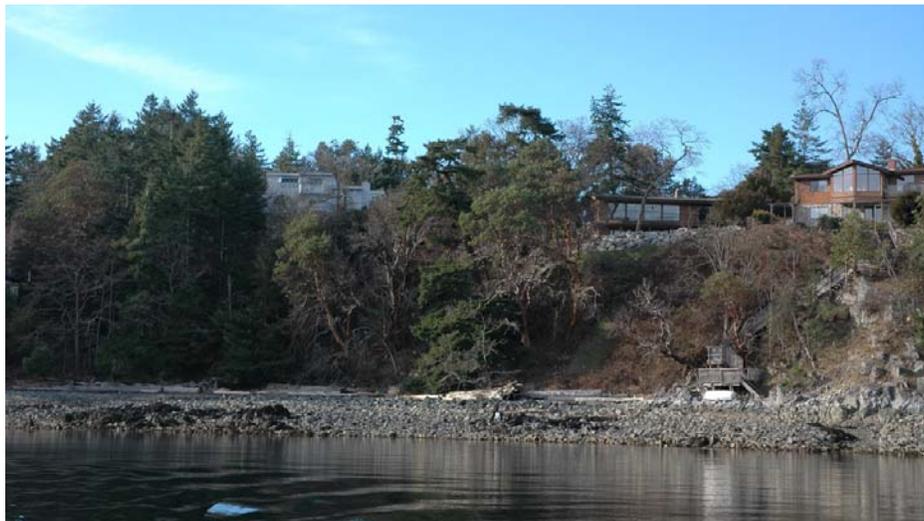
Figure 24: Steep forested backshore and cobble/pebble beach with bedrock outcrops, at the west end of north shore Segment 8 in Schooner Cove.

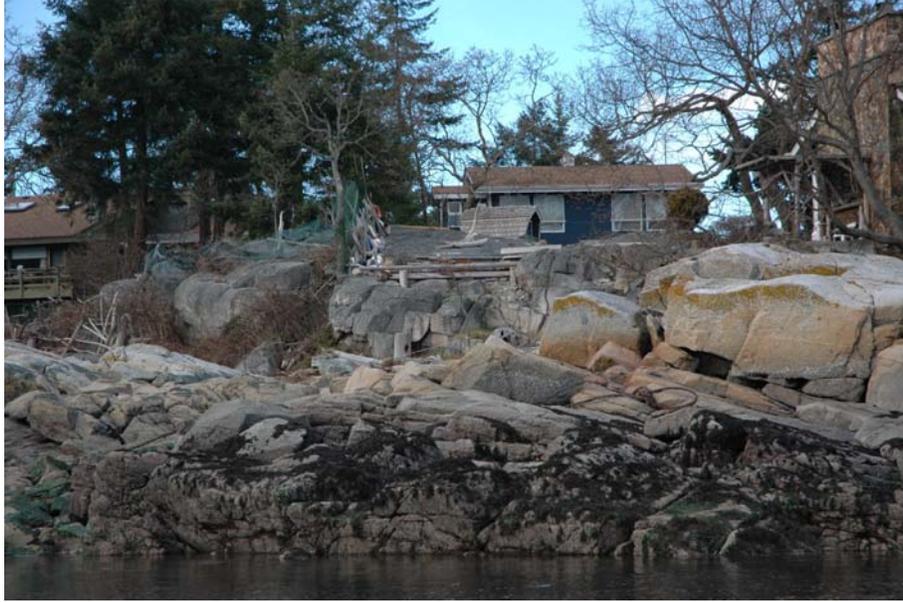
Figure 25: Natural bedrock ramp at east end of north shore Schooner Cove, with private residence building set back from the marine limit.

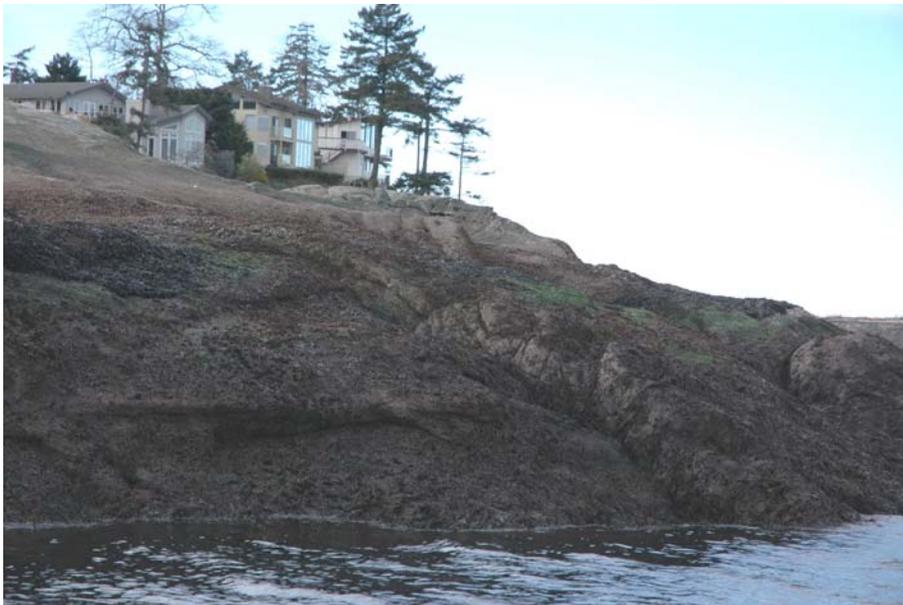
Figure 26: Bedrock ramp at north entrance to Schooner Cove. This section of the segment would be classified as semi-exposed wave energy.

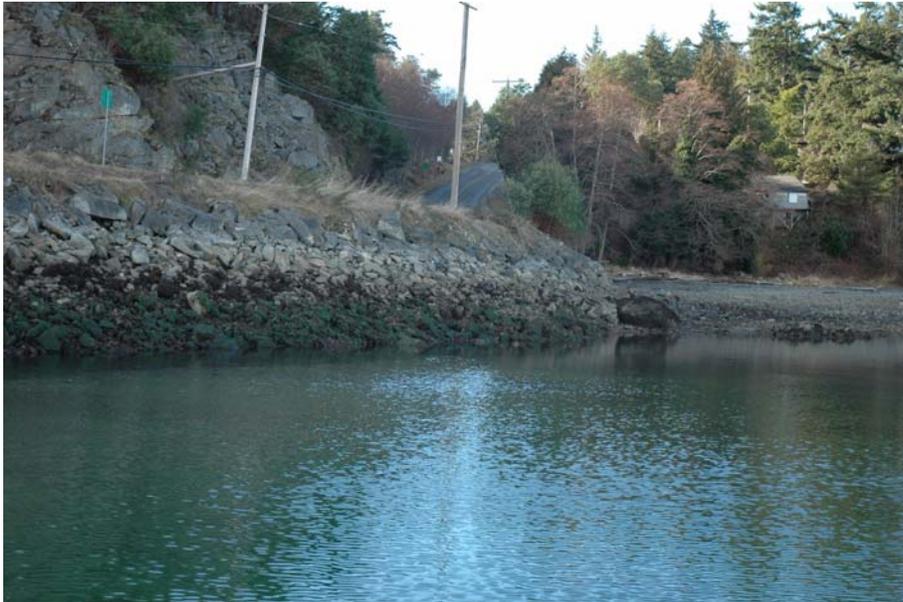
Figure 27: Steep riprap road bank at the west end of Schooner Cove in Segment 9.

Description	The riprap filled roadway along the west side of Schooner Cove, making the shoreline in the segment completely man-modified.
Wave energy	Protected
Supratidal and Upper Intertidal Features	Substrate: riprap and fill Biota: no riparian vegetation present. Upper intertidal has splash zone and barnacles.
Intertidal Features	Substrate: riprap and fill Biota: Rockweed, barnacle and green algae as seen from the skiff-based survey. No on-the-ground observations were made in this segment.
Nearshore Subtidal Features	Substrate: fines/shell hash Biota: scattered eelgrass, moon snail observed with bottom viewer
Figure	Figure 27
Transect	No transects were surveyed in this segment

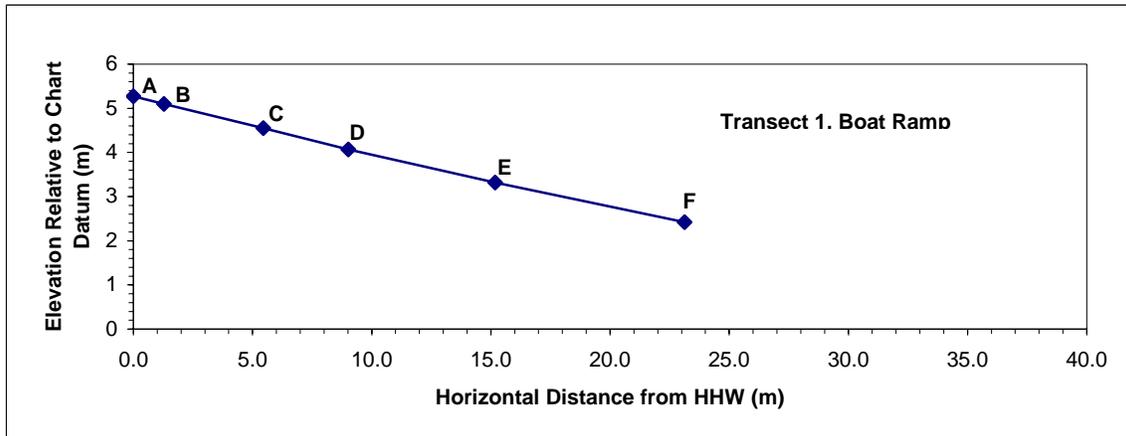
Transect 1. Schooner Cove, Boat Ramp Beach

Profile	Point	Cumulative Horizontal (m)	Cumulative Elevation (m)	Description of Point
Transect 1. Boat ramp beach	A	0.0	5.27	at marine limit
	B	1.3	5.10	top beach face
	C	5.5	4.55	mid beach face
	D	9.0	4.07	top boulder/cobble, top rockweed
	E	15.2	3.32	mid boulder/cobble, rockweed
	F	23.1	2.42	waterline at 12:52
Transect 2. Hotel corner	A	0.0	7.09	edge of hotel deck, concrete
	B	0.6	6.31	mid terrestrial grasses
	C	2.5	5.57	bottom terrestrial grasses, marine limit
	D	4.5	4.34	top barnacles, btm bare
	E	7.5	3.19	mid rockweed
	F	10.7	2.05	waterline at 13:37
Transect 3. Schooner House	A	0.0	7.41	terrestrial grass and moss
	B	1.5	6.40	lower grass and moss
	C	2.8	5.76	btm grass and moss, top riprap, marine limit
	D	4.3	4.70	mid bare riprap
	E	5.4	4.19	top rockweed, barnacle, btm bare
	F	6.8	3.21	mid rockweed
	G	9.7	1.90	waterline at 14:09
Transect 4. North shore beach	A	0.0	5.66	storm log line, marine limit
	B	3.3	4.85	btm log line, last HHW swash

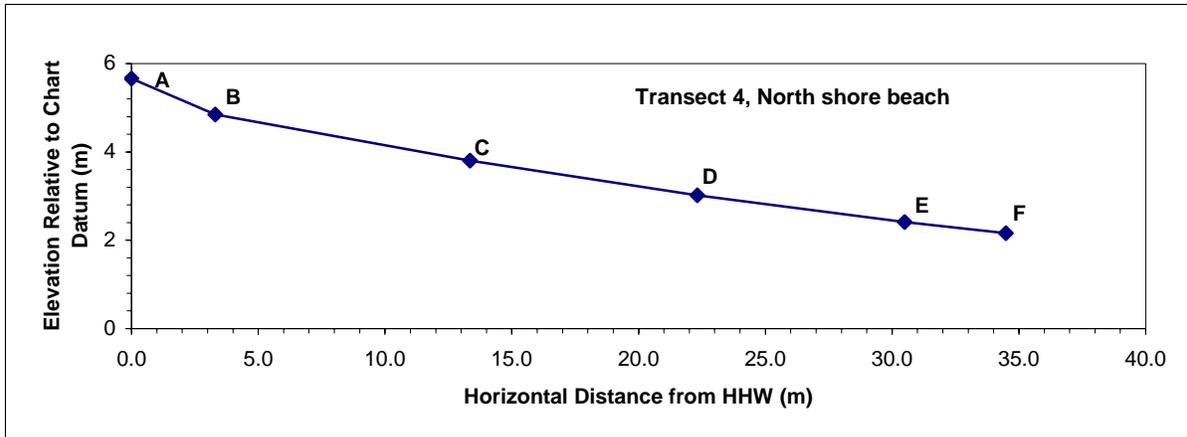
Transect 4. Schooner Cove, north shore beach.

C	13.3	3.80	top barnacle
	D	22.3	3.02	mid beach face
	E	30.5	2.41	mid beach face, abund oyster
	F	34.5	2.16	waterline at 16:12
