REGIONAL DISTRICT OF NANAIMO

Water Service Area Annual Report 2023

Melrose Terrace Water Service Area

June 2024

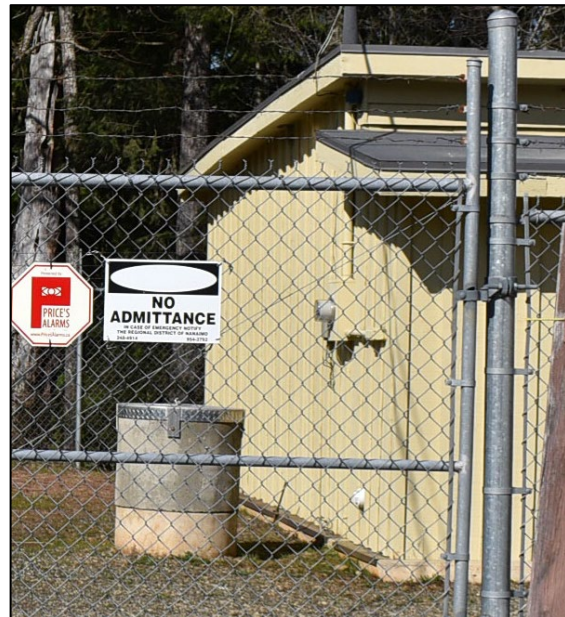
Melrose Well and Pumphouse

One groundwater production well is present at the reservoir site on Melrose Road, west of Coombs, B.C.

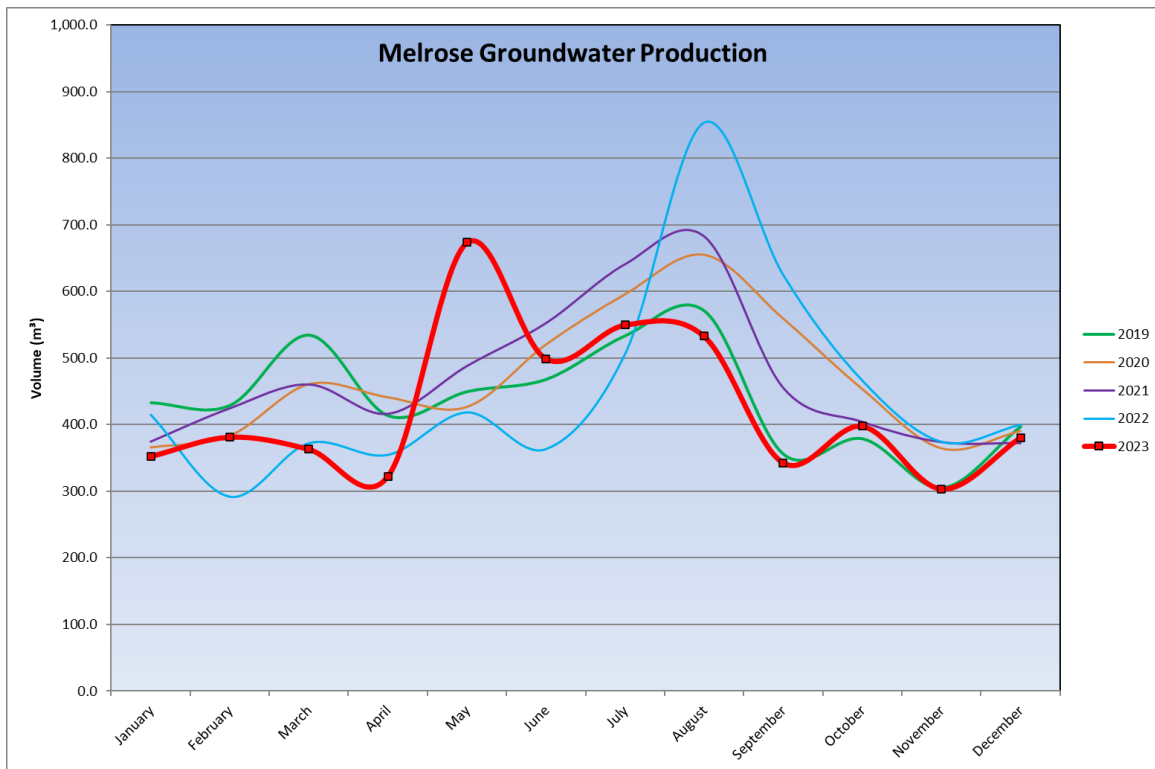
The monthly groundwater production in the Melrose system for the past 6 years is shown in the chart below.

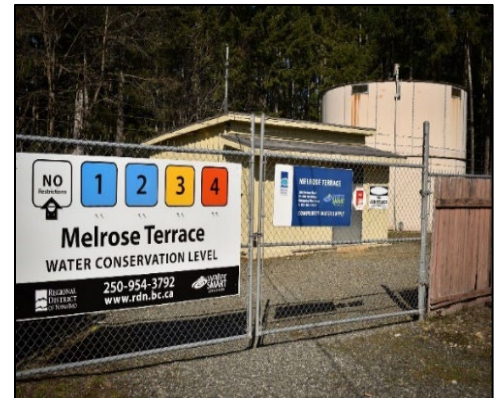
**Melrose
Pumphouse and
Reservoir**

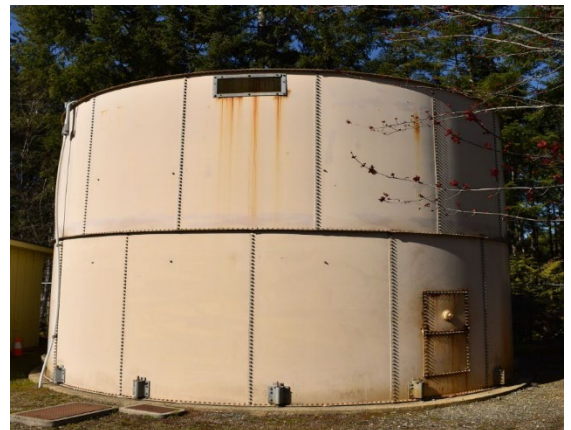
Melrose Water Storage Reservoir

One service reservoir (steel structure) is present at 3853 Melrose Road, and has a capacity of 136 m³ (30,000 imperial gallons).
