## REGIONAL DISTRICT OF NANAIMO Water Service Area Annual Report 2019

Surfside Water System

June 2020

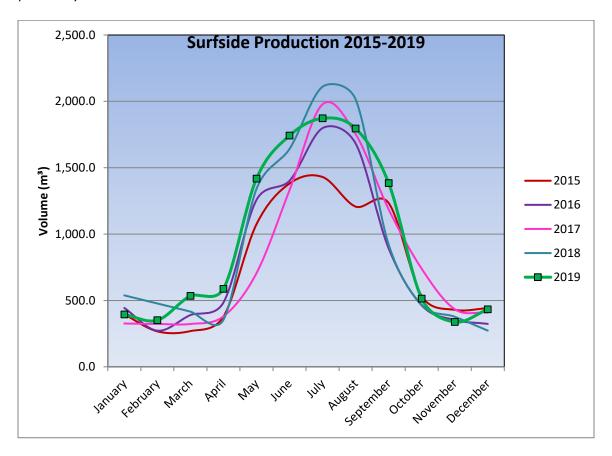
Monthly groundwater production in the Surfside Water Service Area for the past 5 years is shown in the chart below. Groundwater production in 2019 was about average in comparison to previous years.

In the Fall/Winter of 2019, the average usage per home in Surfside was 0.39 cubic metres per day (85.8 imperial gallons). In the summer, the average water usage was 1.31 cubic metres per day (288.2 imperial gallons). Based on these figures, the annual consumption per capita is estimated to be 294 L/day (based on 2.4 people/household). This consumption is 1% less than all the other RDN system averages of 295 L/day/capita in 2019.
