# APPENDIX C: HAZARD TREE ASSESSMENT

March 30, 2017

# Tree Risk Assessment Report – Beachcomber Regional Park

Walter Ernst, RPF (#4071), ISA Certified Arborist (PN-7288A),  
Certified Tree Risk Assessor (CTRA 1467)

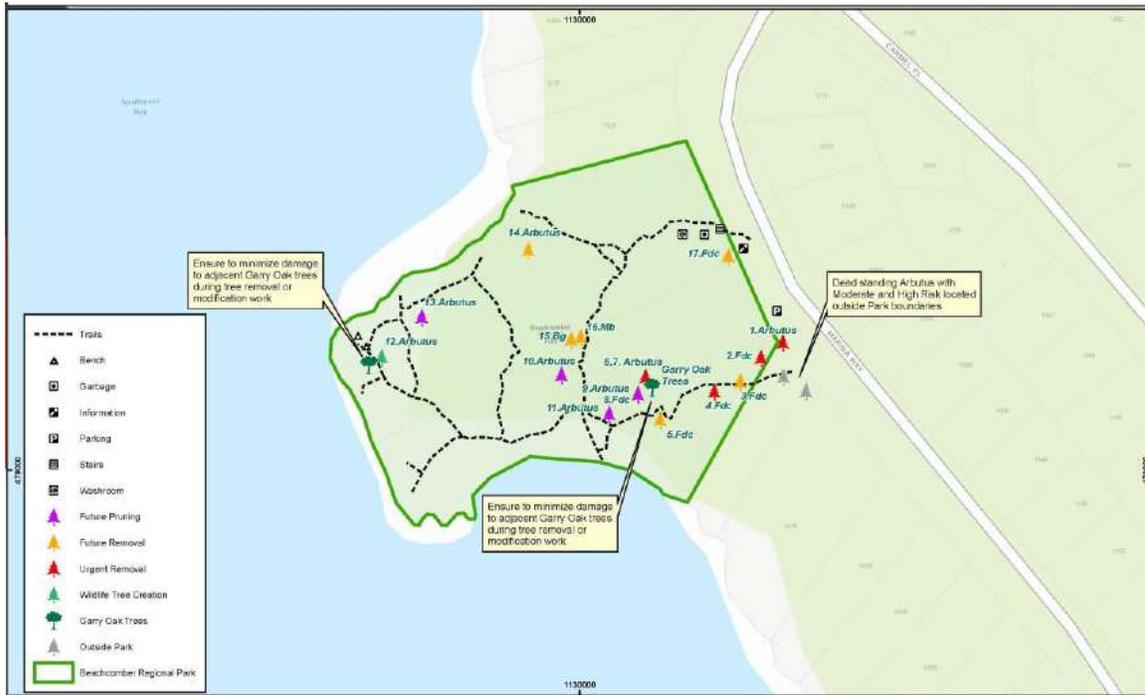
**Figure 5: Beachcomber Regional Park – Tree Risk Assessment Map**

Based on the tree assessment, 17 trees were identified for either ‘Urgent’ or ‘Potential Future’ treatment (9 Arbutus, 6 Douglas-fir, 1 grand fir and 1 bigleaf maple). The diameters of these trees averaged at 47cm, and the heights averaged at 14.7m. All trees were either in proximity to high consequence areas including the trail pathways, park benches, beaches, and parking lot. Refer to Figure 5 and Appendix II for the Tree Risk Assessment Map.

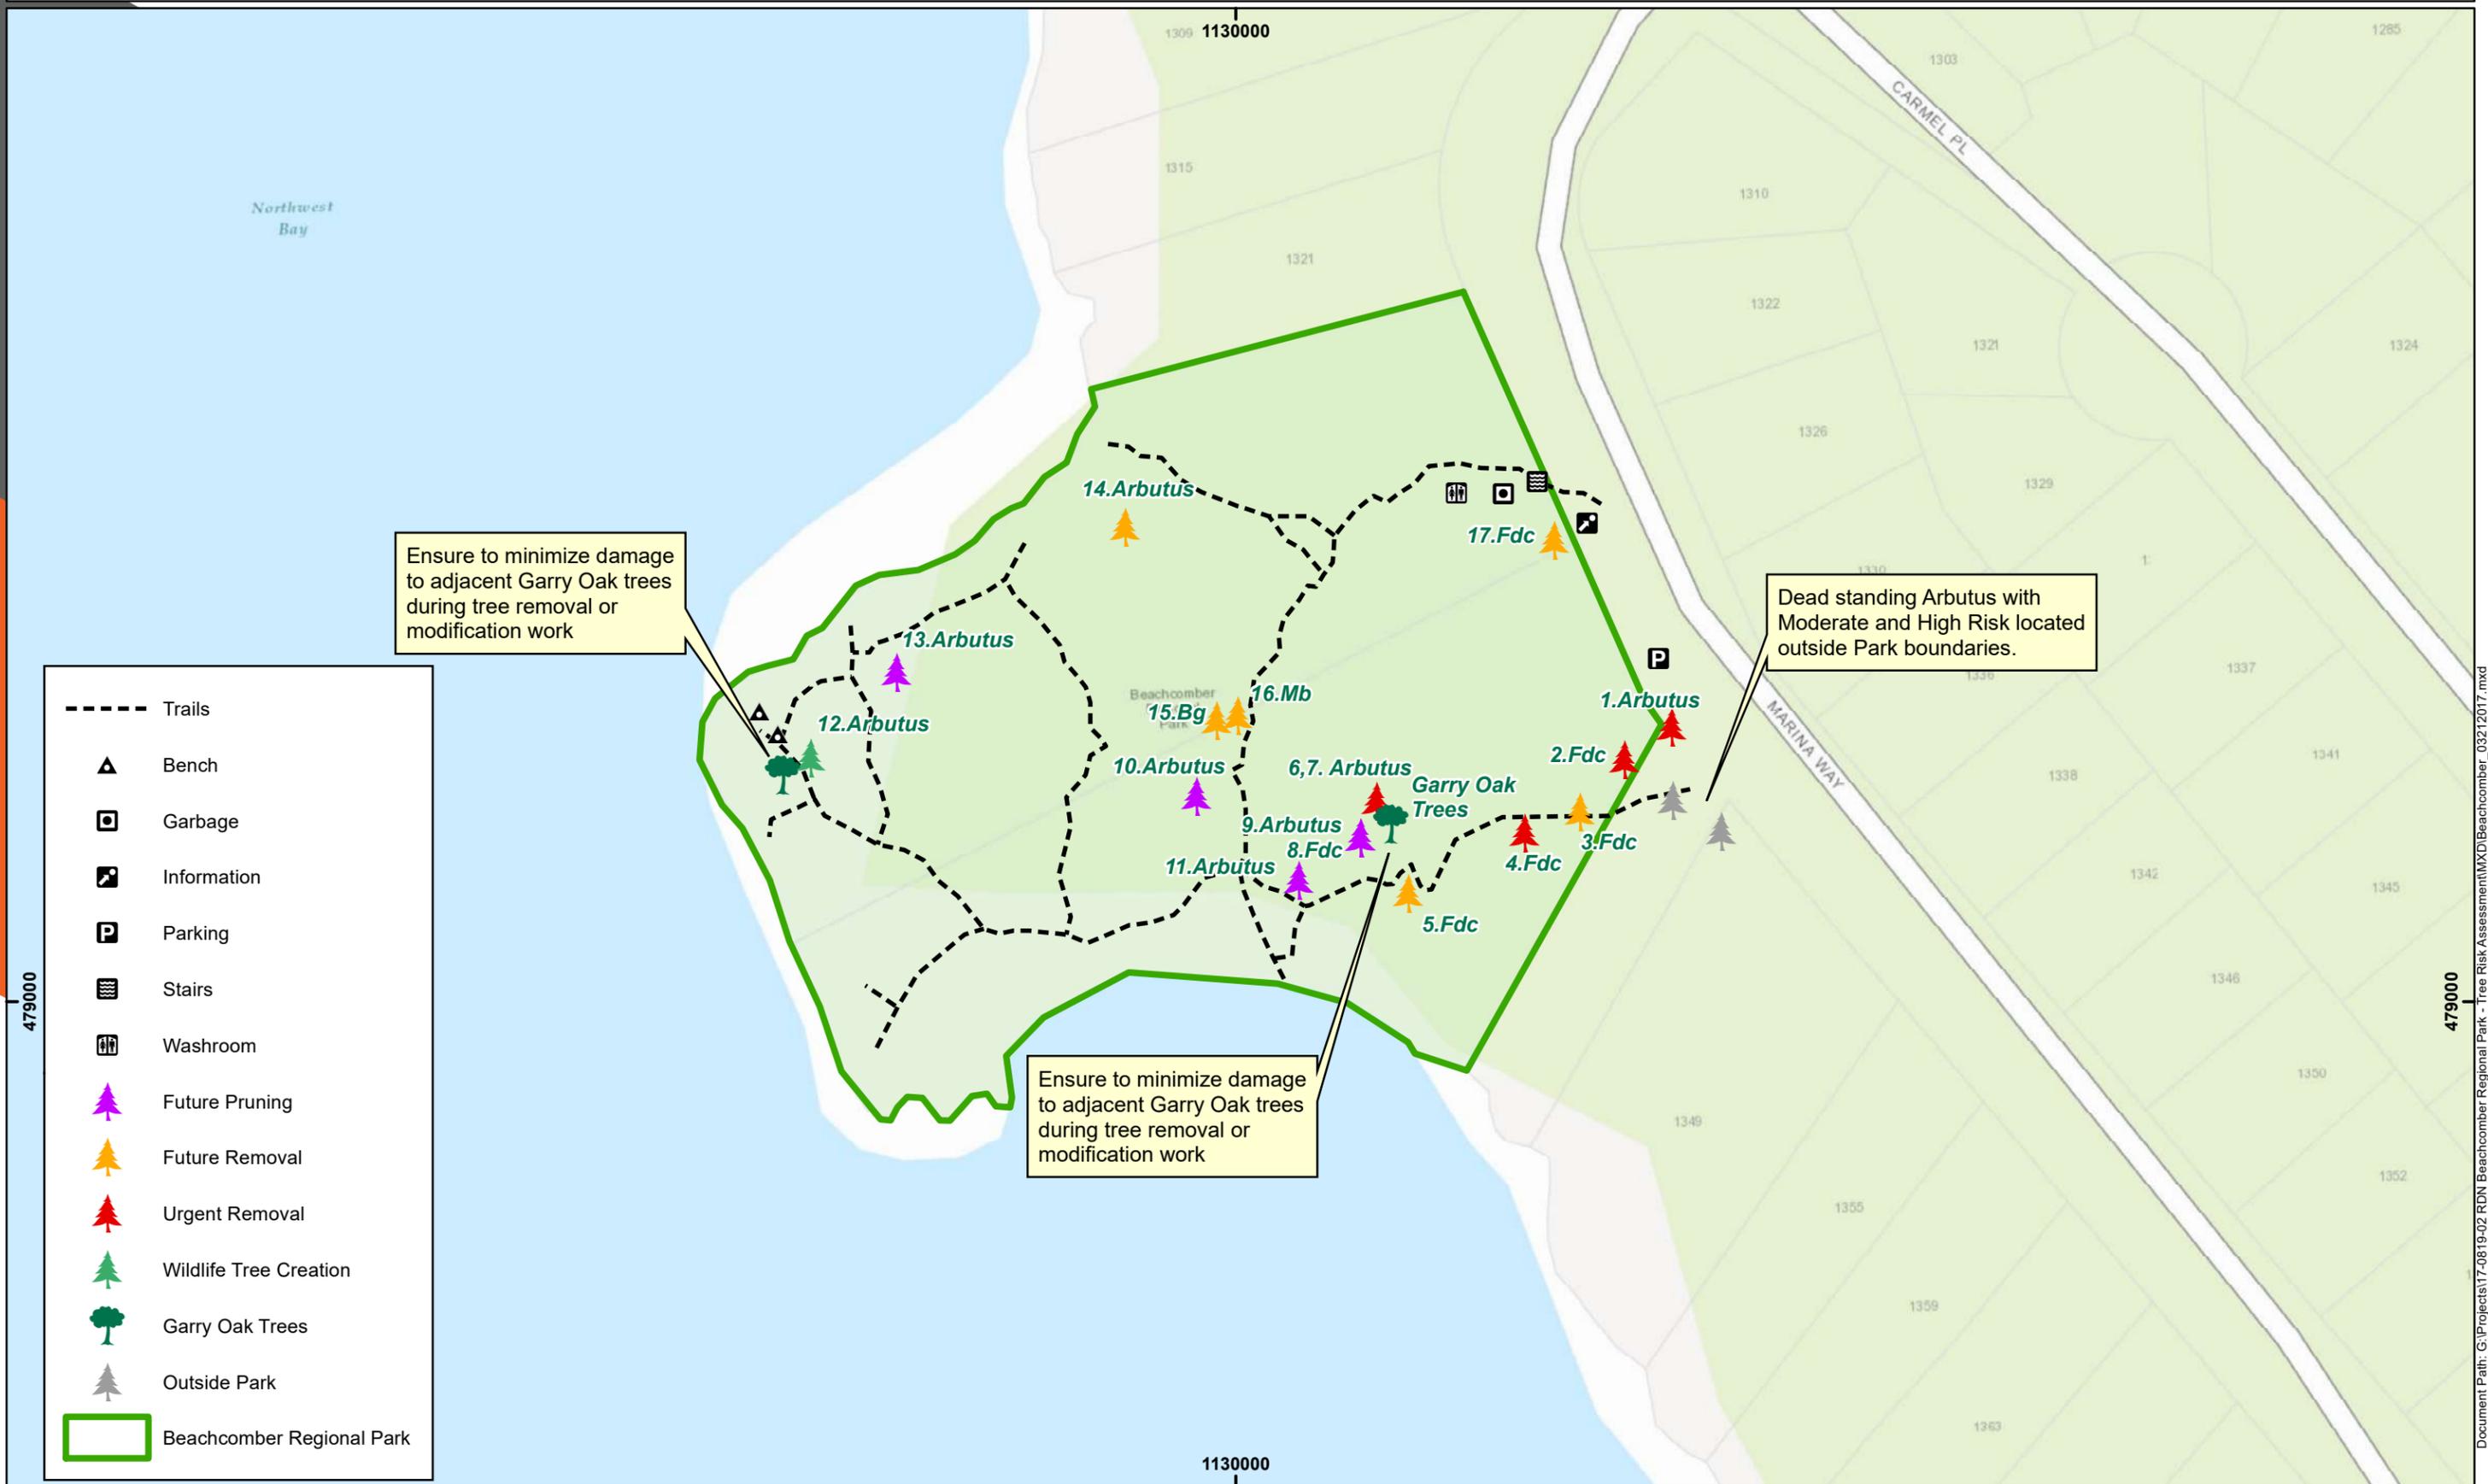
# Appendix II - Beachcomber Regional Park Tree Risk Assessment Map

Two additional dead Arbutus trees were noted outside the park boundary to the east and directly adjacent a trail pathway (refer to Tree Risk map for locations). These trees were not marked in the field. The two Arbutus pose moderate and high risks to trail users, have significant decay within the stems and roots, and are expected to fail within the next 1-2 years. If possible (through consultation with the applicable landowner), it is recommended these trees also be removed (either through directionally falling with a pull rope to avoid damage to neighboring trees or by piecing down) or topped to a level where they pose a lower risk.
