Nanaimo River Chinook Salmon Recovery Plan Habitat Assessment Report.

Fisheries and Oceans Canada
Nanaimo B.C.

December 2021

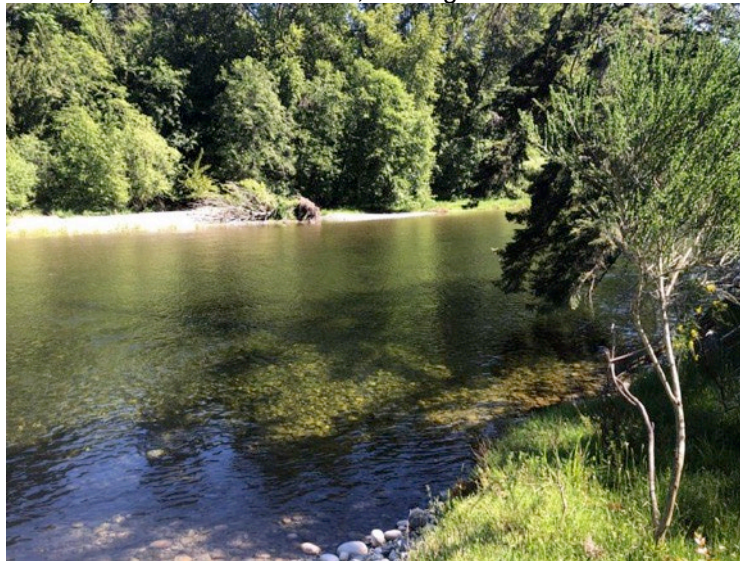
7.) Pool 2 is 309m long with good riparian depth but poor instream cover

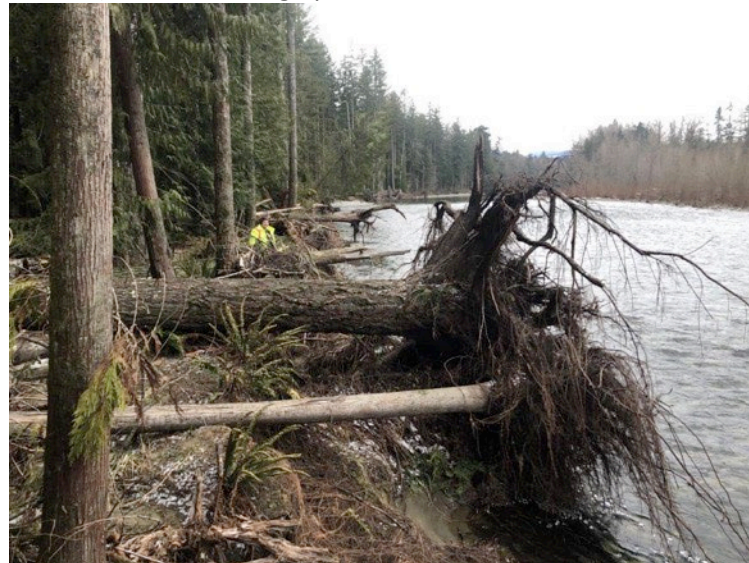
4.) Glide 4 in new route - tree/LWD swept aside.

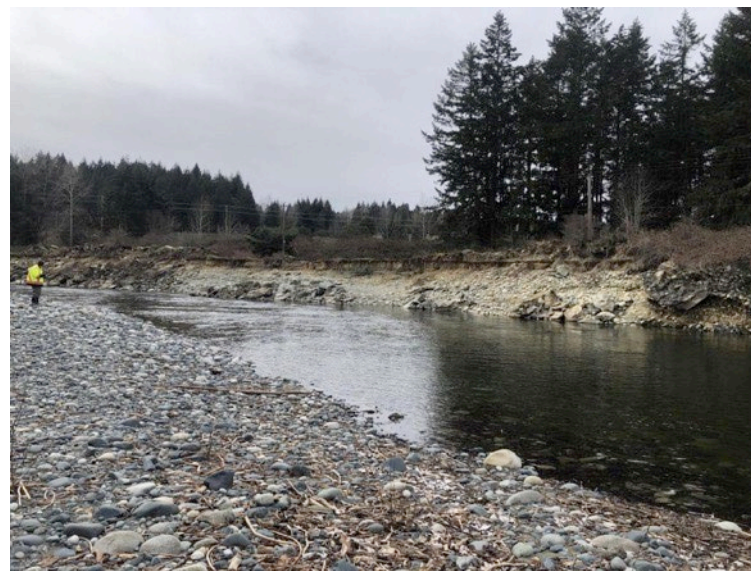
6.) Pool 2 – also showing LB erosion under trail/powerline

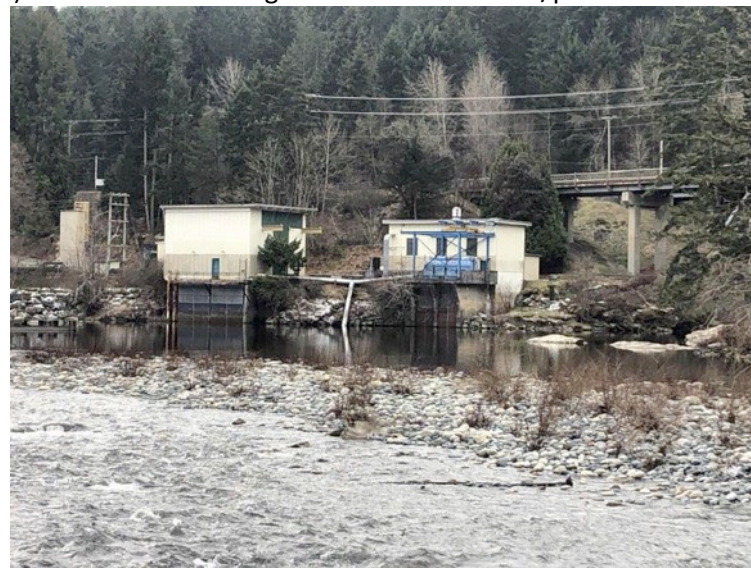
8.) Riffle 8 and Pool 4, pump house at end R4 at Hwy 1.

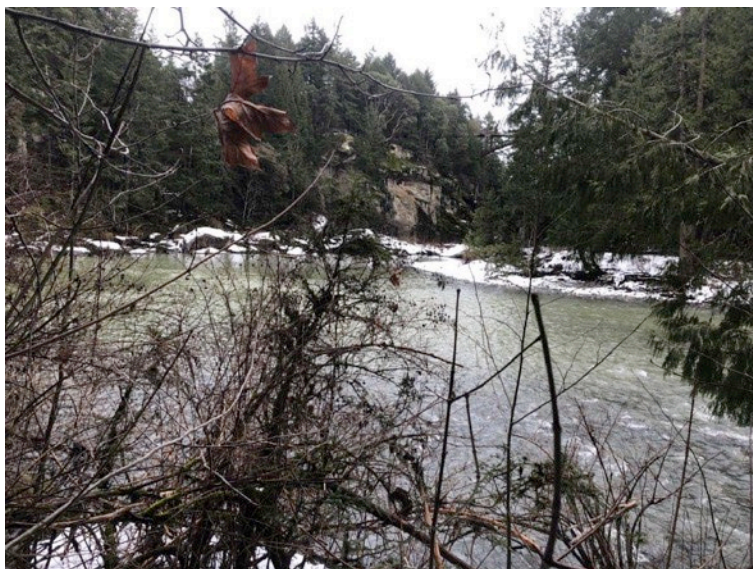
1.) R4-Pool 3 looking downstream to Bungy Zone/Hwy.

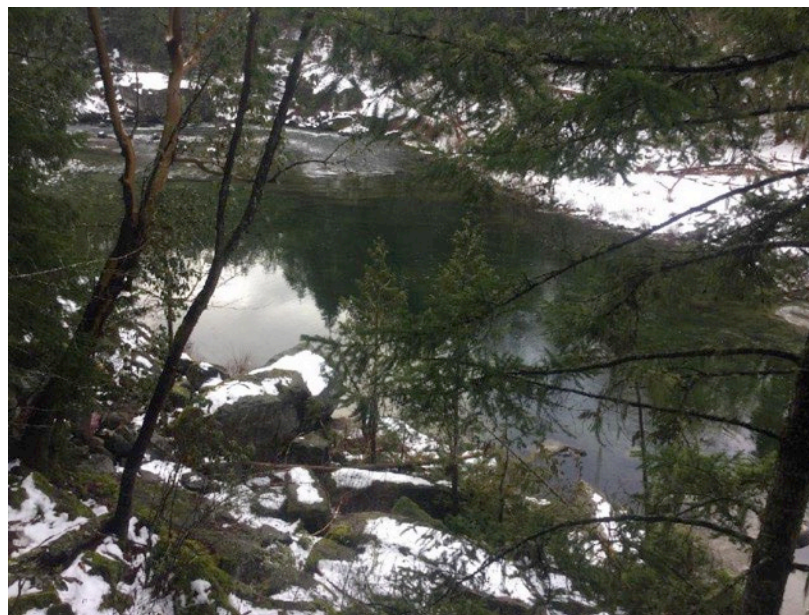
2.) R5 Pool 1 (below Hydro line) heading downstream – widest pool (73m) in R5

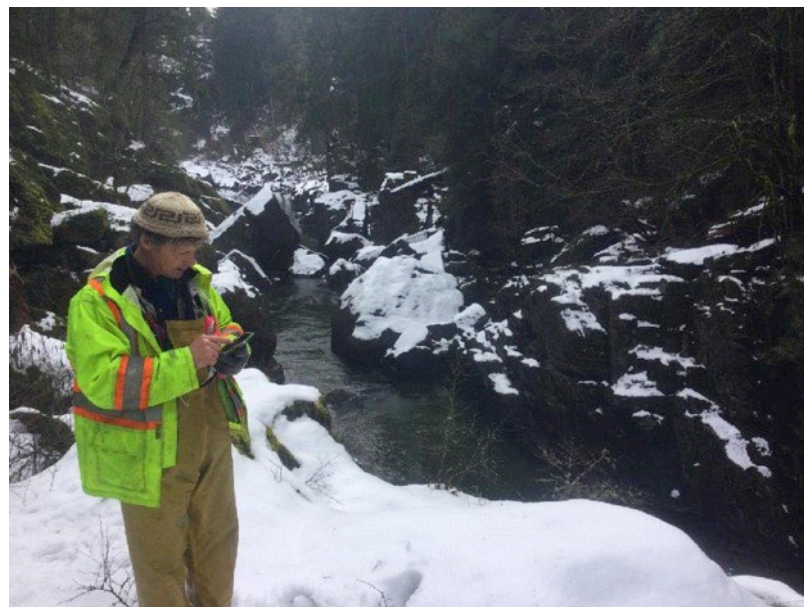
6) R5 - Glide 1 is 100m long narrow (23m) confined in bedrock.

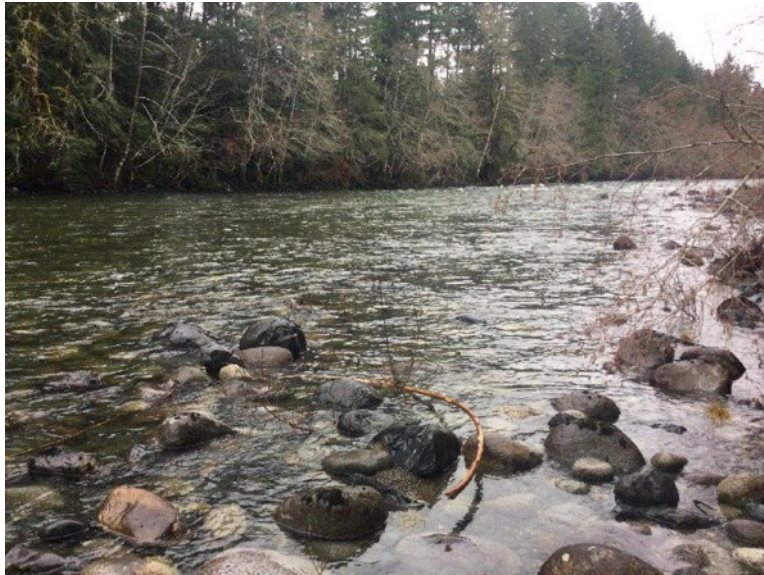
1.) R12- Glide 1 Boulder/cobble upstream at south bank

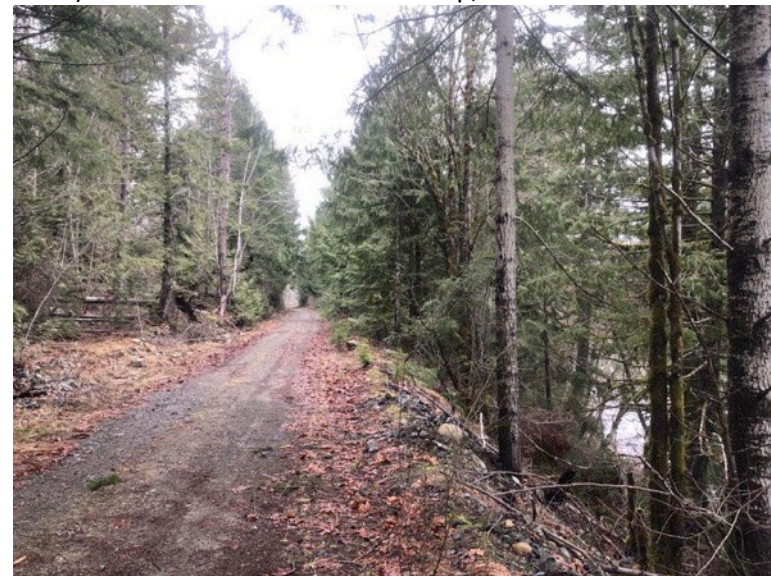
4.) R12 – Glide 4 -start of Rail grade in riparian

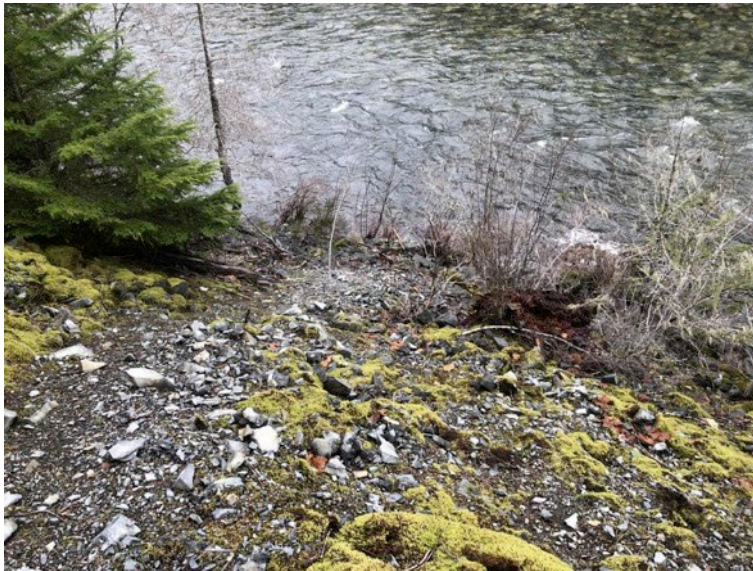
5.) R12- Slide track along rail grade needs planting

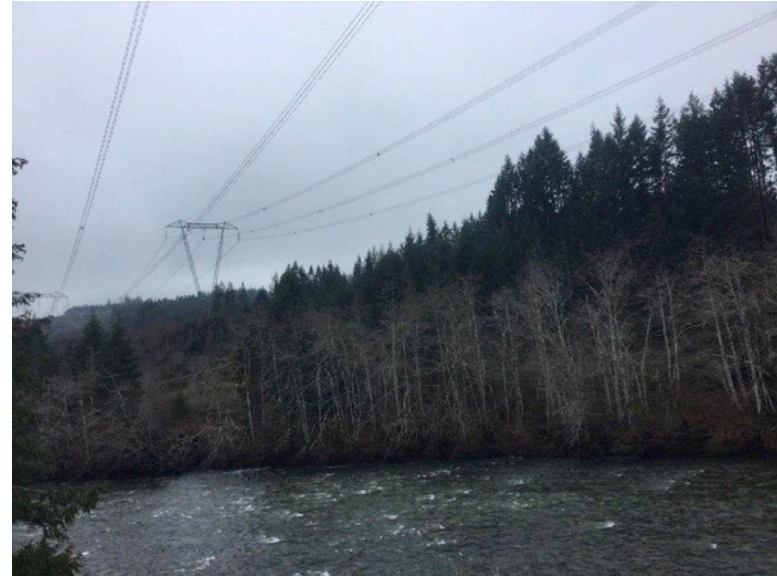
6.) R12- R2 Hydro Line crossing, Riparian is shrubbery/Alder.

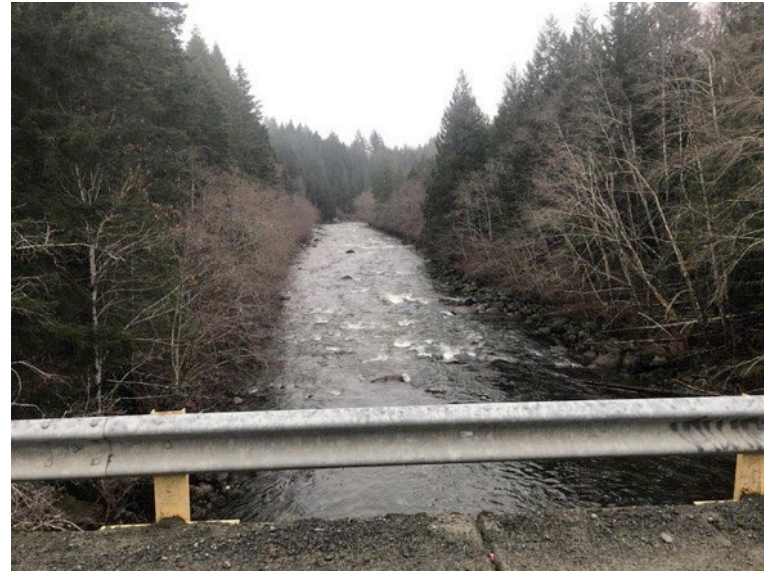
2.) R13 – At Jump Mainline Bridge looking at lower reach

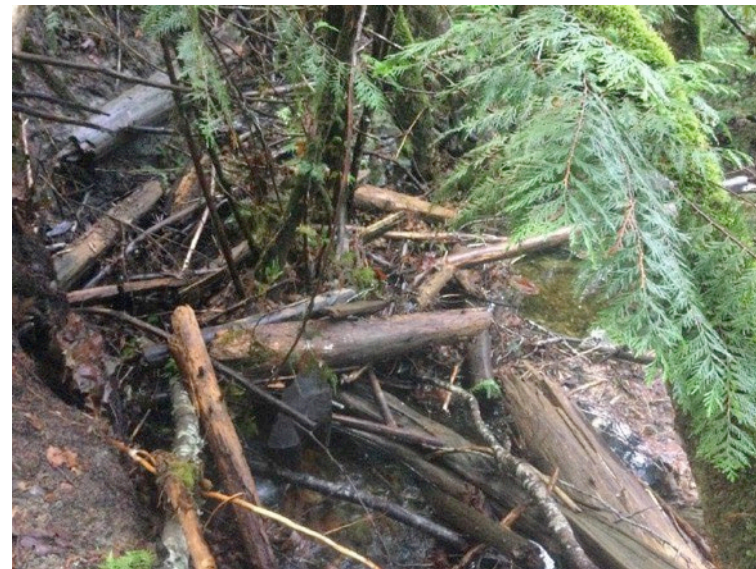
4.) R13 – Wolf Creek plugged culvert

- Erosion and Bank Stability scored Fair. There was 160m of bank erosion in this 2km reach (8%). The main type was trees falling in from undercut banks (i.e. Glide 2 Big Cedar) . The trees were lesser strength second growth (60-80 yrs) and it was more evident in areas where the channel had head cut. The old rail grade culverts are sources of sediment; there was a failure at Pool 3 with loss of fill. Wolf Creek culvert is a concern.

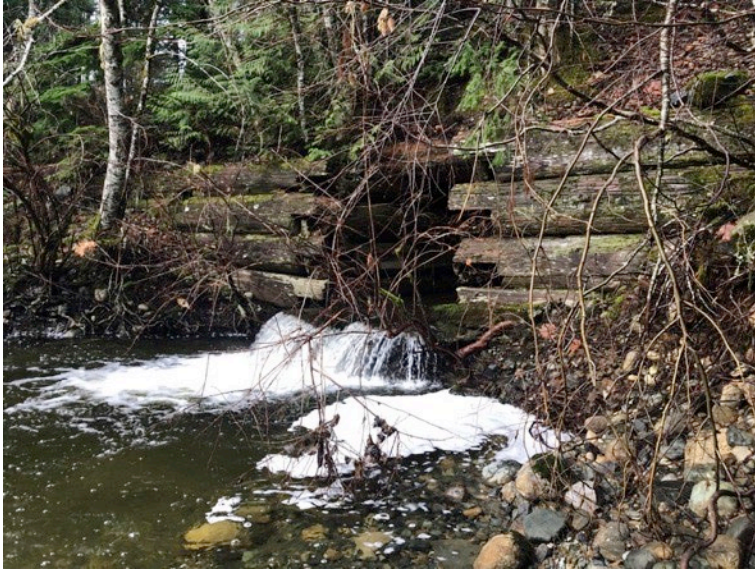
1.) Wolf Creek culvert

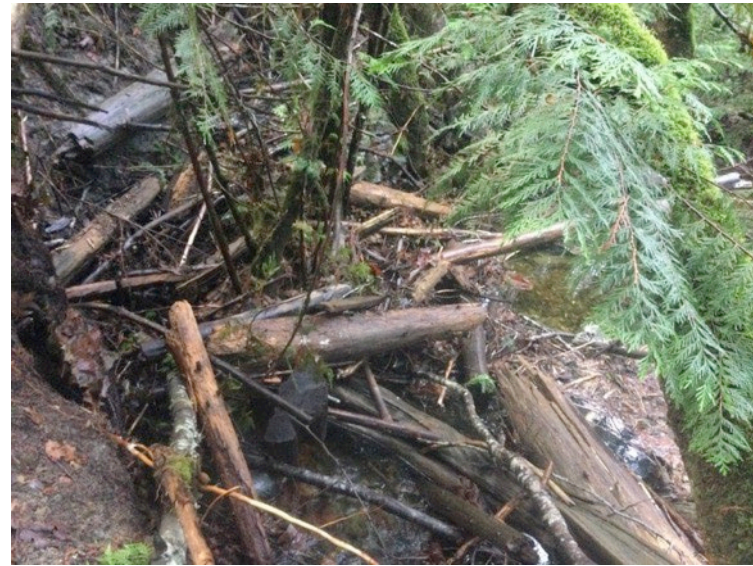
2.) Wolf Creek culvert log Jam

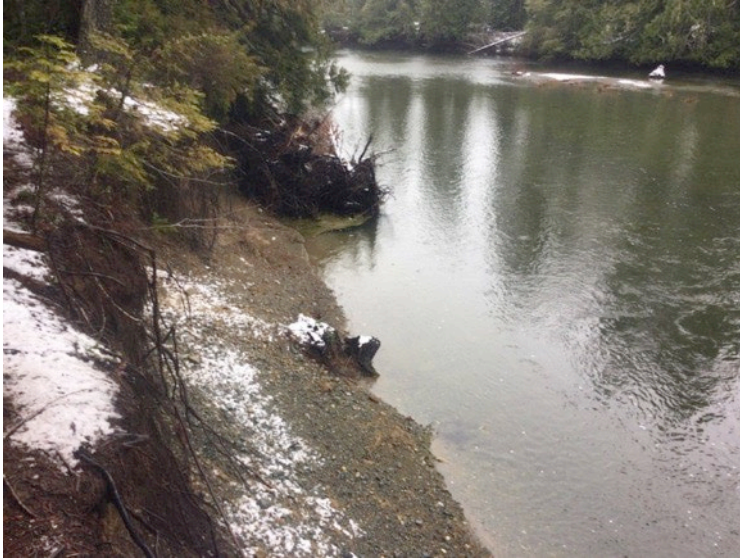
5.) R14-Glide 2 – 20m left bank erosion

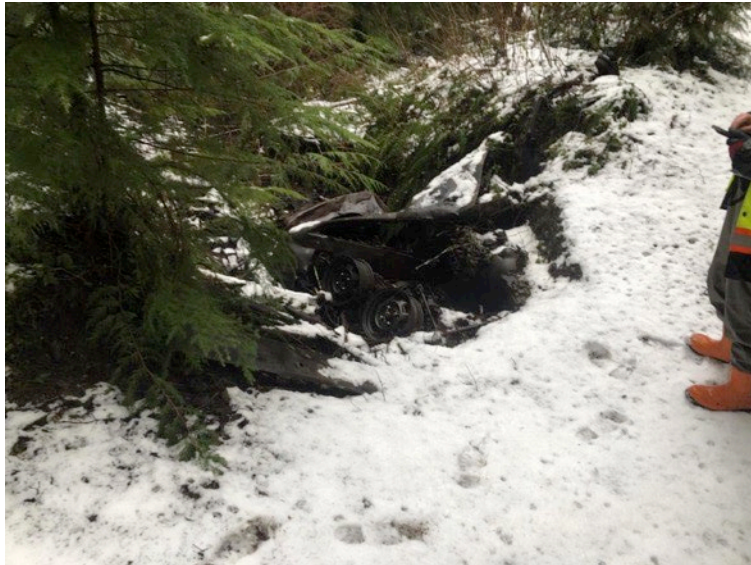
7.) P4- Plugged culvert along rail grade with old car body debris

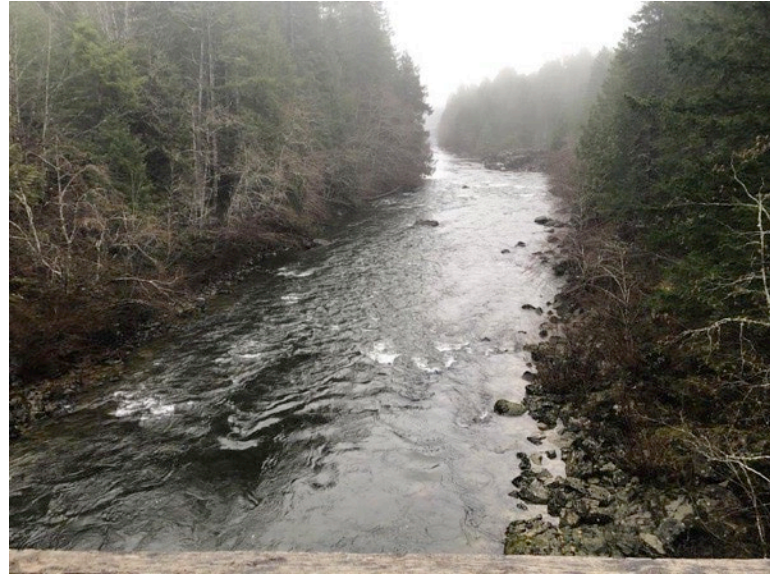
2.) R16 – Riffle 1 looking off Bridge

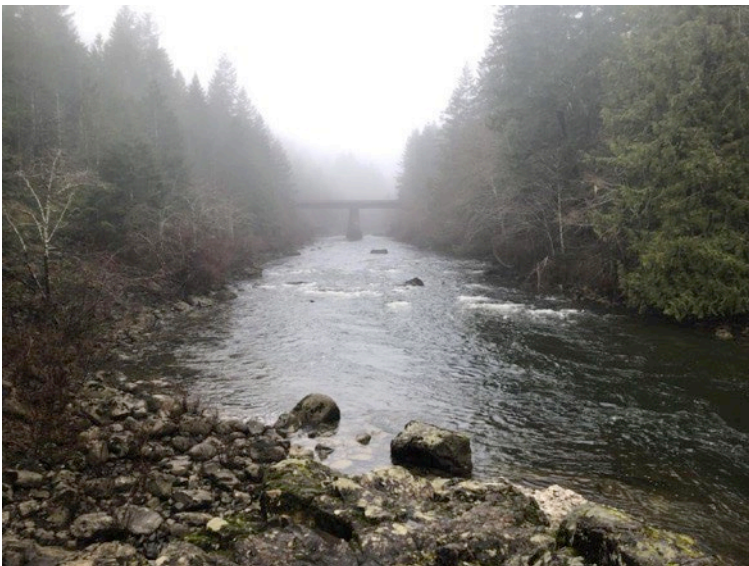
3.) R16 R1 looking up at Bridge with centre span in channel

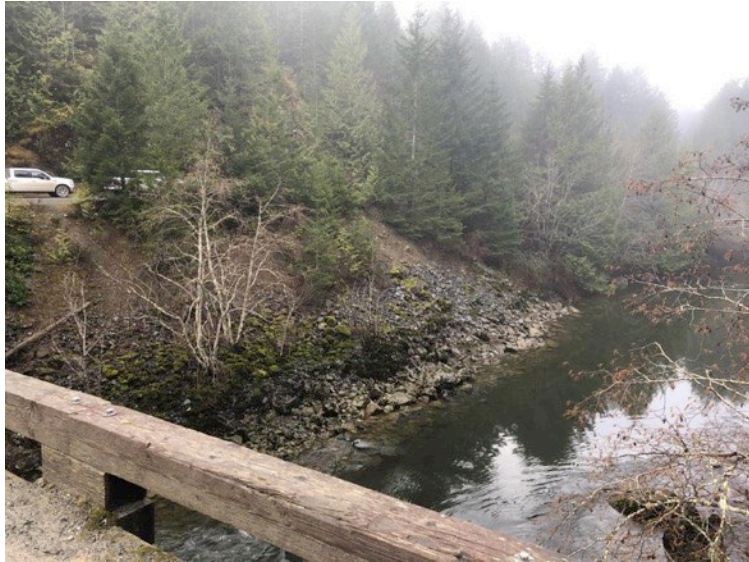
1.) Spawning Gravel placement – possible access site.

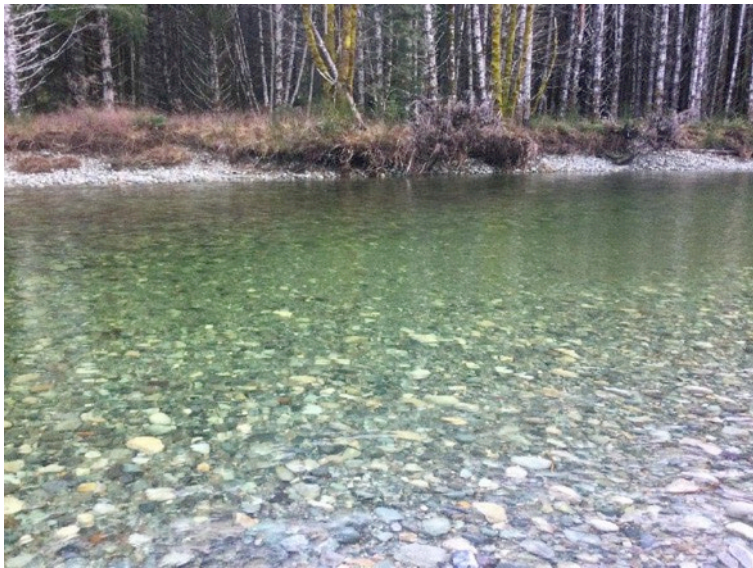
3.) R22 Right bank (Stn 33) erosion and undercutting trees.

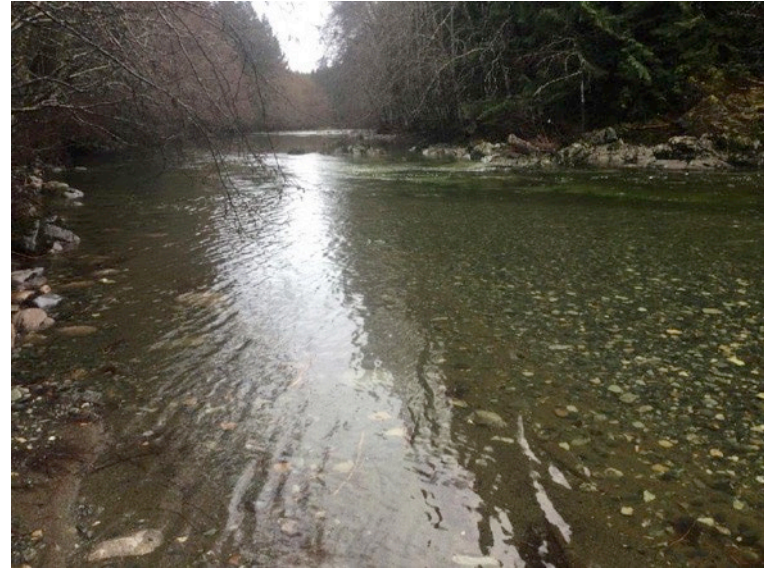
2.) R23 – Pool 1 is the only pool and lacks cover.

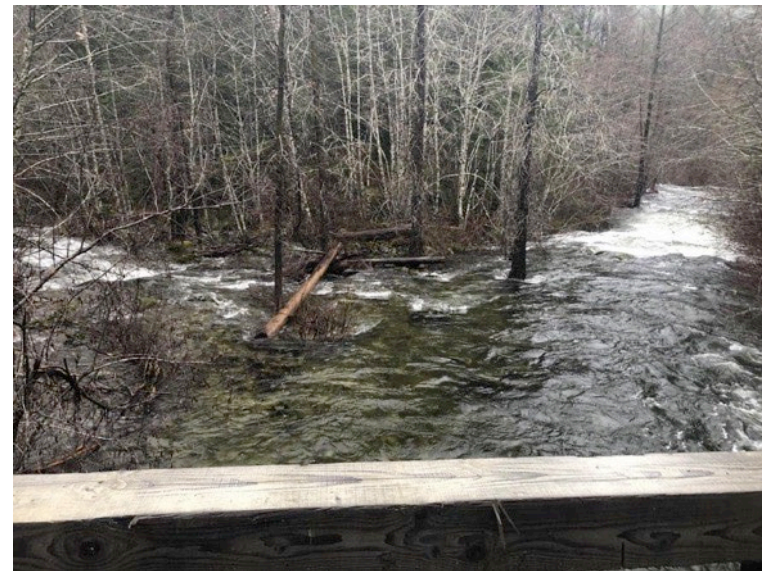
4.) R23 – Sadie Creek at Bridge is flowing through floodplain.

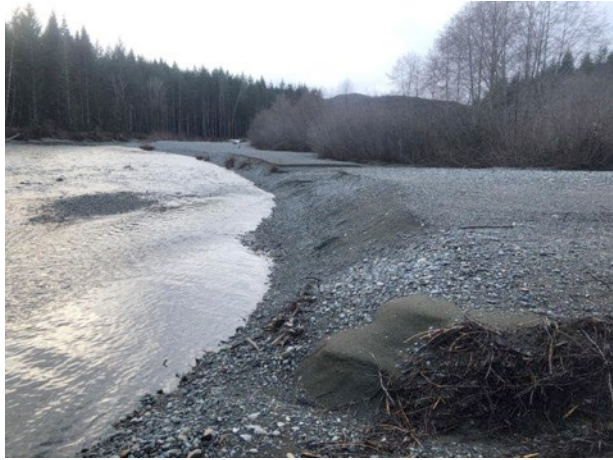
- Cover – Lack of cover throughout the reach was evident. The only functional cover was Boulders.
- Erosion – There is significant bank failure in the upper reach area resulting in loss of riparian forest and a 400m long deposition bar. There is bank erosion on 20% of the survey length. The erosion is caused by flood scour into weak gravel banks. There are many trees along the banks but the second growth Douglas Fir do not have adequate root development to resist the erosion. Several old growth Red Cedar stumps still remain on the river left bank as examples of the greater flood erosion resistance that old trees have.

- Erosion - The large deposition fan is the product of several influences; Green Creek enters 100m upstream and the trail of debris from the creek makes it an obvious supply of sediment. The main fan in the reach is 400m long and over 100m wide. The sediment deposition is increasing the erosion on the right bank of the mainstem. The fan is recommended to be live staked and planted to stabilize the sediment.

Reaches 2, 3 and 22 had Poor scores for erosion. They had 55%, 33%, and 20% respectively of their reach lengths with bank erosion. These reaches had banks of gravel with inadequate tree root protection. The banks were weak as they were not intertwined with tree roots that bind healthy

Reach 22 erosion/deposition bar

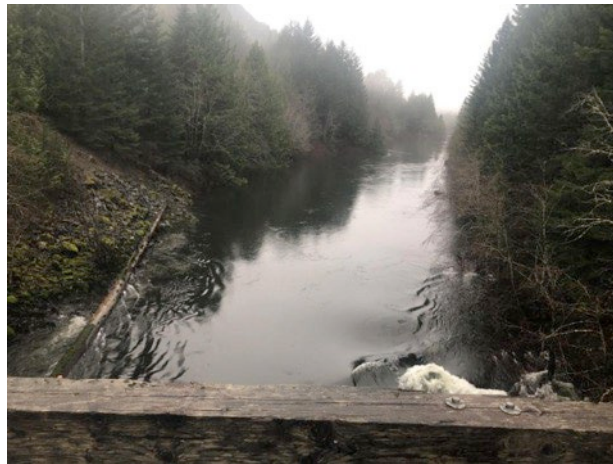
Alteration features in the river were relatively few but significant (Poor) in Reaches 3 and 16. Reach 3 has a 435m long alteration of the south bank from the concrete and rock Pulp Mill water intake infrastructure. This site has virtually no trees and no natural stream bank. Reach 16 above First Lake has a bridge footing and associated dredging and 80m of bank armoured.

Reach 16 has 80m armoured bank at bridge.
