Bentall
Kennedy

Draft Report
The Lakes District and Schooner Cove ISMP

October 3, 2013

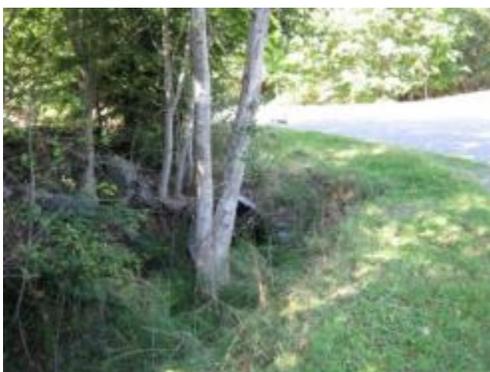
Enos Creek (S1), flows out of Enos Lake and Enos Wetland W1. The creek is about 1.5 m to 2 m wide and flows through a well-defined bedrock gully. Significant wood debris is in the channel, which most likely remains from a beaver dam breach about 13 years ago. The stream downstream of the beaver dam shows signs of erosion.

Enos Creek (S1) at Swallow Rd and Dolphin Drive looking upstream at 1,500 mm dia

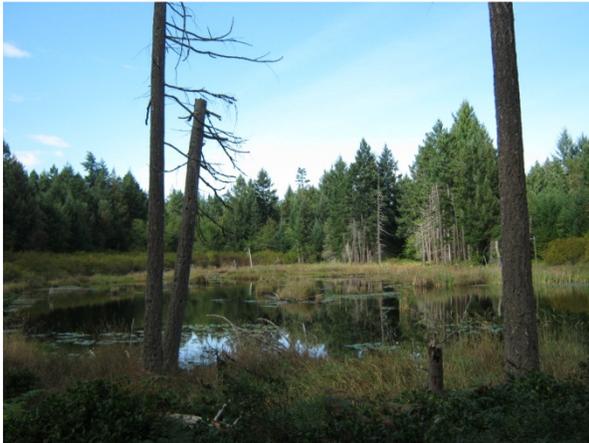
Wetland W2 on Stream S3

Stream S3 flows out of **Wetland W2** on the south-west side of Enos Lake. This wetland is located high on a bedrock ridge above the lake. The pond was formed when peat was excavated from the area and the water level has been raised about 0.5 m by a beaver dam at the outlet. There were no signs of recent beaver activity or active erosion or instability of the dam. The stream flowing out of the wetland flows over an exposed bedrock meadow and over a cliff into the lake.

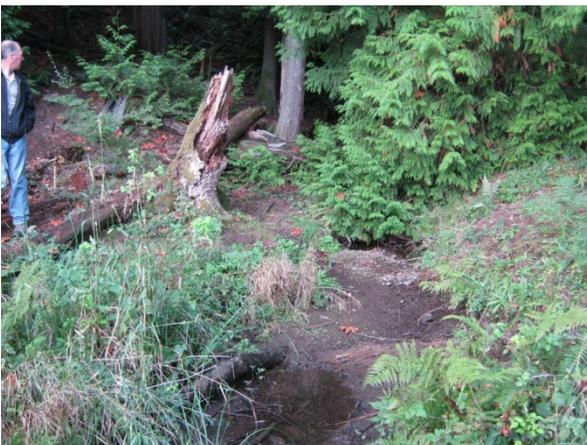
Stream S6 near Outlet to Lake

Stream S6 flows out of Wetland W4 and outlets over a 5 m high bedrock waterfall to Enos Lake. It is approximately 1 m wide and about 0.5 m deep and flows down a well-defined bedrock valley. The banks of the channel are cut into cohesive clay and glacial till soils and appear to be resistant to erosion. The banks are well vegetated, except where the stream flows through cedar groves.

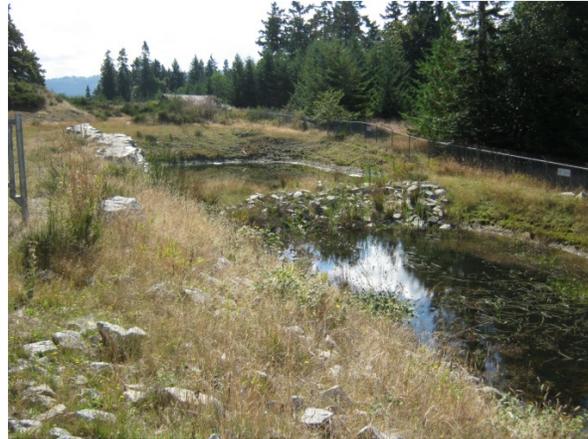
Wetland W7 flows into Enos Lake. No erosion or stability concerns were observed. There are existing stormwater detention ponds located upstream (south) of Wetland W7.

Existing stormwater detention ponds south of Fairwinds Drive

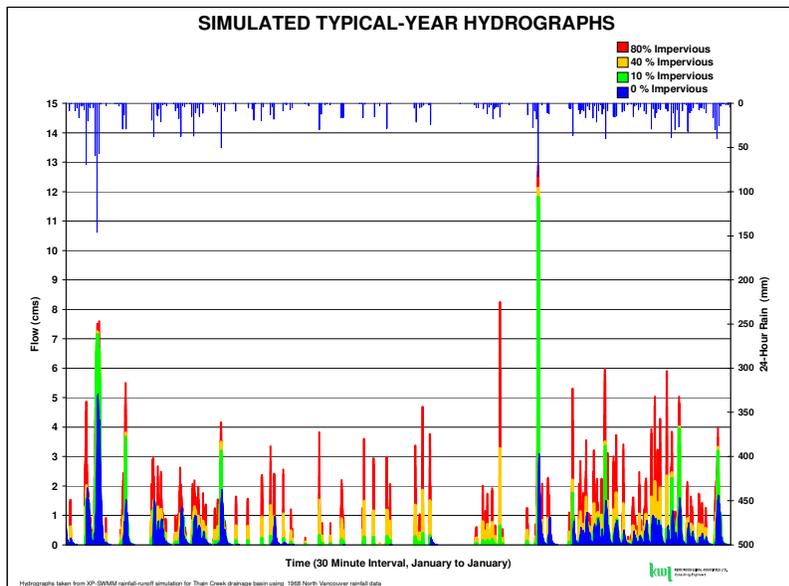
Prior to land development, minor rainfall events do not yield surface runoff. However, because of increased impermeable area, surface runoff from these minor storms is produced after land development. This is clearly shown in the typical-year hydrograph for various levels of development.

Simulated Typical-Event Hydrograph for Levels of Imperviousness

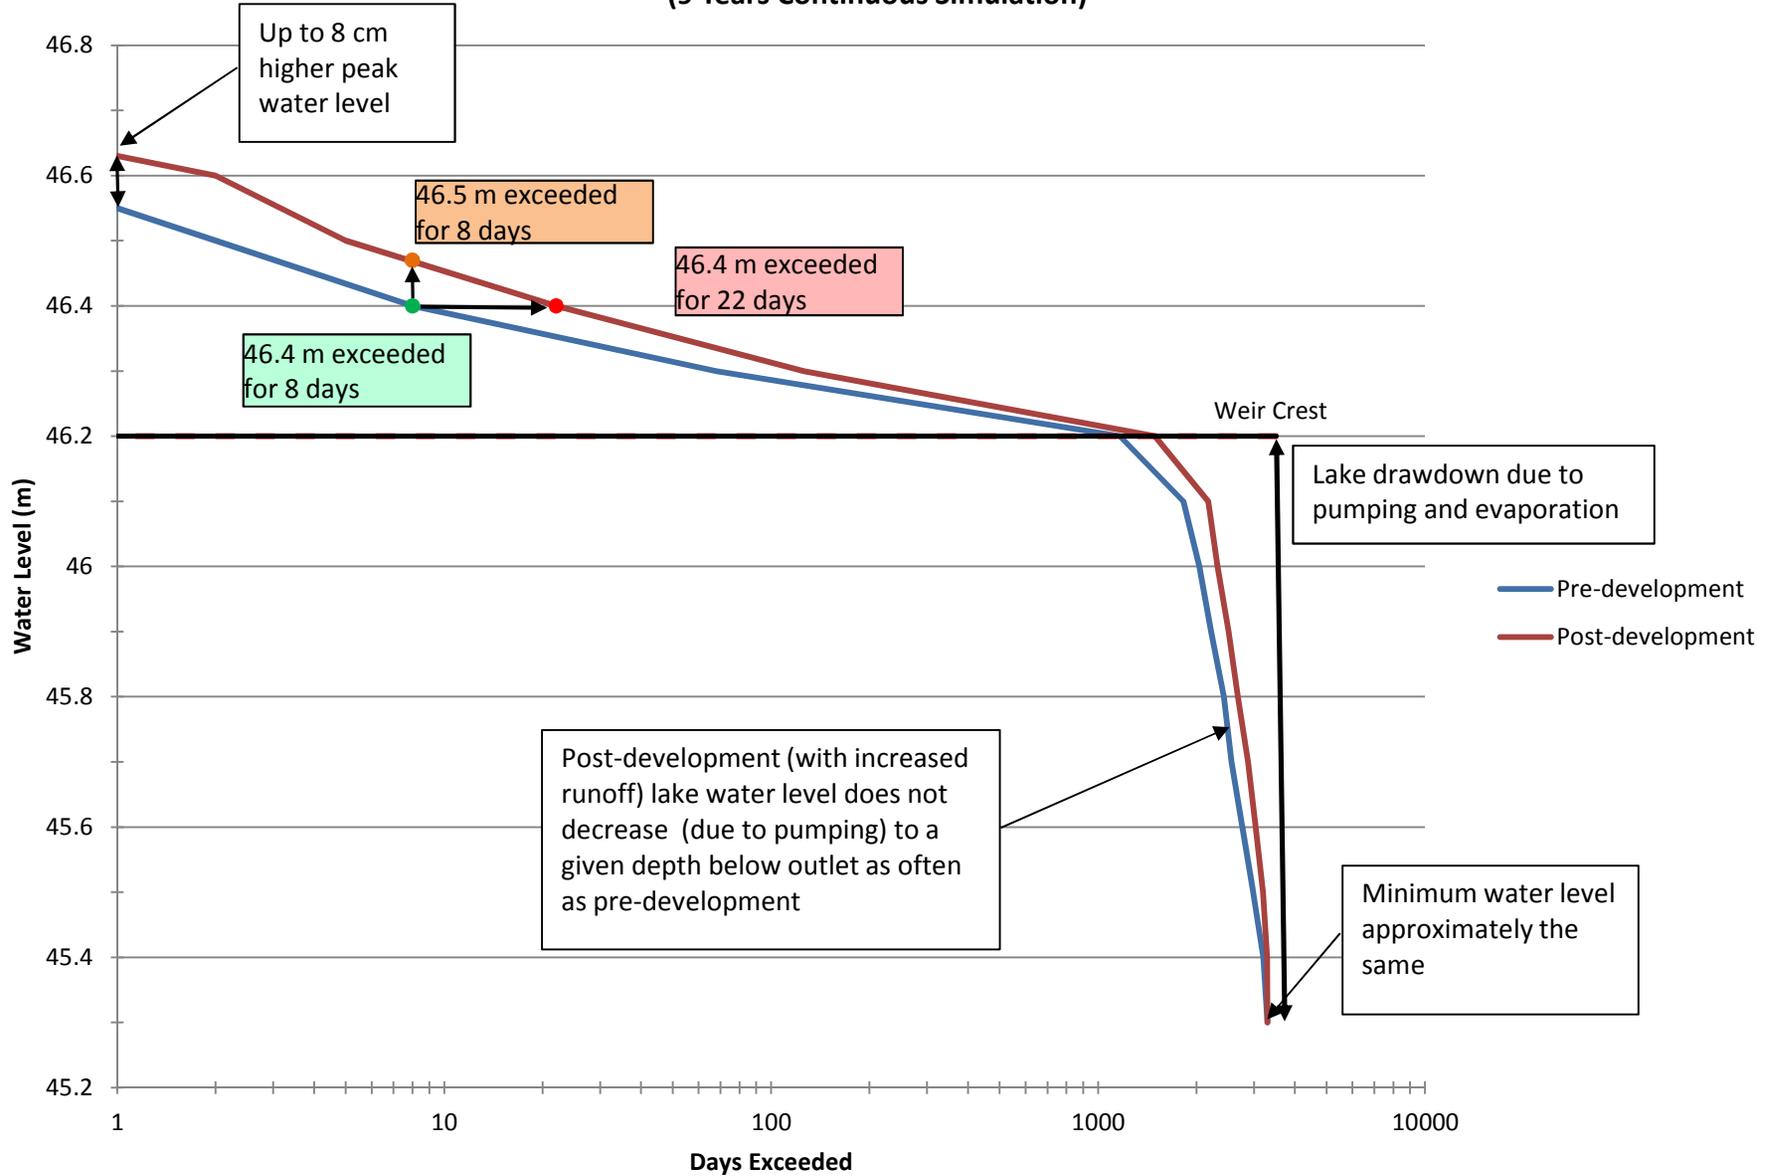
To process and find meaningful results from such a large data set of results, the cumulative distribution of the water levels were summarized into water level exceedance duration curves. Exceedance duration curves generally show a comparison between the amount of days any given water level occurs for pre- and post-development. Post-development curves often show higher water levels for more time, while pre-development conditions often have lower water levels for more time. The exceedance duration curves for Enos and Dolphin Lakes are shown in Figures A1 and A2.

Enos Lake Exceedance Duration Curve (9 Years Continuous Simulation)

Comparing the model results with recorded lake water levels record shows that a water level rise of 40-50 cm above the outlet weir is consistent to what is being observed during monitoring.

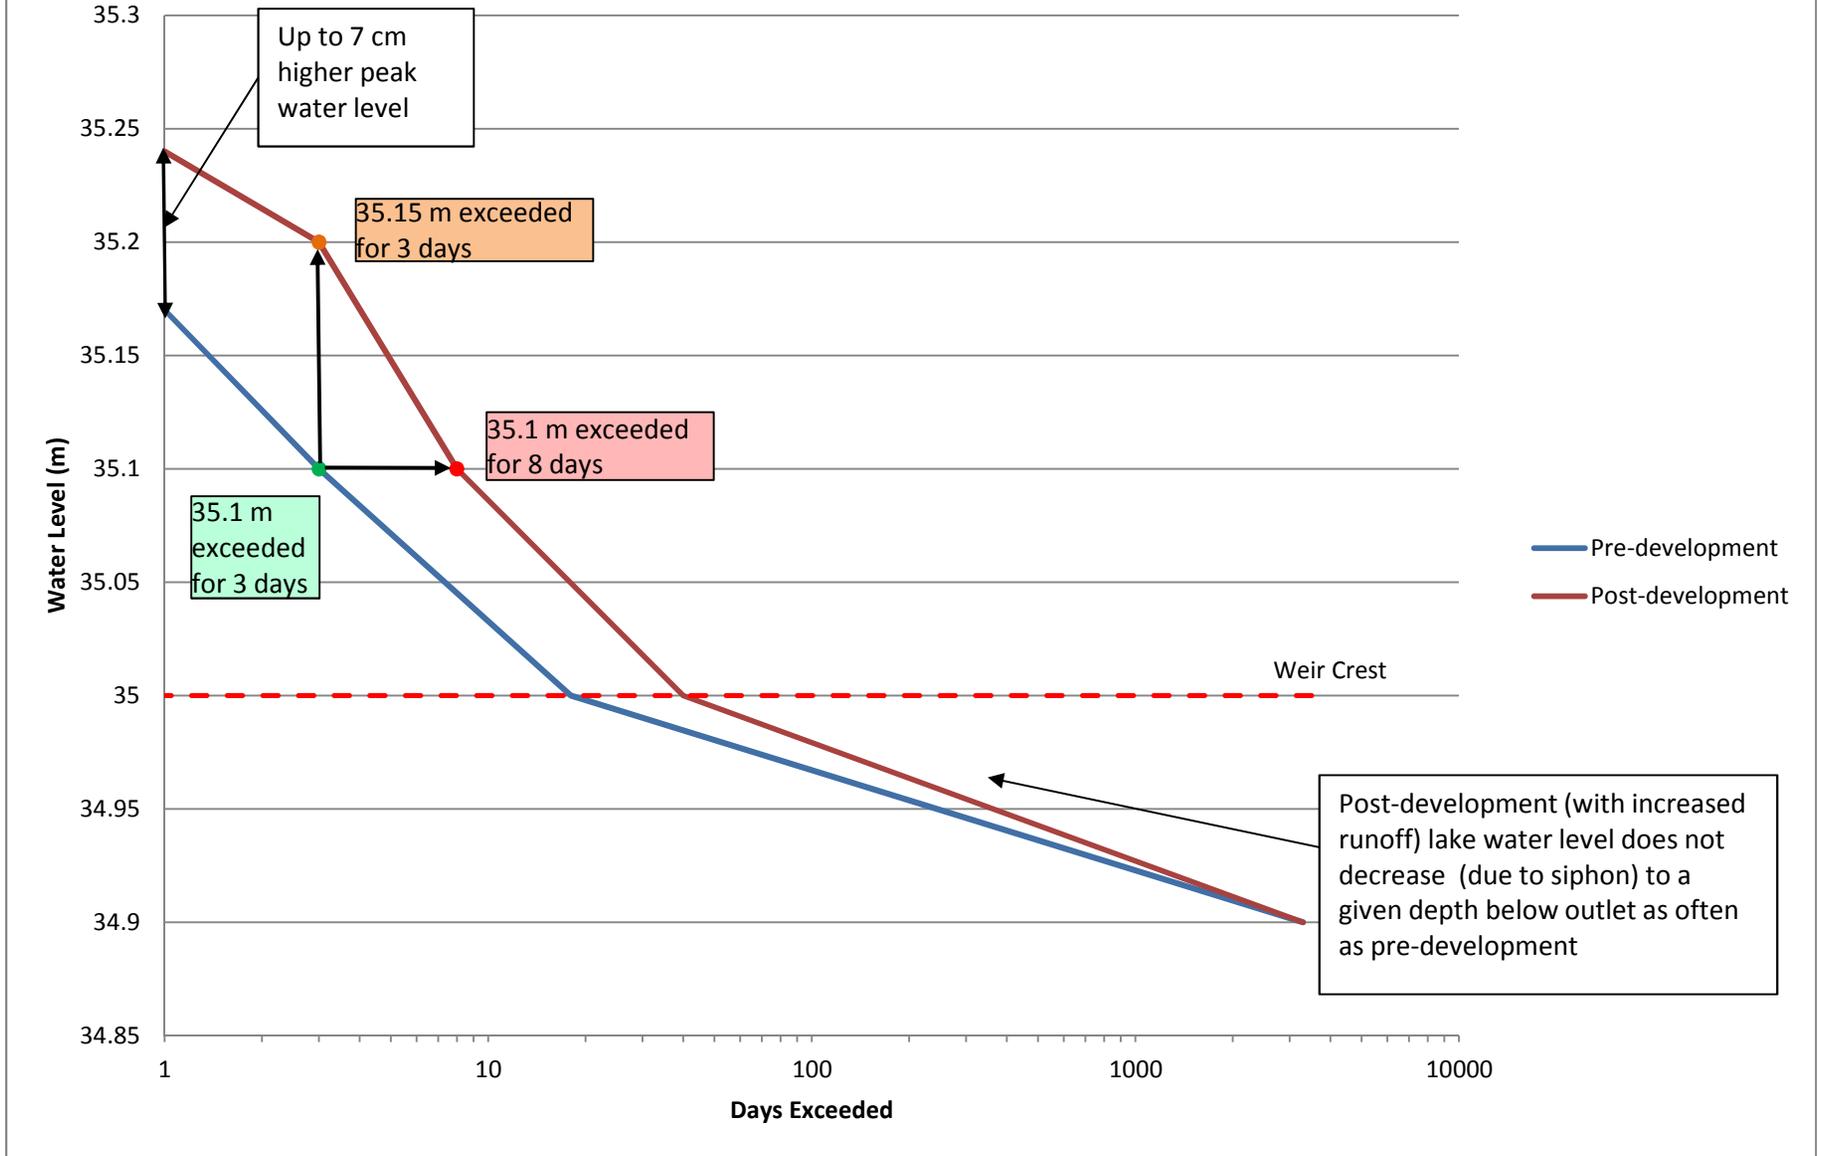
Figure A2

Dolphin Lake Exceedance Duration Curve

(9 Years Continuous Simulation)

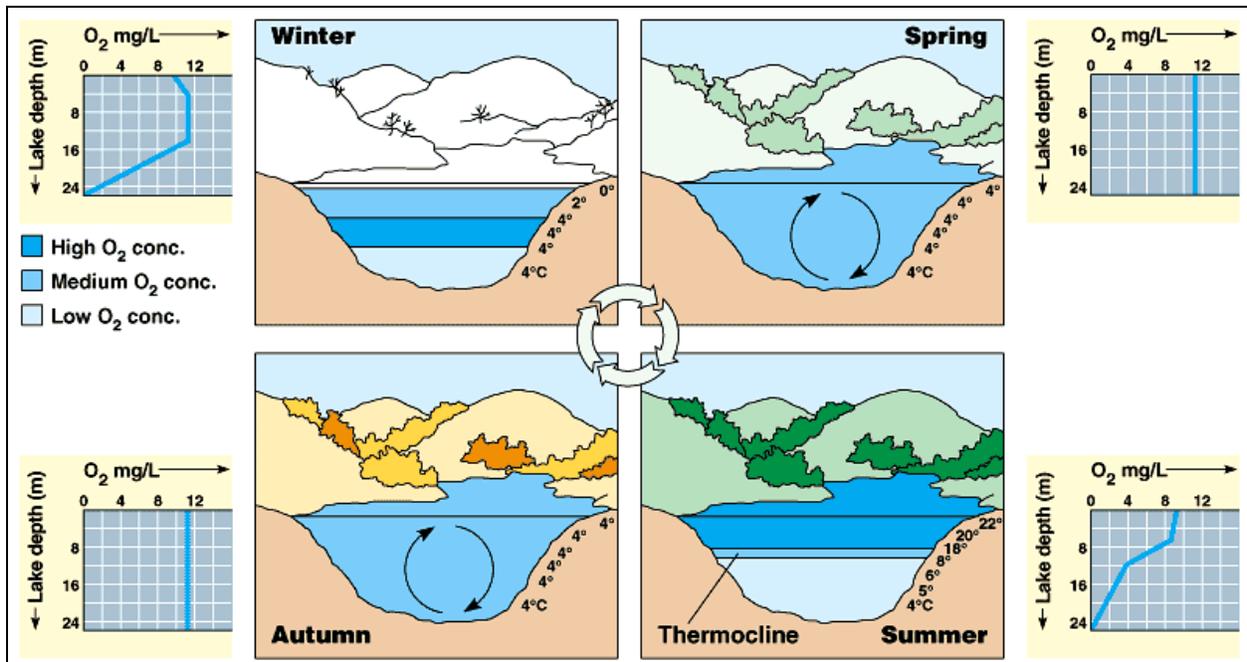
Seasonal lake stratification and de-stratification are a common occurrence and can affect the physiochemical parameters and chemical composition of a lake (**Figure 1**). Stratification, which occurs primarily during the summer in temperate regions, occurs because the temperature of the water in the water column becomes less uniform between the top (epilimnion) and the bottom (hypolimnion), resulting in a temperature gradient. As a result, water at the surface becomes less dense and floats above the denser, cooler water beneath it. During stratification, less mixing occurs between layers, often resulting in an oxygenated epilimnion and little (hypoxic)-to-no (anoxic) oxygen containing hypolimnion. In the fall, stratification breaks down as a result of cooler temperatures and the lake mixes (termed 'autumn overturn') as a result of uniform water density, recharging the bottom water with oxygen and bringing nutrients up to the surface. The result permits a greater vertical movement for aquatic inhabitants within the water column without experiencing hypoxia. Winter conditions can also result in stratification, termed 'winter stagnation', which becomes more pronounced during sub-zero temperatures resulting in ice formation. Again, in the spring, stratification breaks down resulting in 'spring overturn'.

Figure 1: Typical Lake Annual Stratification and De-Stratification Cycle
