Nanaimo River Chinook Salmon Recovery Plan Habitat Assessment Report.

Fisheries and Oceans Canada
Nanaimo B.C.

December 2021

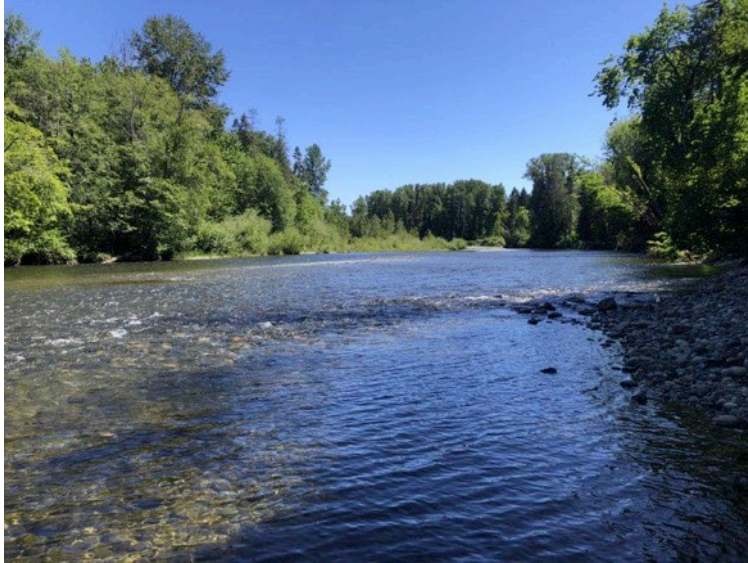
1.) Riffle 1 Placemark 7, Morden Trail head, clean gravel

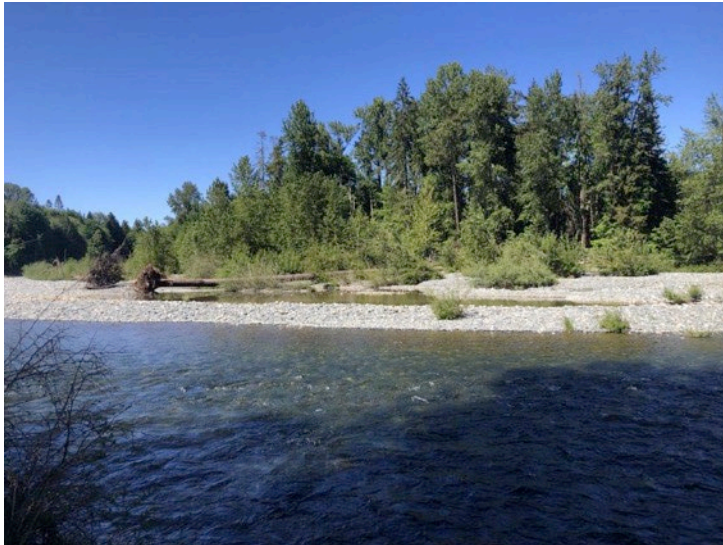
3.) Riffle 2, right bank island with dry flood channel and LWD.

A lack of LWD. There were only five second growth fir/cedar washed on to bars (Photo 3) in the 1679m survey length. These logs offer bar stability but little fish cover. No old growth size logs were observed.

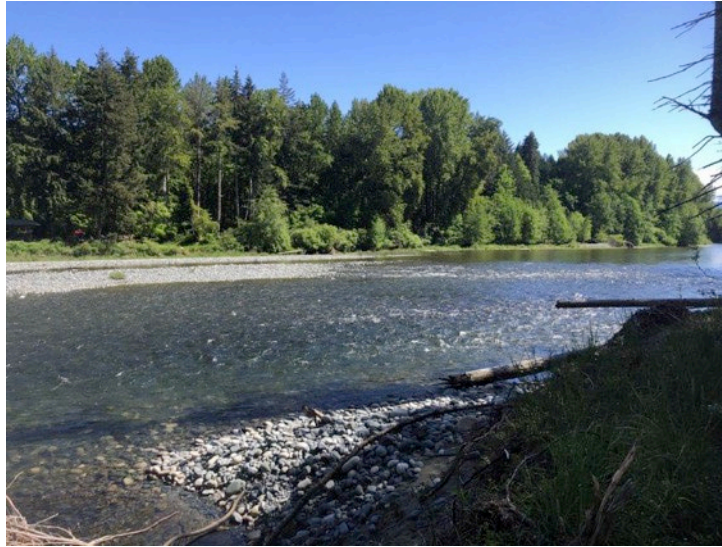
5.) Riffle 3 Placemark 14, clean gravels no boulders/LWD

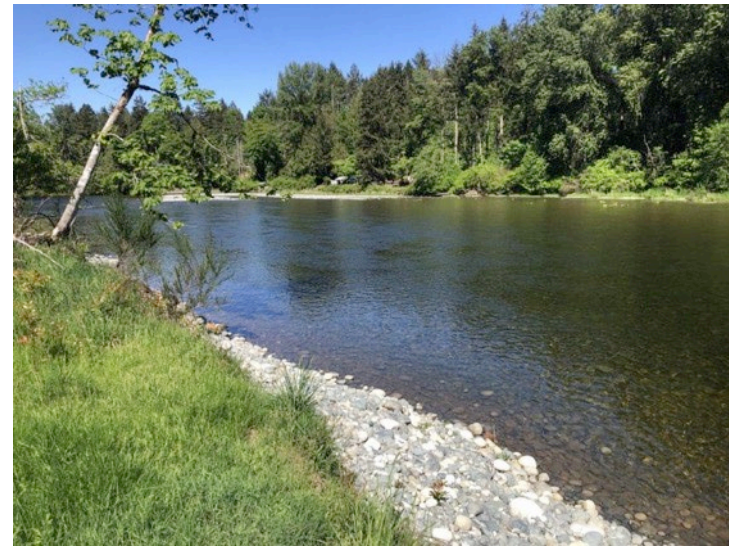
6.) Glide 2 is 55m wide, 115m long, no instream cover

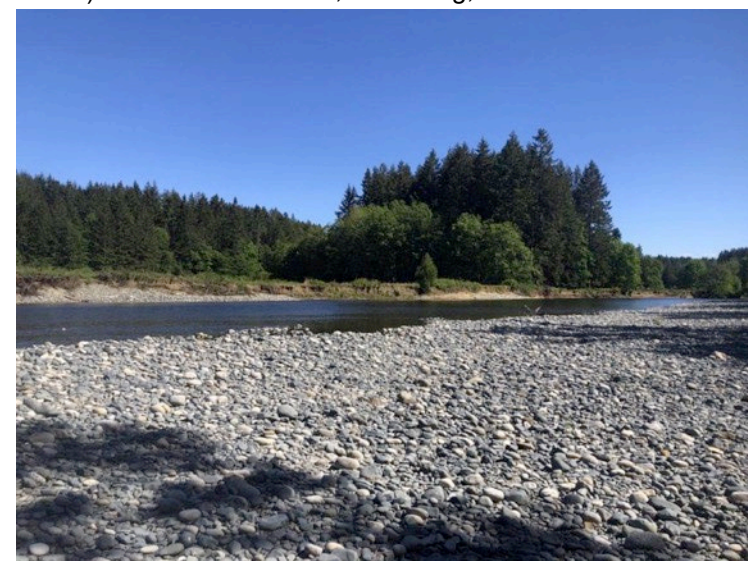
8.) Glide 3 (Placemark 23) near top of Reach 2, has 220m RB bank erosion

Reach 2 is the lowest non-tidal reach in the Nanaimo river. The location means it is habitat for all salmon species for migration, spawning and/or rearing. The protection of this habitat is vital. It is relatively un-developed by industrial and urban pressure. It has a wide floodplain which has not been dyked or channelized. In the left bank floodplain, the second generation of forest vegetation has been undisturbed in most areas. Most agricultural developments lie further out in the floodplain (i.e. Akenhead Creek) and are buffered by riparian vegetation. There is one streamside agriculture area in this reach (Figure 4, Placemark 23) and the lack of riparian protection has resulted in loss of pasture and river bank erosion.

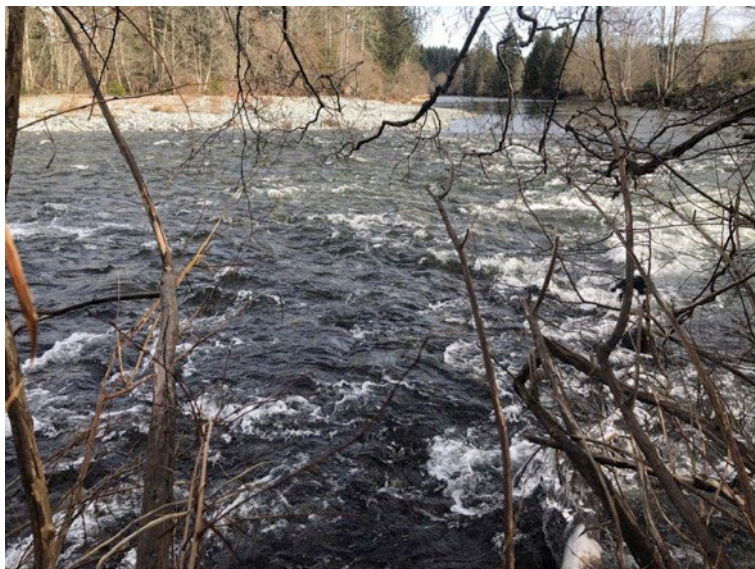
1.) Riffle 1 looking downstream with Haslam Creek on right

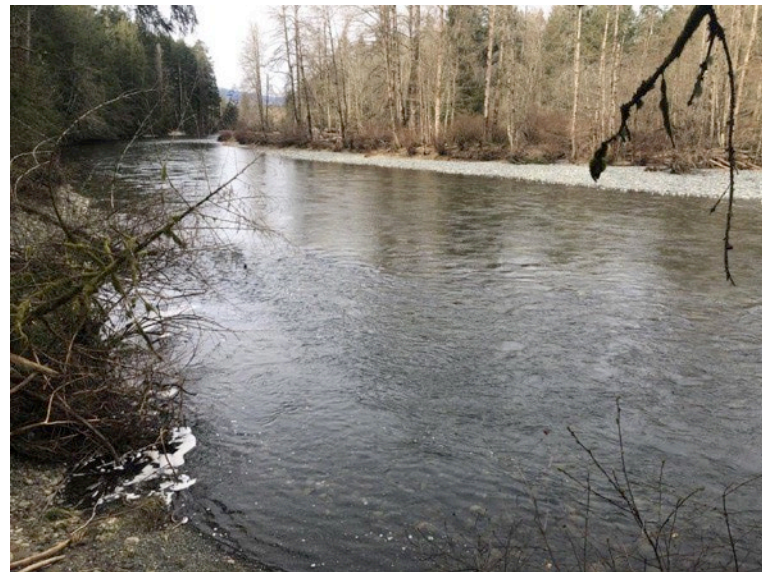
2.) Glide 1 looking upstream

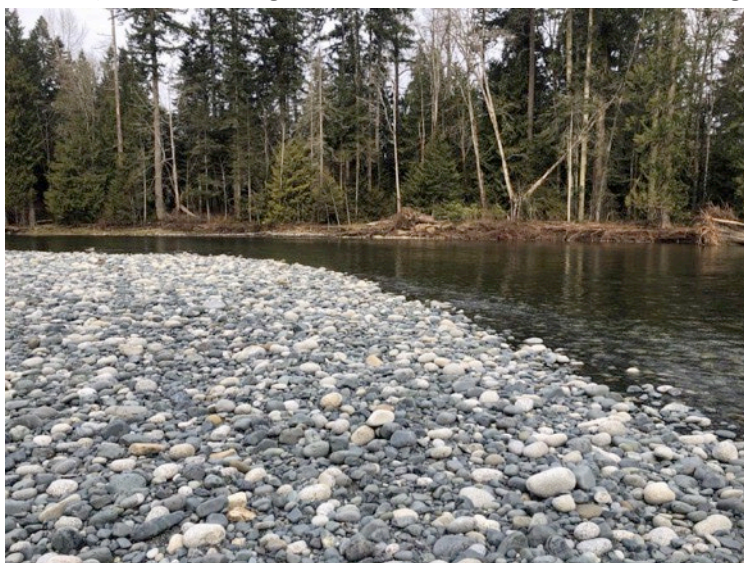
3.) Corner Glide - left bank spills into Frey Rd Sidechannel

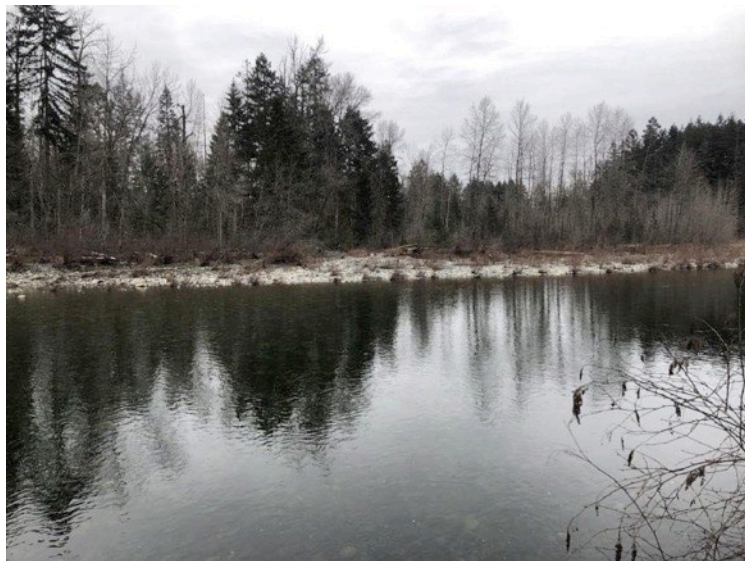
5.) Glide 5 looking at LB sidechannel entrance

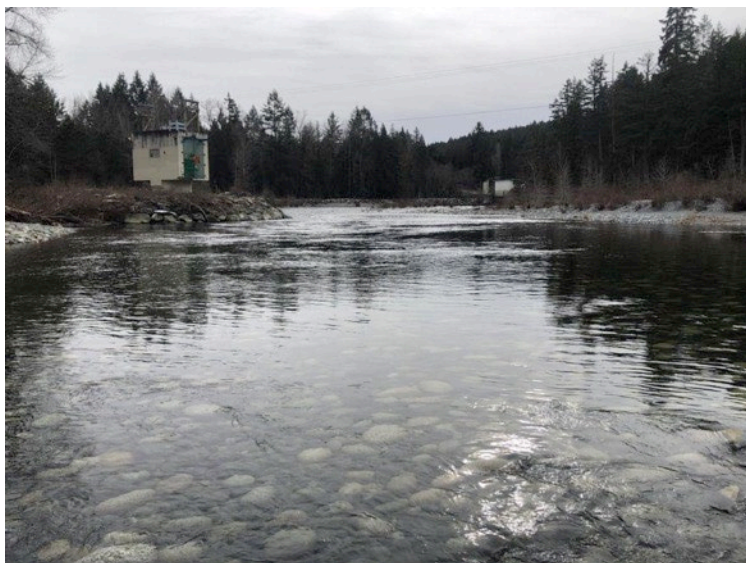
7.) Pool 3 tailout is cobble and boulder limited gravel

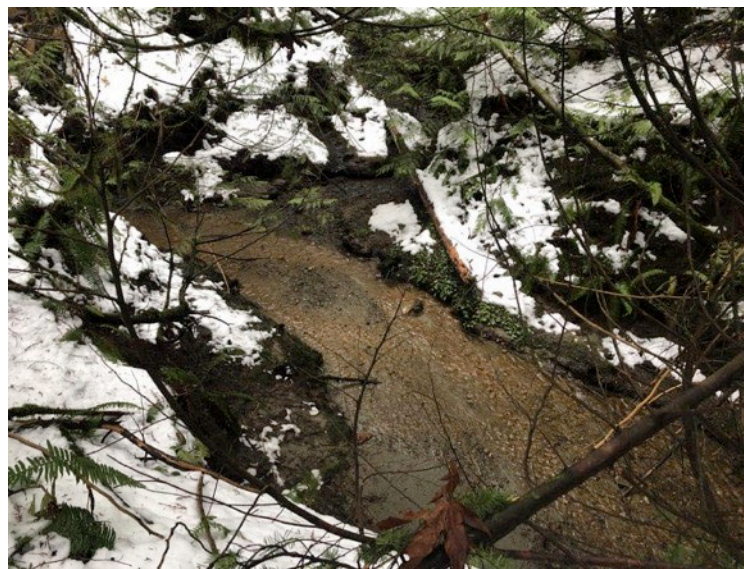
2.) R4- Accessible tributary enters Pool 3 from pit side

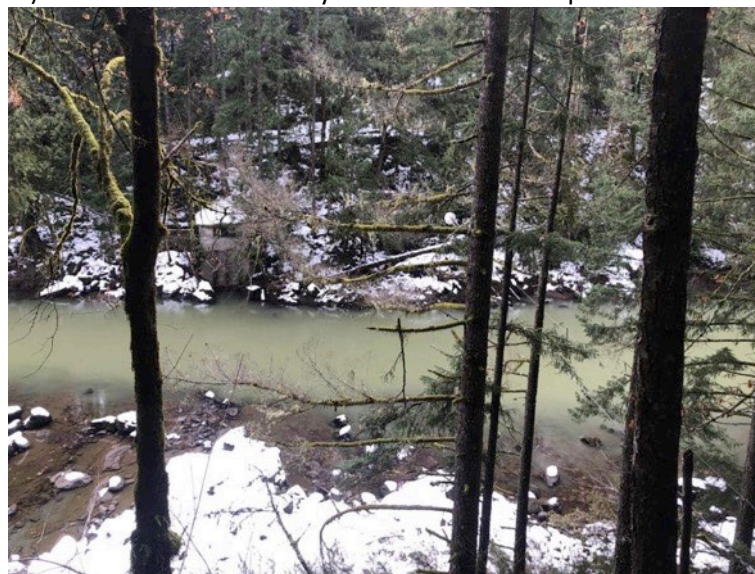
4.) Pool 2 is 280m long, at Water Survey Stn., with snowmelt

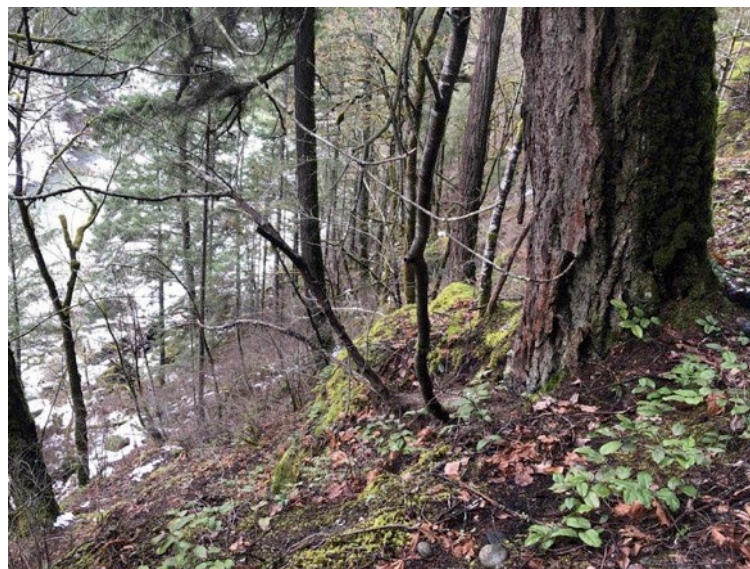
6.) R4-Most trees are 60-100 yrs with occasional vet. (shown)

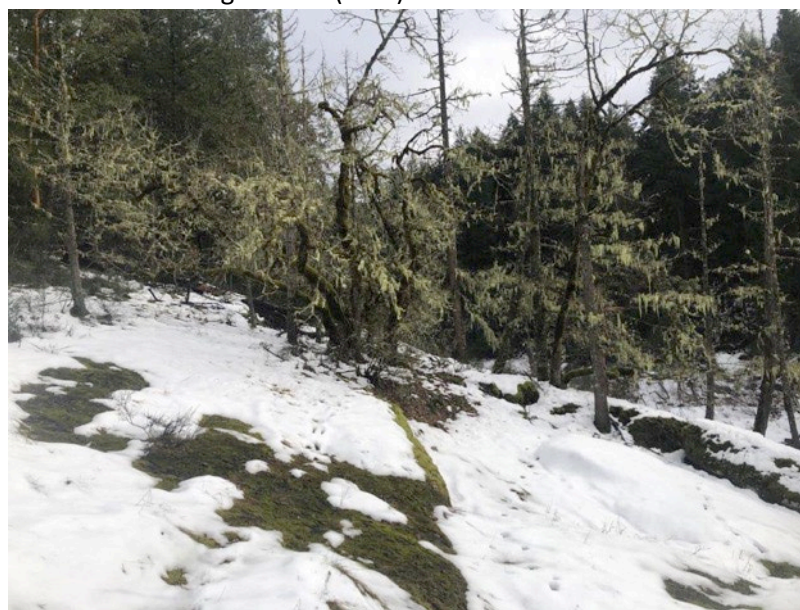
8.) Garry Oak bench along left bank (Placemark 12)

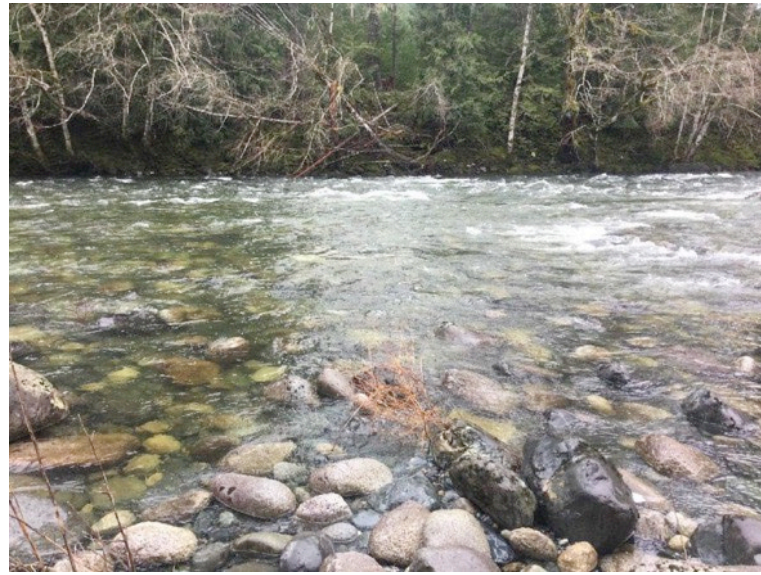
2.) R12 –R1-Riffles were 0.5m deep, some boulder cover

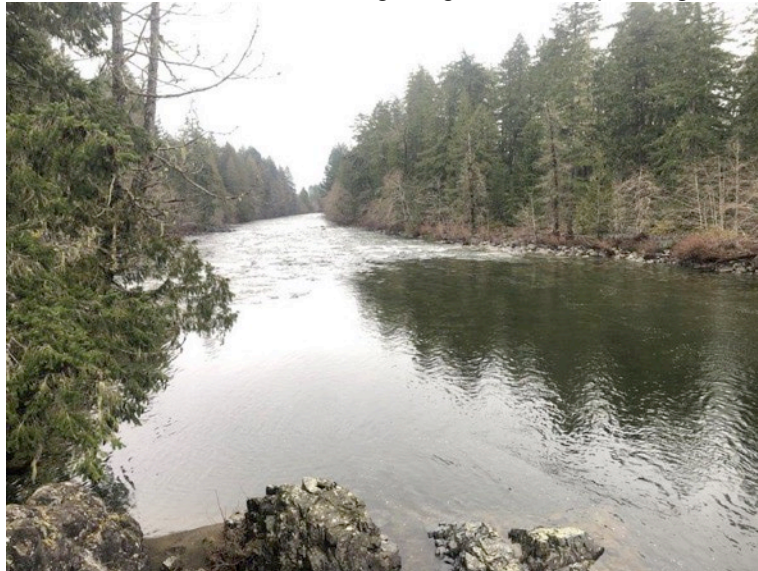
7.) R12- Pool 1 (Jump Ck) looking downstream at reach.

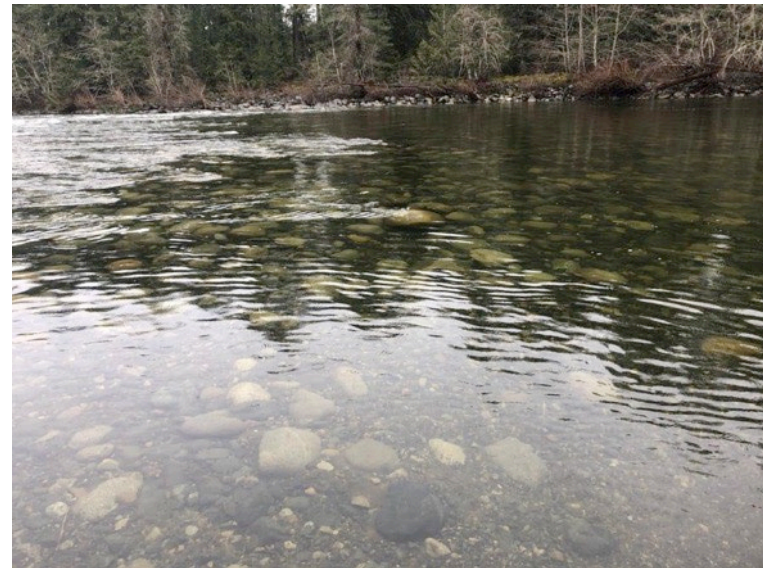
8.) Pool 1 Tail out lacks spawning gravel.

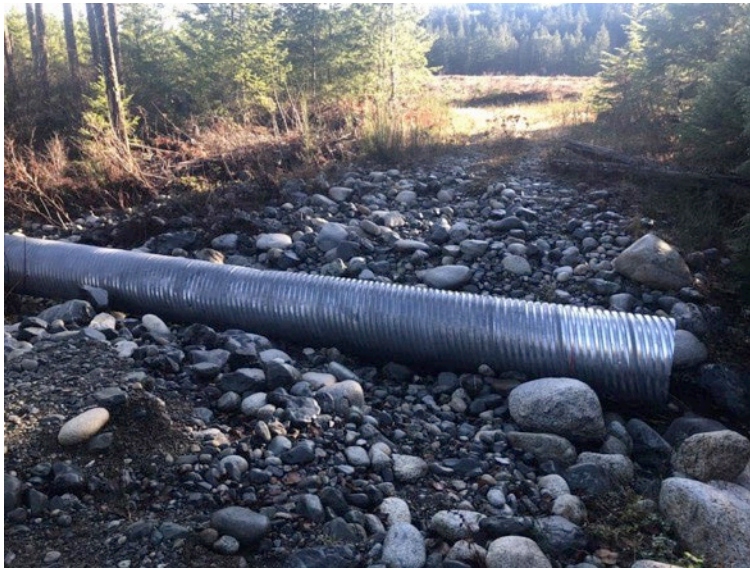
9.) Sidechannel top end near inlet is seasonal and 5-6m wide

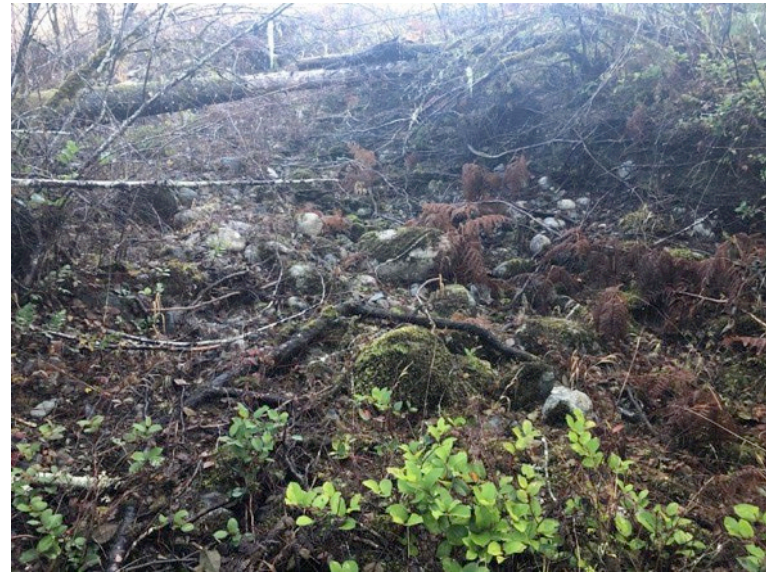
10.) Sidechannel goes across old road.

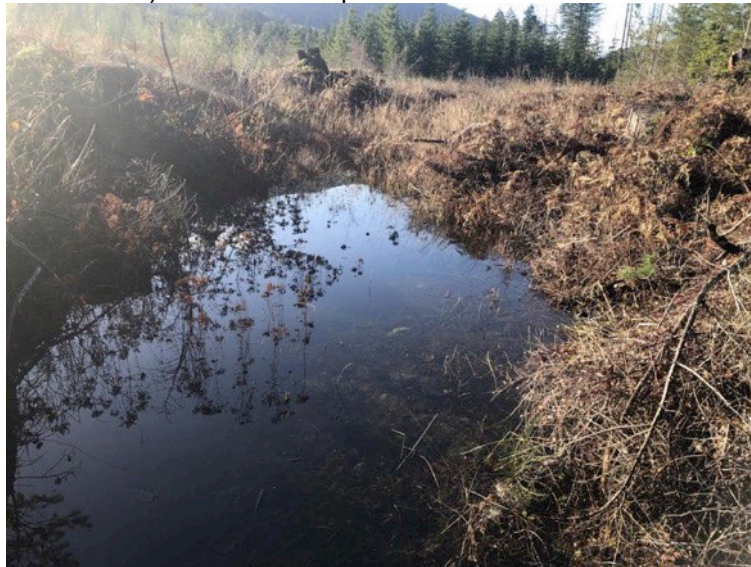
11.) Midreach seasonal pool formed at junction

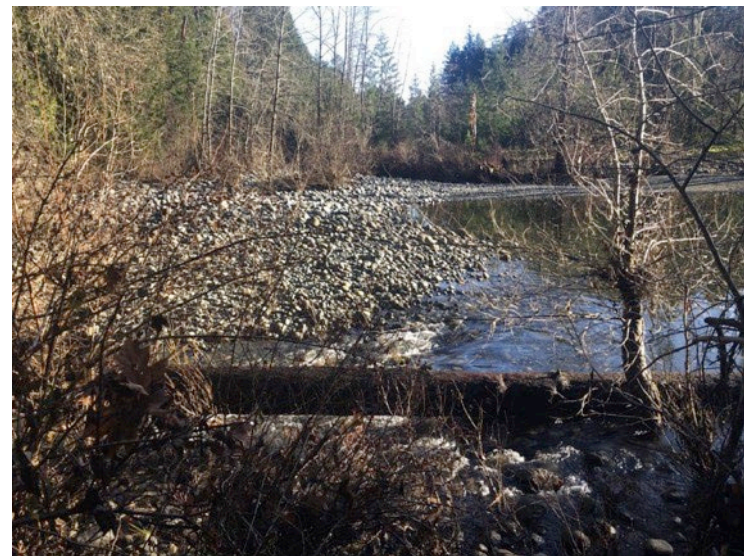
12.) Outlet joins mainstem in corner pool Reach 11.

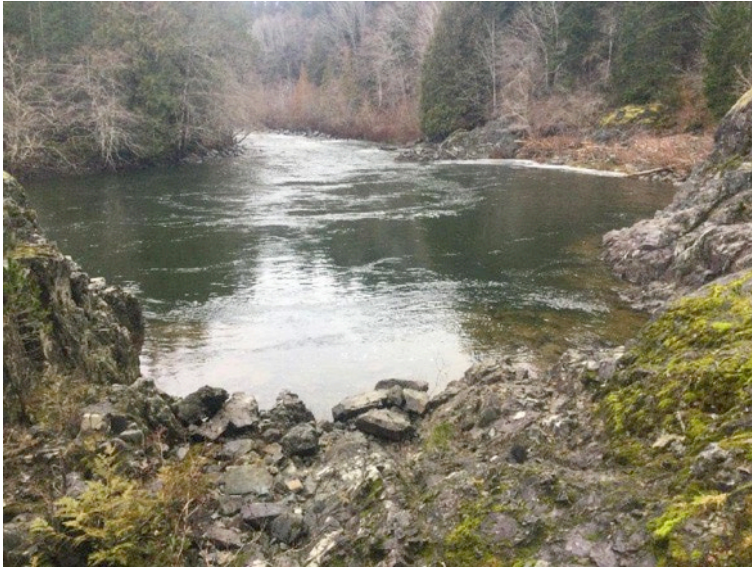
1.) R13- Pool 4 above Jump CK is deepest pool in reach (4m)

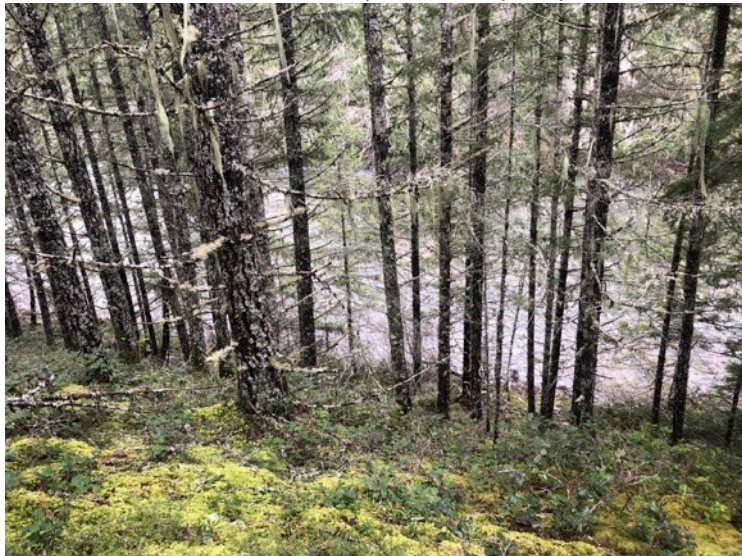
3.) R13 confined reach with steep slopes

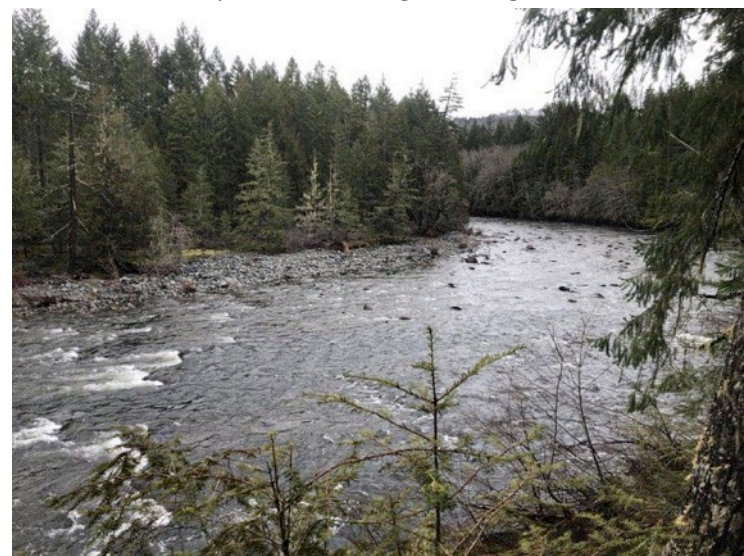
4.) R13 – Riffle 3 below Wolf Creek in big bend

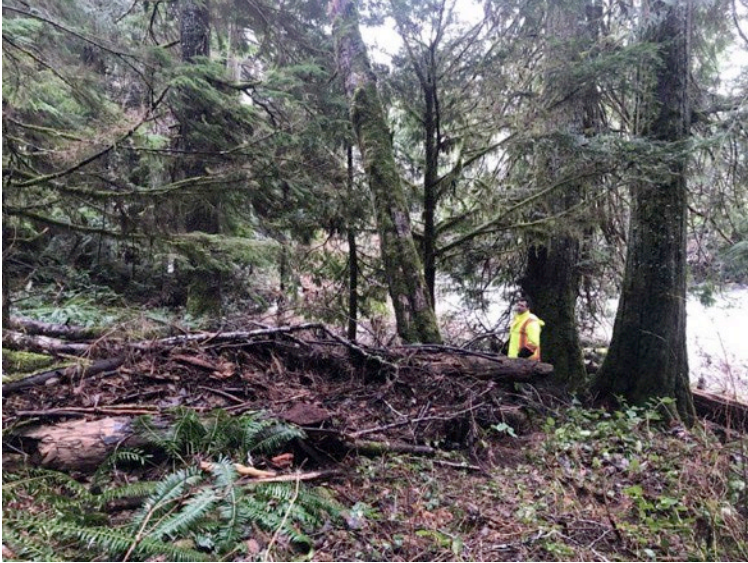
1.) R13- flood debris deposited high in riparian area

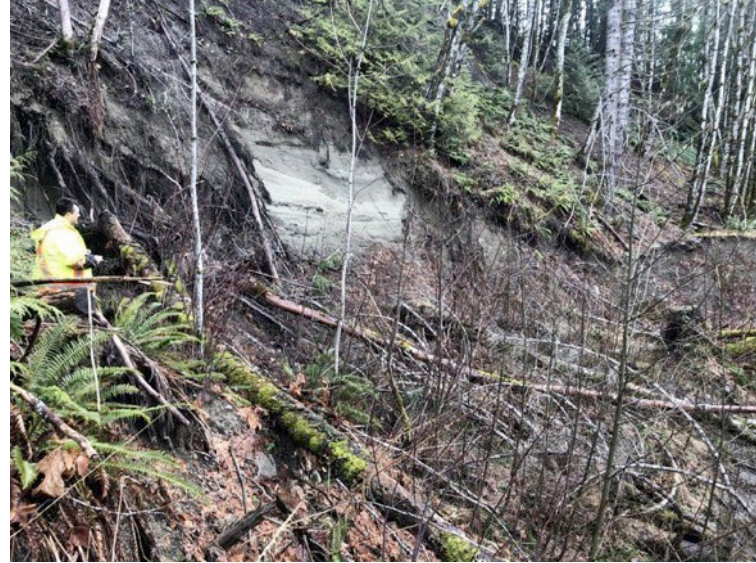
The habitat summary results in a Fair score. The Good rating for erosion is due to the fact the river bed is washed down to hard substrates. There are rail culvert washouts (Placemark 9 & 10) that are eroding off steep slopes into the river that need remediation. The Good rating for Obstructions such as log jams is because they must have been removed or historically washed away as none exist. Some residual log debris is observed in the narrow floodplain trapped amongst tree stems. The Alterations to the river are historic: the logging railway ceased operation approximately 60 years ago. The rail bed is in surprisingly good condition given there has been no sign of maintenance. Erosion was low for the overall length but two sites were observed along the rail grade. There is a plugged culvert at Placemark 9 has that needs cleaning. Downstream at Placemark 10 there is a bank failure approximately 30m wide eroding sand down to the river.

2.) R13 – Placemark 10 slide track from rail line

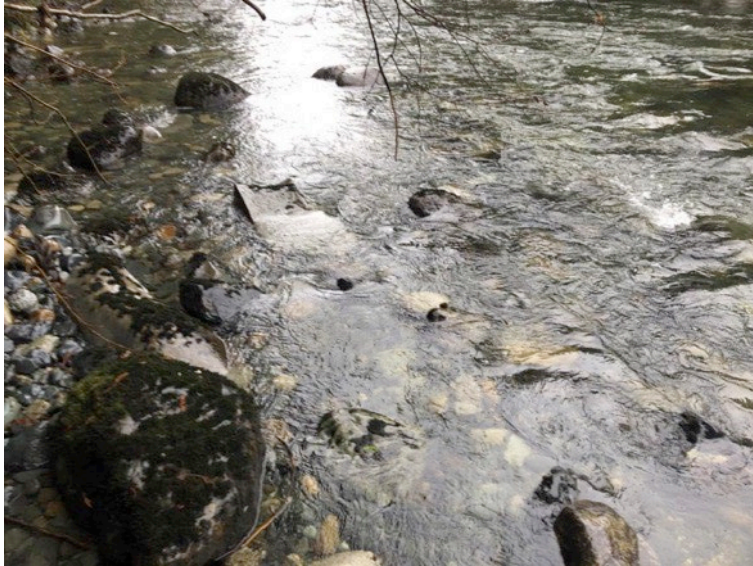
1.) R14 Riffle 5 has functional Boulder (1-2m diam) cover structures

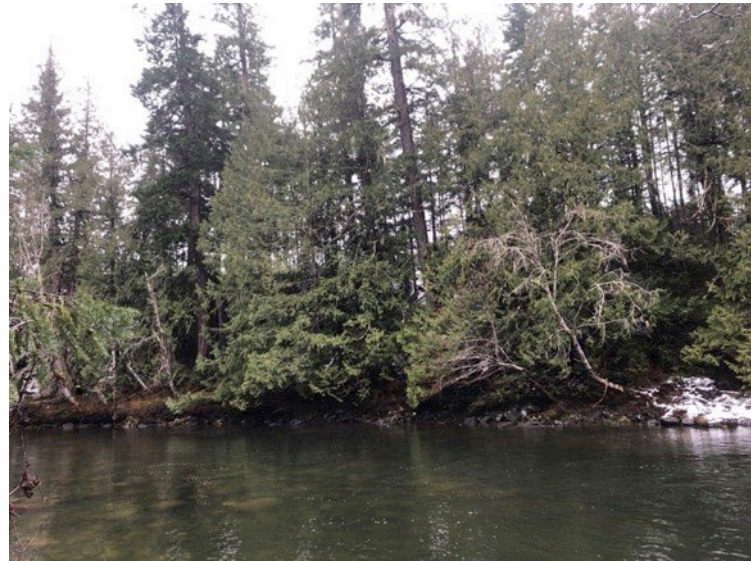
2.) R14 P6 Right bank (south side) featured older trees.

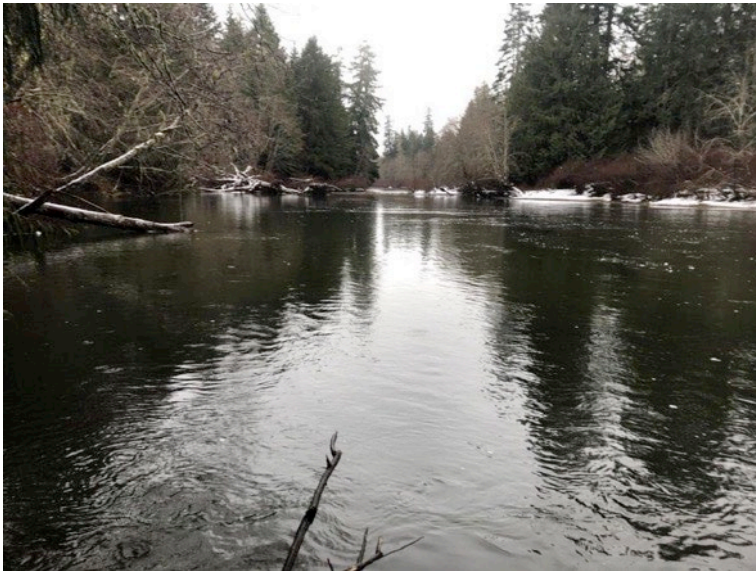
3.) R14 – Pool 3 had the highest LWD Count (4)

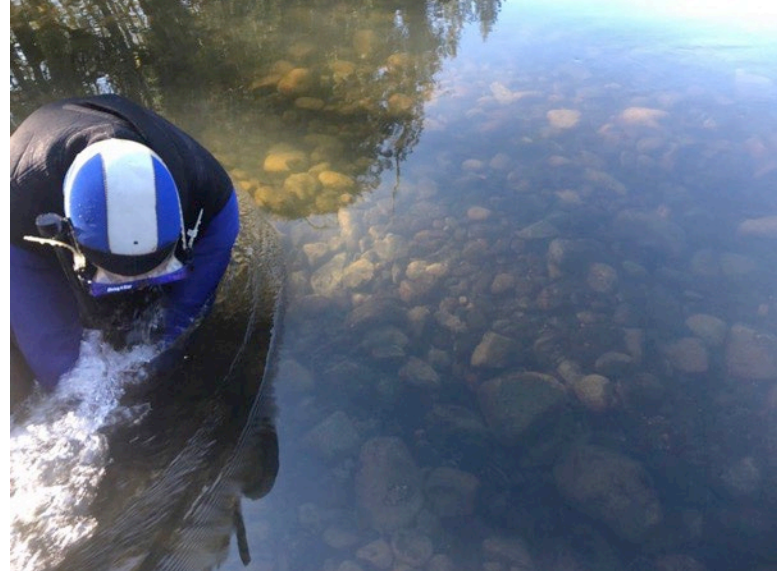
4.) R14 – Riffle 1 North Nanaimo R contributes spawning gravel

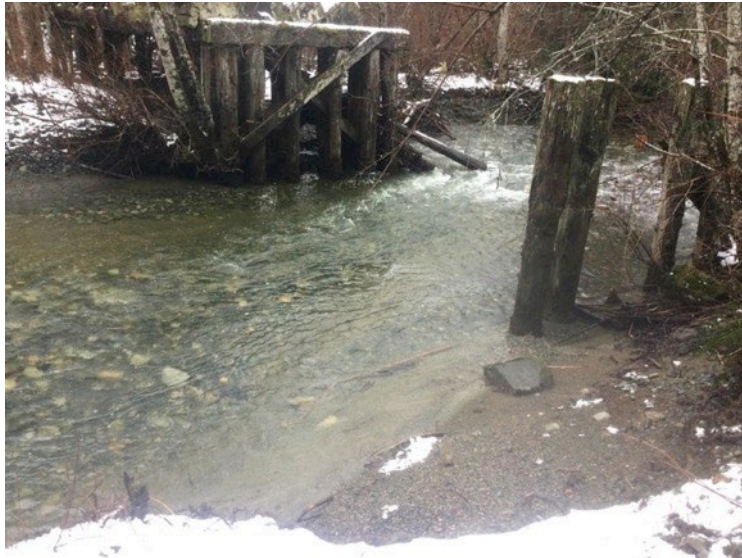
3.) North Nanaimo overflows left bank to 590m channel

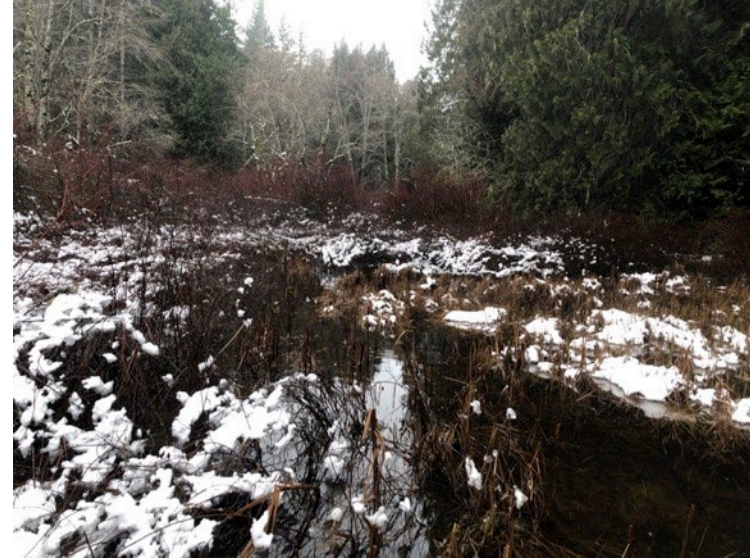
4.) Sidechannel near entrance to mainstem is fish accessible.

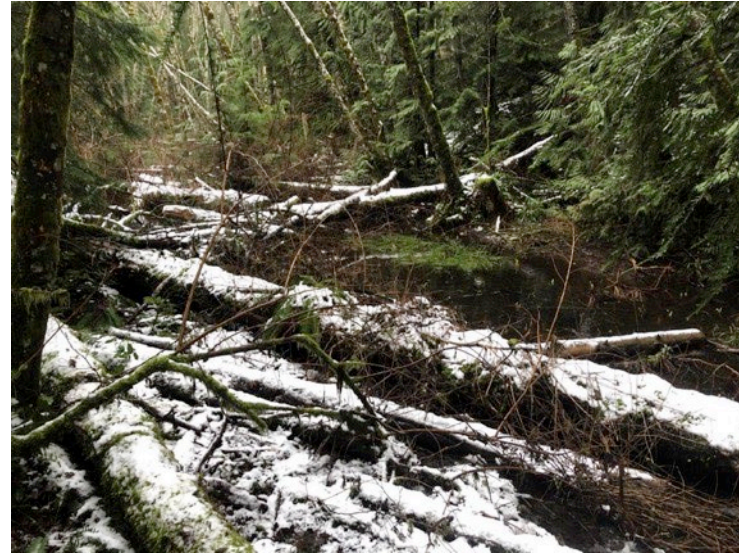
6.) R14-P5 Offchannel is 200m low gradient refuge

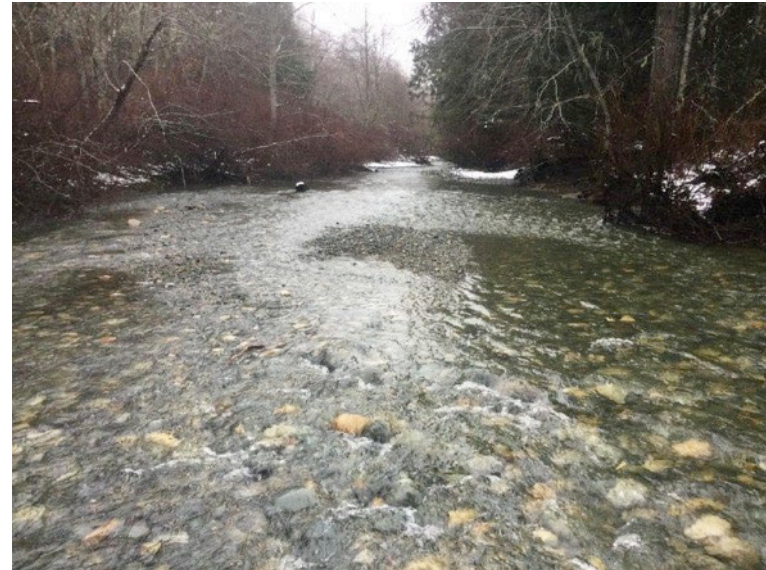
8.) North Nanaimo River is a major spawning gravel supply to R14

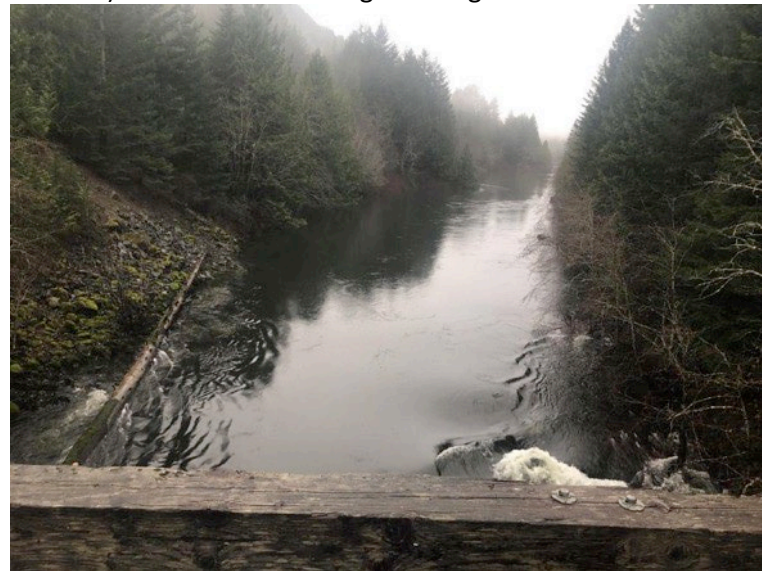
4.) R16 – Glide 1 (Spawning Gravel Site)

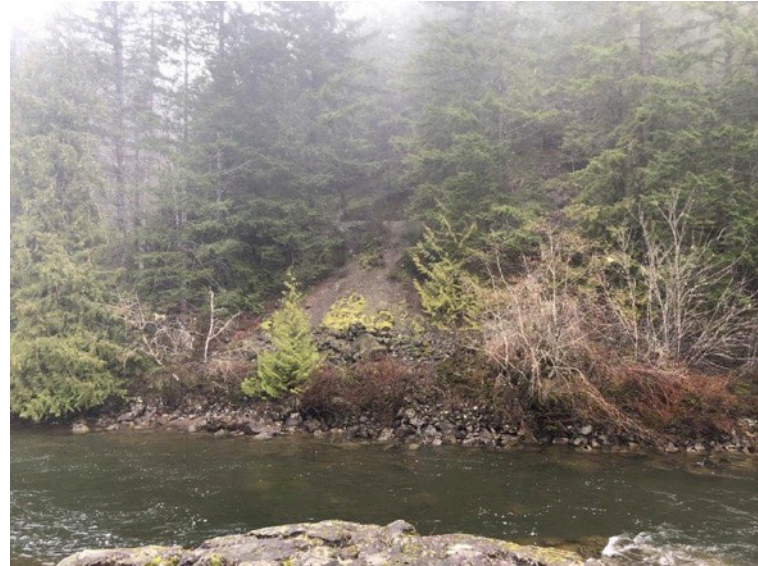
2.) Exposed slope – planting opportunity

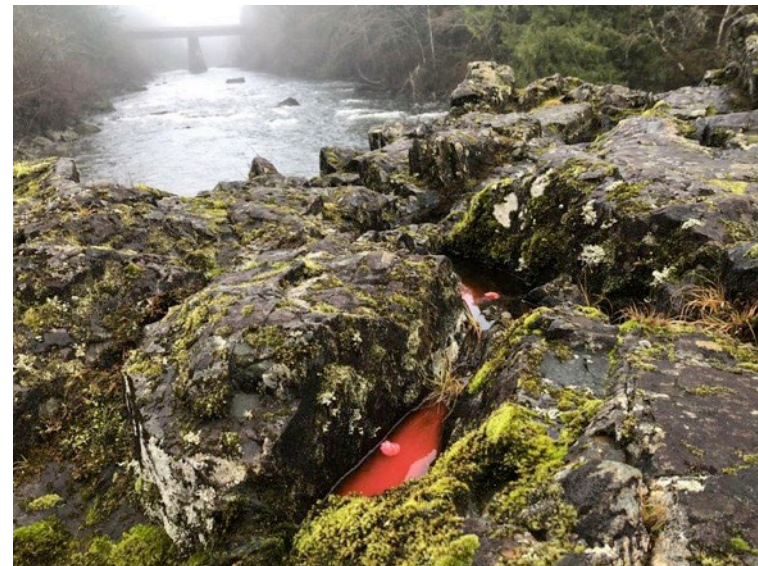
4.) Popular angler site and trail in R16, site cleanup of gear.

There are no other significant opportunities observed in the reach but small restoration activities that could be done with stewardship groups given the high public use in the area; such as water quality sampling, garbage clean up and planting disturbed areas at angling sites (Table 25).

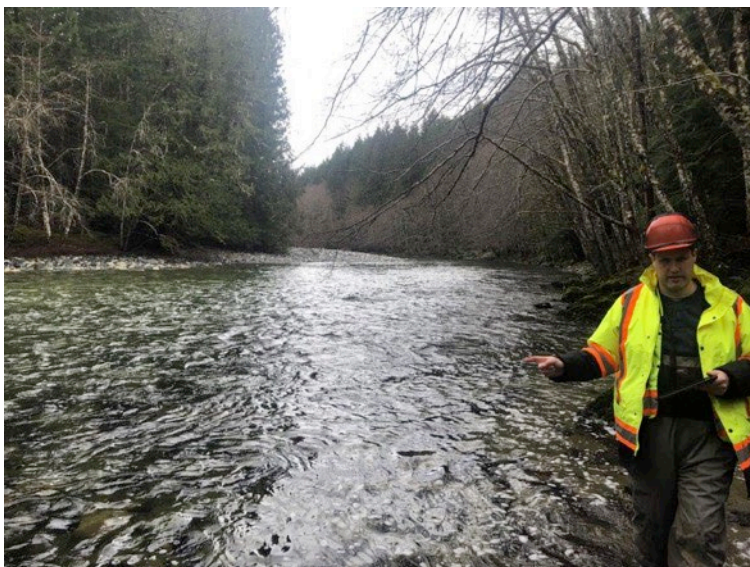
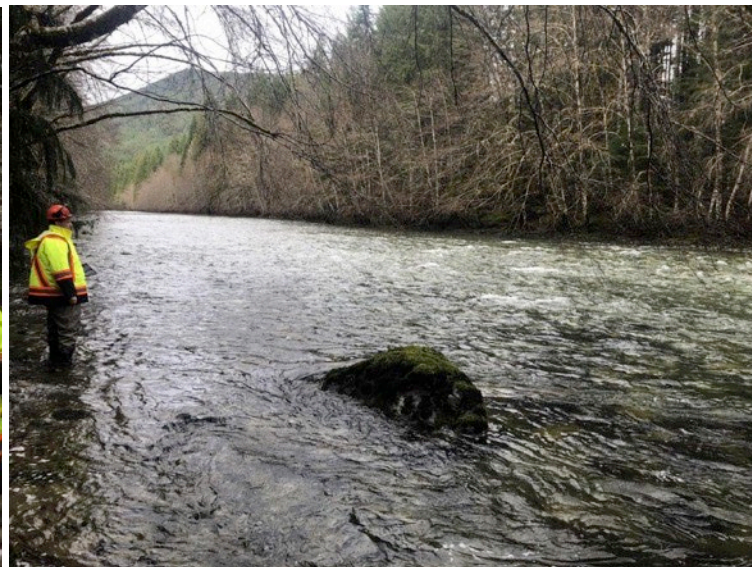
1.) R18- Glide 1 looking 130m downstream 39m wide channel 2.) R18 – Riffle 1 is 108m long in a 45m wide channel

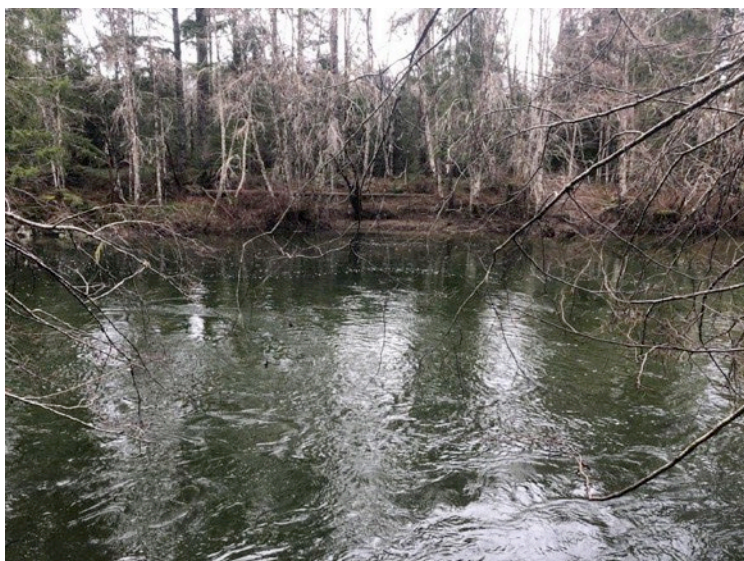
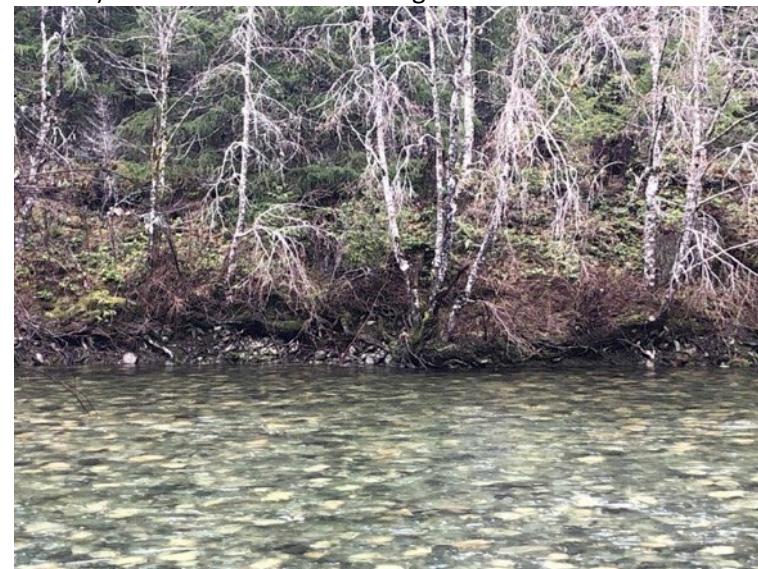
- LWD – the reach lacks LWD (0) due to historic logging effects. The lack of LWD results in a lack of cover for fish along the long glides. There is the opportunity to add LWD to the banks to protect eroding areas and create cover. Both banks are relatively low and accessible.
- Cover – Lack of cover throughout the reach was evident. The only cover was found in exposed Boulders not buried by sediments. Addition of cover that is flood proof is recommended and benefit juvenile fish greatly in this reach. Boulder habitat is evident in the reach but access to distribute boulders from bank areas is limited to the few roads near the banks.

3.) R18 Pool 1 – is 92m long and 3-4m deep, no LWD 4.) R18 – Glide 3 is 318m long, shallow no cover, small erosion pockets as trees fall in

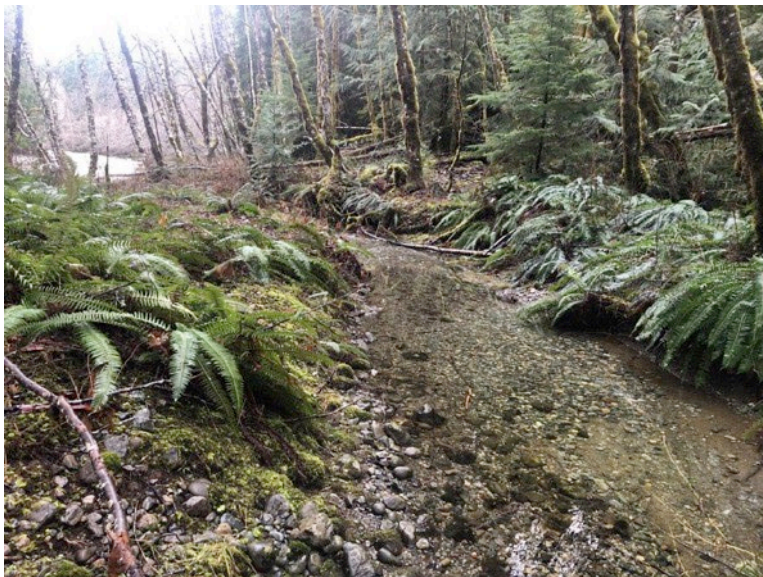
1.) R18- Sidechannel on south bank

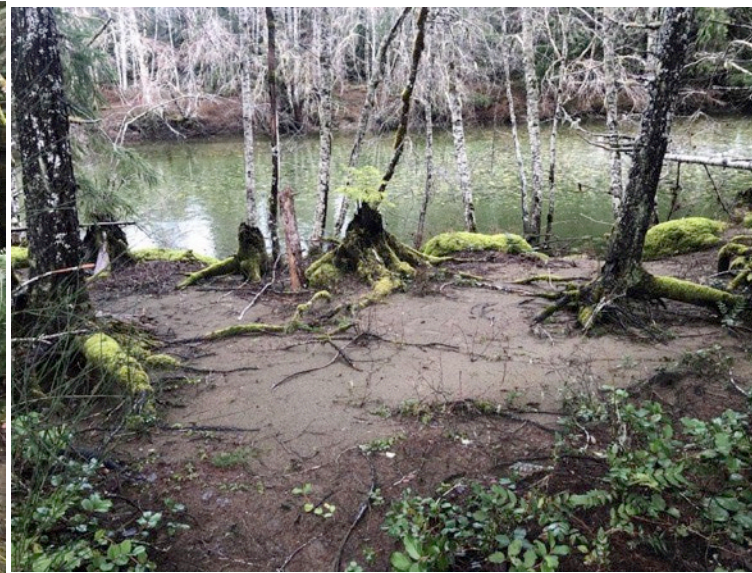
2.) R18 – Flood plain on south (right) bank

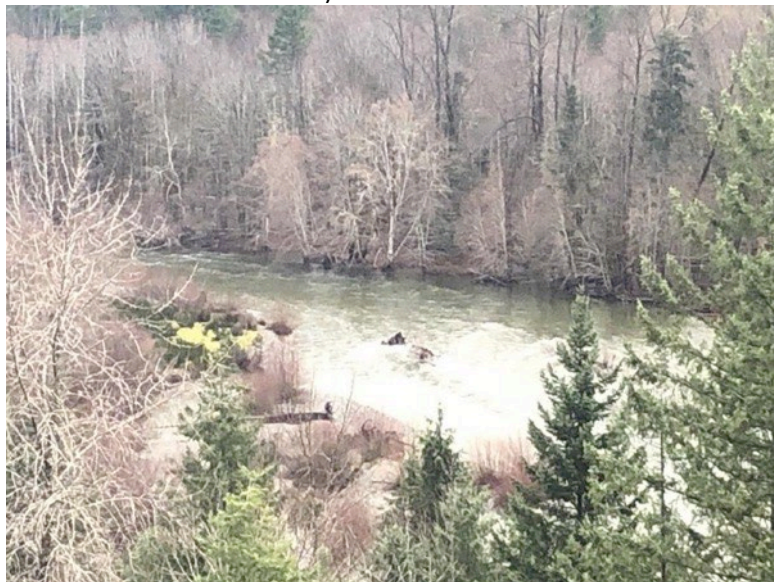
3.) R18 Gravel Bar below Dash Creek.

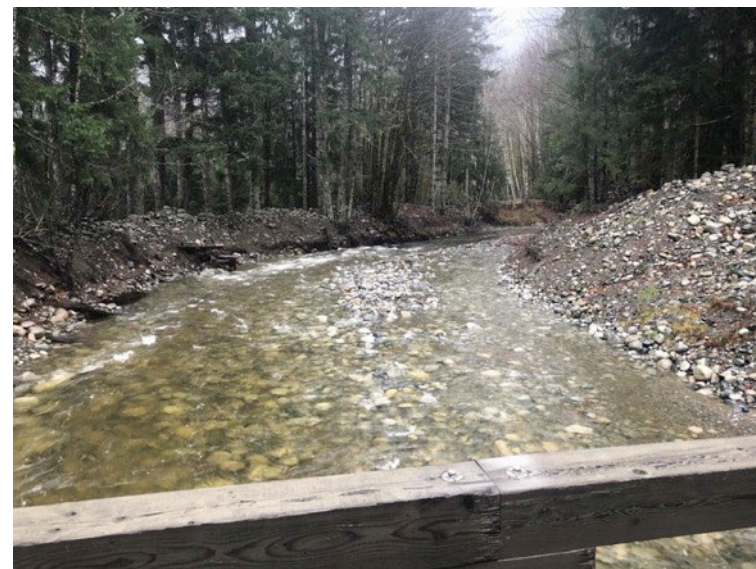
4.) R18 – Dash Creek sediment deposits at road crossing

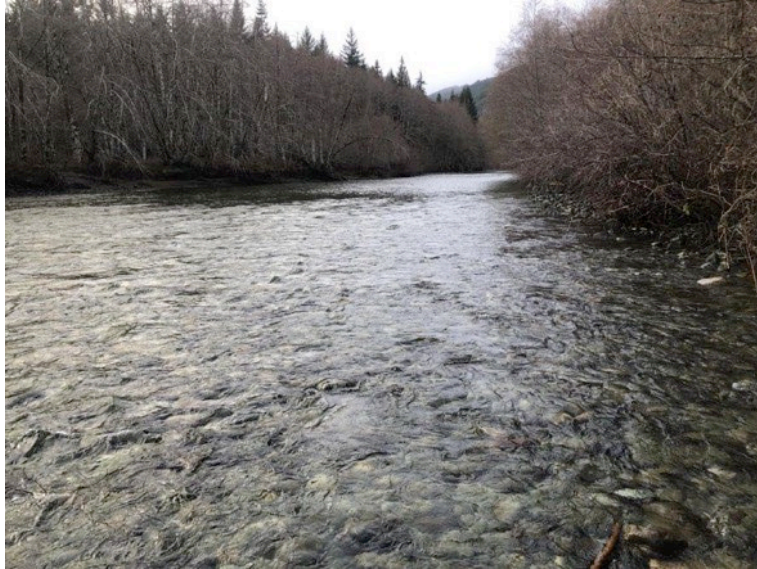
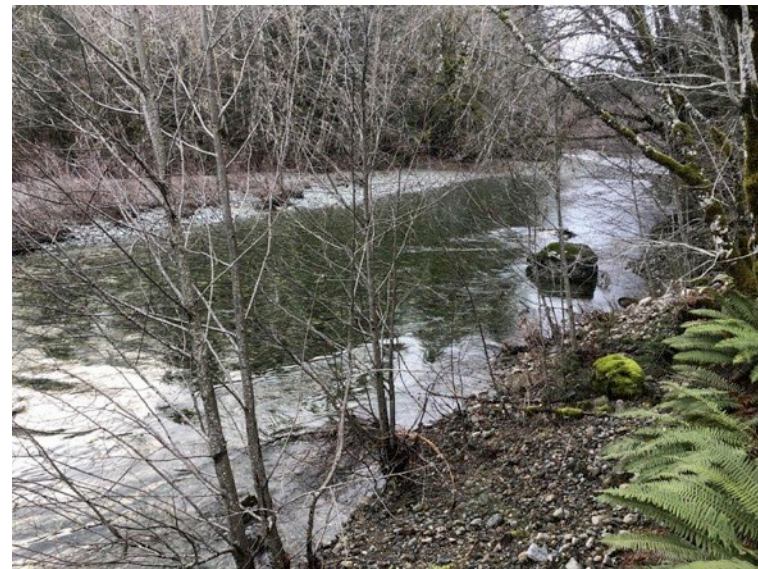
1.) R22 – Riffle 1 is 180m long and 0.3m deep. 2.) R22 – Glide 2 features a big rock

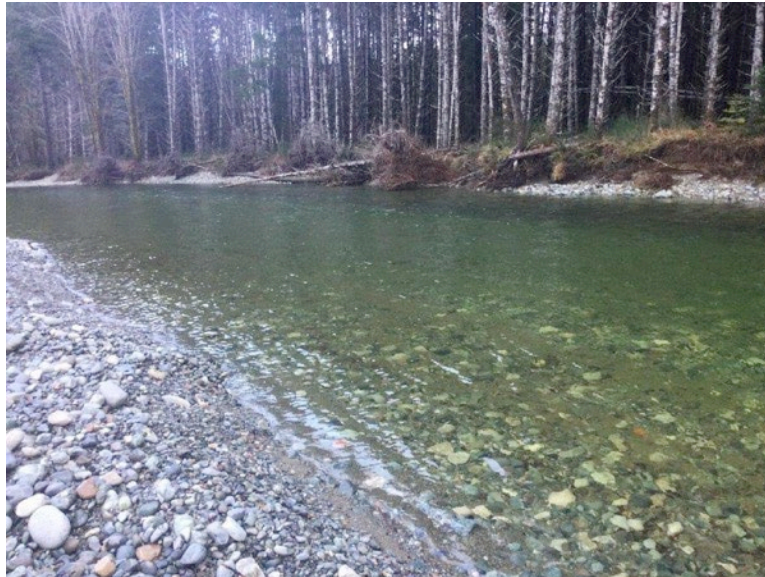
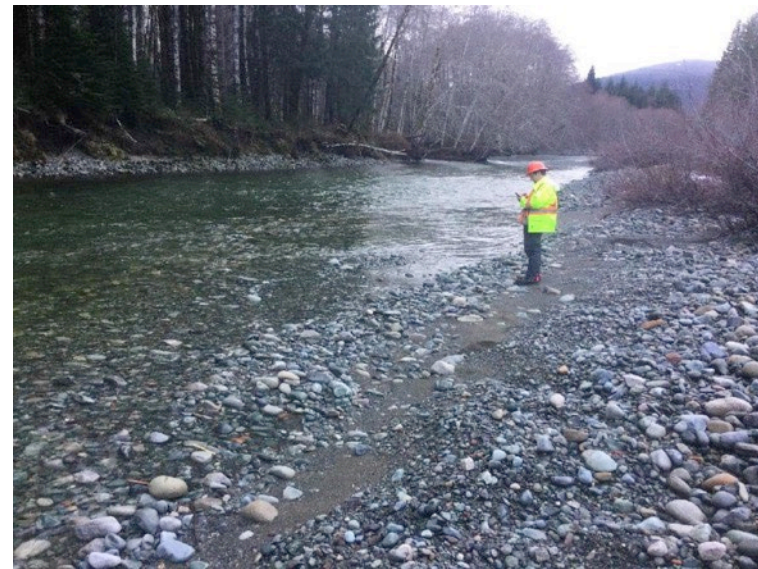
3.) R22 Pool 1 formed by meander scour on right bank erosion 4.) R22 Glide 3 erodes right bank along the alluvial fan

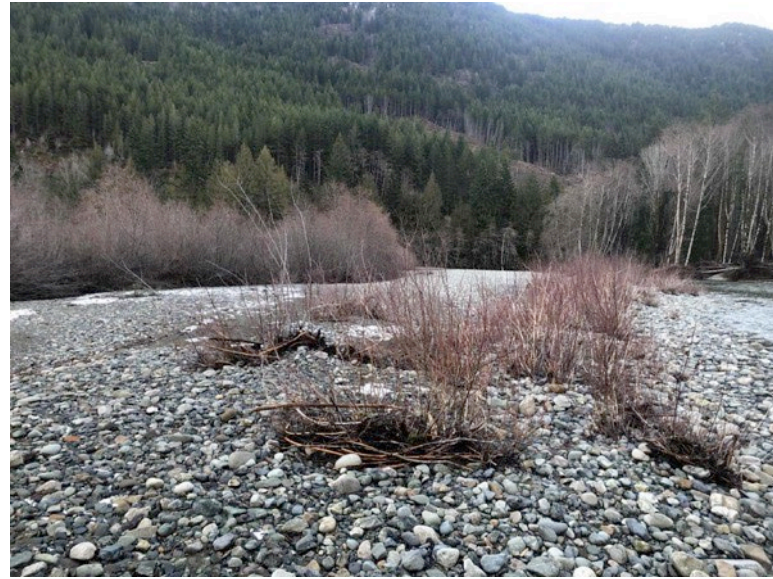
2.) R22 – Gravel bar looking downstream 400m
