Nanaimo River Chinook Salmon Recovery Plan Habitat Assessment Report.

Fisheries and Oceans Canada
Nanaimo B.C.

December 2021

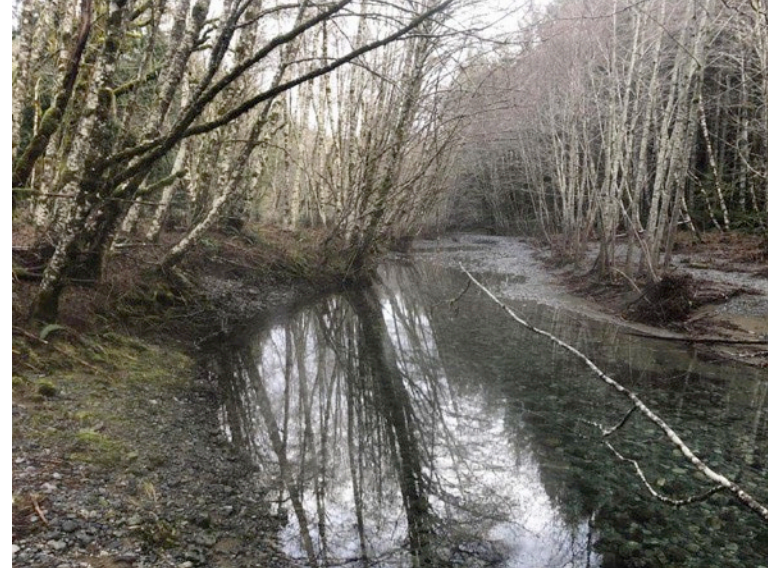
4.) R22- Sidechannel 4 (stn27) offers fish habitat

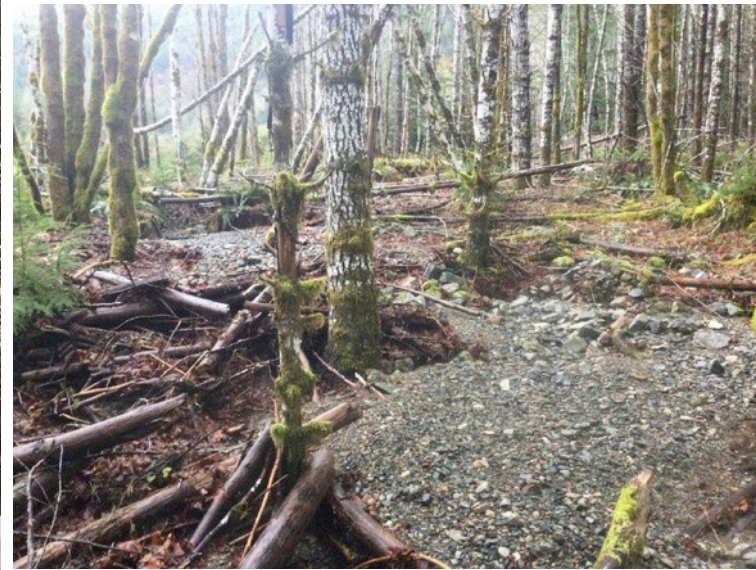
2.) R23 – Left bank Tributary channel disturbance (Site 21)

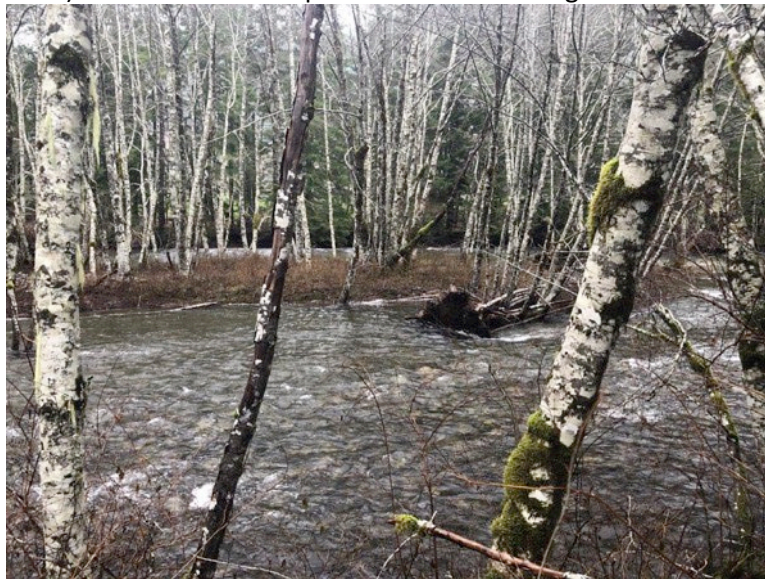
3.) R23 Braid at Stn 24 .

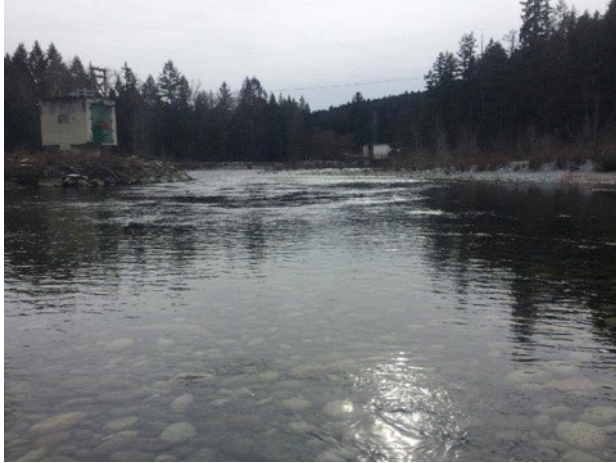
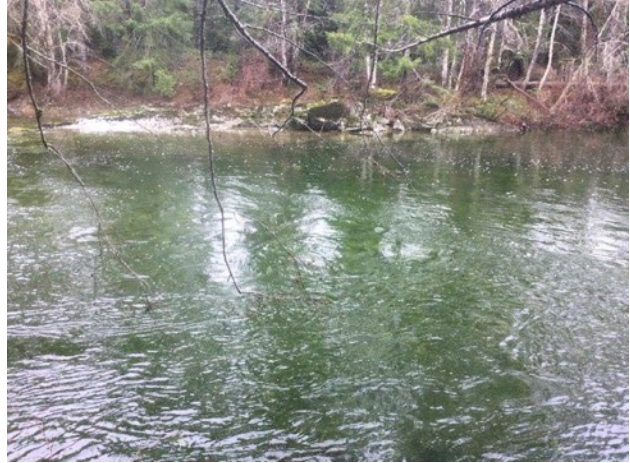
Cover in pools was ranked by percent wetted area with expected ranges of 5-20% of wetted area. Cover components included LWD, Vegetation, Rooted Bank undercuts and Boulders). The results of the survey were 2-7% total cover with a Poor rating in all but reaches 5 and 16 due to small amounts of Boulder cover. Cover in pools offers juvenile and adult salmon refuge as well as food supplies as the surfaces support invertebrates. The lack of cover is for the same reason as discussed above in the LWD section; the material has washed away. During our survey, despite higher water levels, pools were visible to the bottom, there was no cover blocking the view. Restoration efforts to improve cover include addition of LWD, Vegetation, Boulders or planting Vegetation. These items are best done in pools with high fish use and opportunity for success. Installation of LWD in Reach 3 and 22 is recommended. The Nanaimo hatchery (Napoleon) sidechannel was not included in the assessment but visual observations suggest the need for more LWD and/or brush bundles.

Reach 3 Pool 3 and Reach 18 Pool 1 have a lack of cover (LWD, Veg. Undercuts, Boulders)

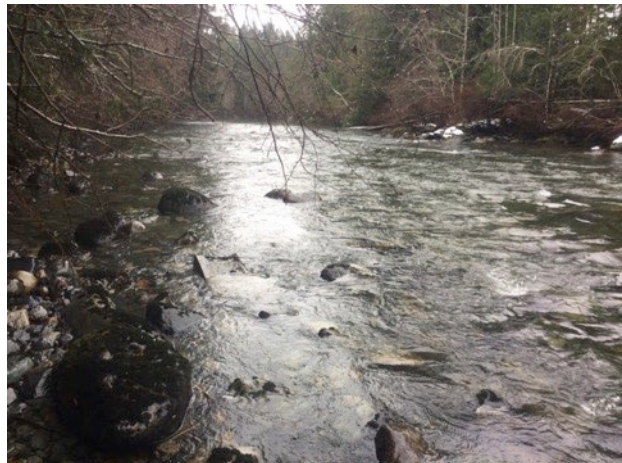
Reach 14 Boulder grouping offering cover and food production

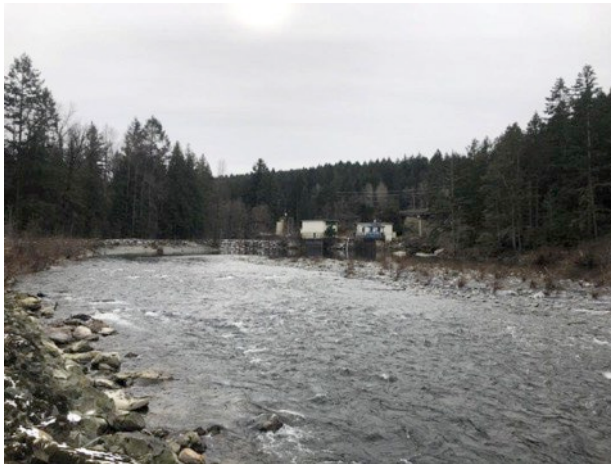
Alteration features in the river were relatively few but significant (Poor) in Reaches 3 and 16. Reach 3 has a 435m long alteration of the south bank from the concrete and rock Pulp Mill water intake infrastructure. This site has virtually no trees and no natural stream bank. Reach 16 above First Lake has a bridge footing and associated dredging and 80m of bank armoured.

Reach 3 has over 400m of armoured bank

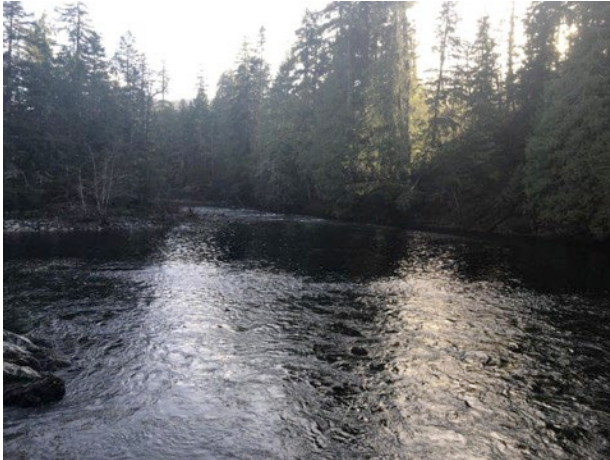
The only Pool in R12 is Jump Creek confluence pool

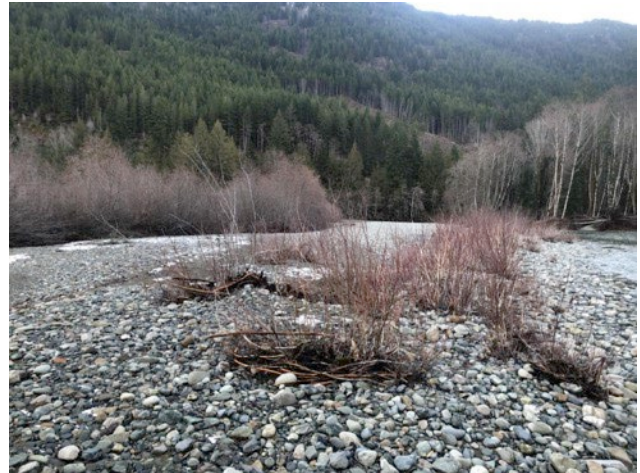
exception of Reach 5 with canyon pools. The Poor rating is partly a result of bank erosion increasing the width. In Reach 22 the river was over 90m wide in some eroded sections with a 45% wetted area, while nearby Reach 23 had 84% wetted area in an average of 35m wide channel. Reducing the bank erosion is key to maintaining water in summer. Wetted area can also be increased in summer by increasing the number and size of pools. One of advantages for the Nanaimo Watershed is having First, Second and Third Lakes accessible to anadromous salmon. The lakes increase the total wetted area significantly and offer refuge, holding and rearing habitat for salmon.

Reach 22 – Dry river bar in winter.
